Geotextiles and Geomembranes

Professional Practice Paper

Case history on failure of a 67 M tall reinforced soil slope

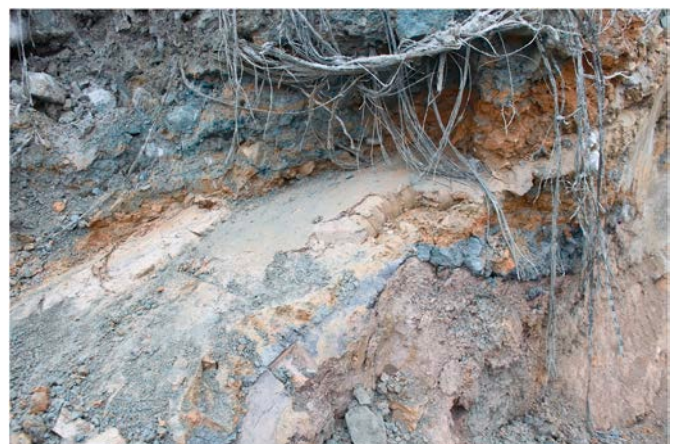
Fig. 2. Example of shear failure plane identified in the trenches excavated below the base of the RSS. (Photo credit: James G. Collin).

investigate and identify the stratigraphy and the location of the failure surface below the base of the RSS. Each trench was orientated in the same direction along a predetermined centerline. The trenches orientation and location were agreed on by the litigants in this case and were in the direction of movement of the RSS slide. Sheared failure planes were identified in these trenches and included failure planes of clay over top of coal seam, clay seam on top of rock, and clay to clay interface, see Fig. 2. A sheared failure plane, below a coal seam, on top of hard rock was found in several locations.

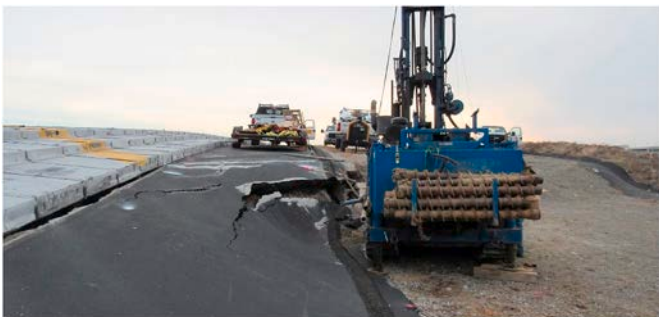
Fig. 5. Deformation at top of RSS structure and within the reinforced soil zone, approximately 1 month prior to collapse. (Photo credit: CWVRAA).

The large crest deformation of approximately 0.8 m that formed within the reinforced mass (see Fig. 5) approximately one month prior to collapse along this plane was a sign of impending failure of the RSS. Significant movement within the reinforced soil mass resulted in additional strain in both the soil and the geogrid soil reinforcement. As the soil exceeded its peak strength, additional load was shed to the geogrid soil reinforcement. The increased load on the geogrid mobilized creep of the geogrid that, in-turn, created more movement and load shedding to the geogrid; eventually leading to geogrid failure. Such failure would likely be progressive, though relatively quick, as zones of geogrid within the reinforced mass fail and result in higher loads on remaining layers of geogrid.

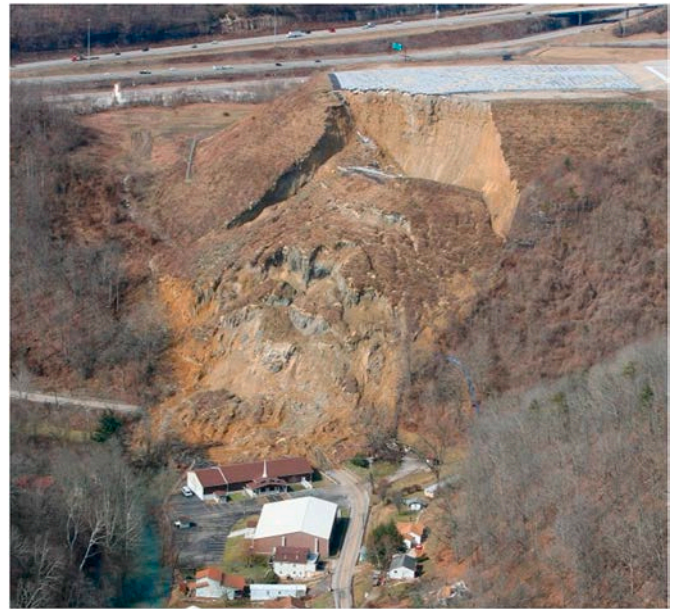
The slope catastrophically failed (see Fig. 6) on 12 March 2015 after 8.3 years in-service. The failure plane propagated through the reinforced soil mass, resulting in a head scarp that was near vertical for approximately 30 m in height (see Fig. 7). The failure surface sheared through more than 30 layers of geogrid, each layer had a manufacturer published minimum average roll value, MARV (ASTM D4439), ultimate strength of 187.8 kN/m, throughout the exposed head scarp. Rupture of the soil reinforcement in a failed RSS seldom occurs, and never to the magnitude observed at the Yeager failure.

Fig. 6. Aerial failure photo, prior to debris mass creeping over and destroying the church. (Photo credit: W.VA. National Guard).

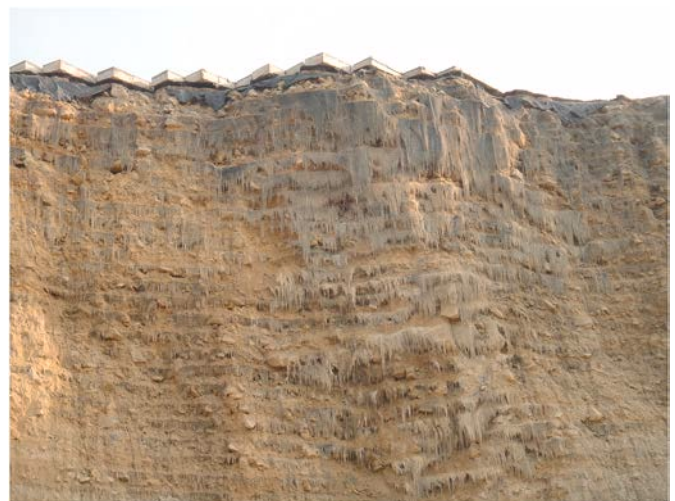
This RSS structure was in-service and performing adequately after it was constructed. Then, after 7 years in-service, a tension crack on top of the RSS was observed at a distance back from the crest of 53 m (the length of the geogrid layers), and monitoring of it began. Then about one month prior to collapse, a 0.8 m scarp developed over the reinforced soil mass at an approximate distance back from the slope crest of 28 m, as shown in Fig. 5. Something was changing with this structure, either the stability resistance was decreasing or the loading was increasing, or a combination of the two. On 12 March 2015, with 8.3 years in-service, this 67 m high RSS structure suffered a catastrophic collapse, as shown in Figs. 6 and 7.

Fig. 7. Photo of 30 m high failure scarp through the reinforced mass. (Photo credit: Ryan R. Berg).

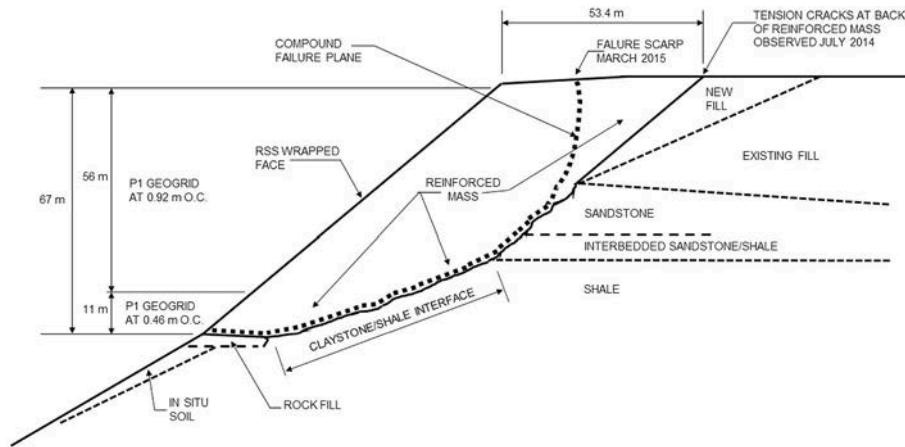
The geology and soils information gained from the combination of the subsurface investigations (previously discussed), as illustrated in Fig. 8, was used for the stability analyses. A cross section for the 2D failure analysis for the dry water assumption, with critical failure plane, is presented in Fig. 9. The stress pattern and failure surface from the numerical modeling is shown in Fig. 10. In all cases analyzed, the emergence of the shear failure surface is close (3 m) to the one observed in the field, 28 m back from the slope crest. The numerical analyses also found of a high stress zone at 53 m behind the crest where, after 7 years in-service, a tension crack on top of the RSS was observed. Results of the stability analyses are presented and discussed in Collin et al. (2020), and are summarized in Table 5.

Fig. 8. Cross-section of RSS with failure surface and soil/rock stratigraphy shown.

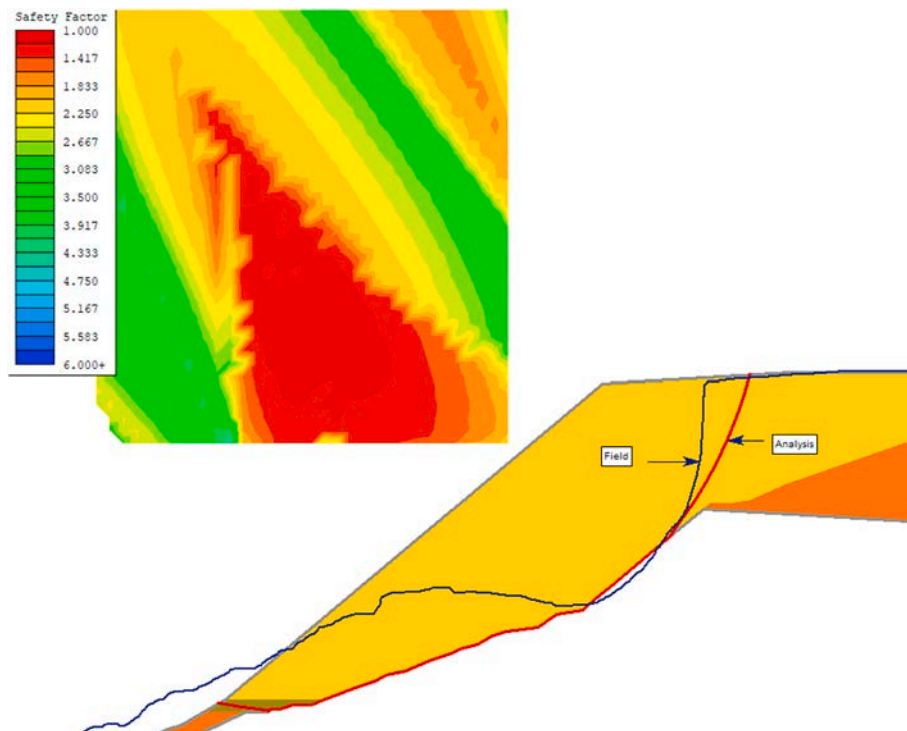
Fig. 9. 2D limit equilibrium analyses cross section and critical failure plane, with post-collapse geometry with debris surface, and field observed and analysis predicted scarps noted.

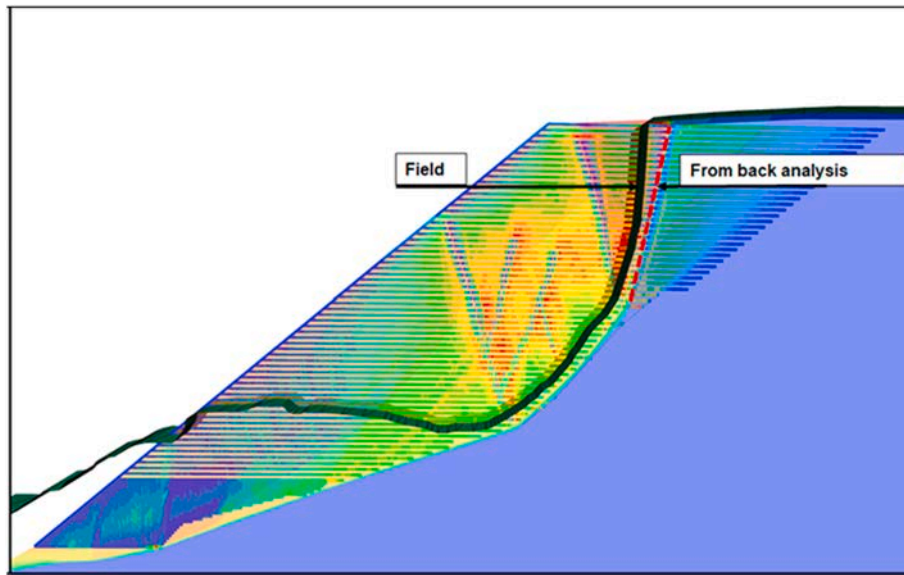
Fig. 10. Numerical modeling cross section with stress pattern at collapse (with stress levels increasing from blue to red) and post-collapse geometry with debris surface, and with field observed and back-analysis predicted scarps noted.

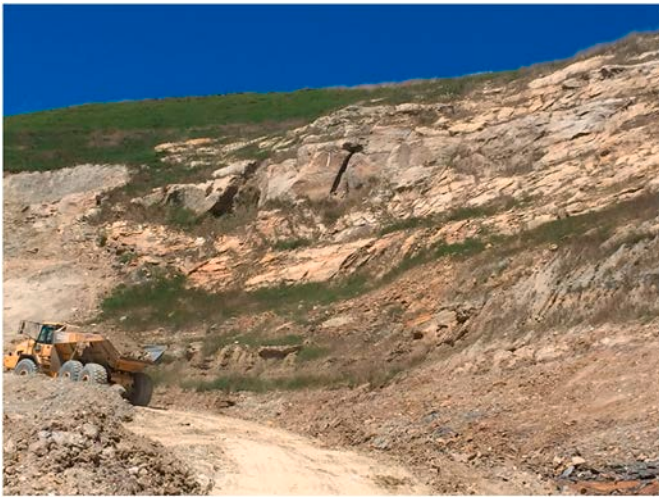
Behind the RSS mass, the failure plane followed the face of the relatively smooth and inclined sandstone rock (see Fig. 11). This rock face was fully exposed with slide debris removal. Movements along this interface may have mobilized residual interface shear strength. However, interface shear strength testing was not performed to quantify interface properties as our investigation deemed the foundation clay layer to be critical.

Fig. 11. Relatively smooth (non-benched) rock slope behind the RSS structure, after removal of slide debris. (Photo credit: Ryan R. Berg).

A comprehensively designed RSS would have been designed for minimum stability FS of 1.5, or higher. To achieve this, the primary features modified from the original design would include the following: The RSS base is founded on competent rock, by identification and removal of weak interface seams. The backcut into the rock is benched to
