# Avoiding Surprises in Slope Stability

By Timothy D. Stark, Ph.D., P.E., D.GE, F.ASCE, Brian H. Queen, and Hangseok Choi, Ph.D., P.E.

## A Unique Case History

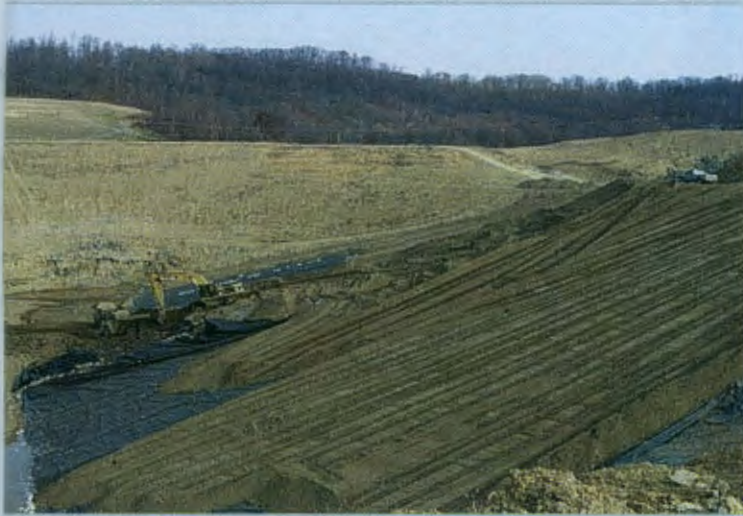
who were constructing the liner system, decided to save time by spreading the granular drainage layer (GDL) from the top of the slope to the bottom on the completed geomembrane (Figure 2). Landfill personnel who were performing the construction decided to spread the GDL from slope top to bottom because there was easy access for gravel trucks to unload at the top of the slope instead of accessing the bottom of the slope.

**Figure 2. Overview of sideslope and protective sand placement on geomembrane from top of slope to bottom.**

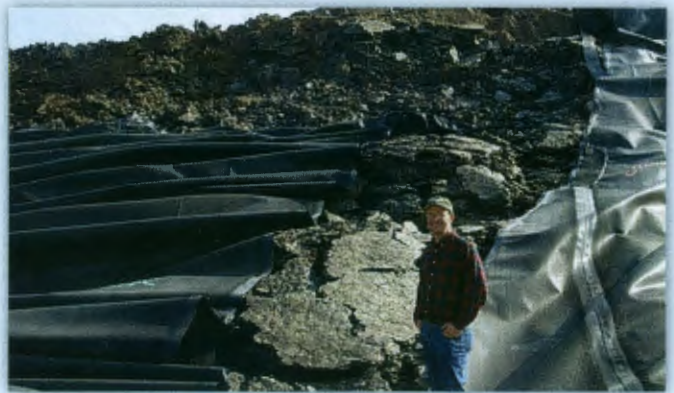
Figure 3 shows the damaged geomembrane near the toe of the slope due to the slope movement. This type of geomembrane damage is typical when slope movement occurs because the geomembrane and other geosynthetics easily tear under the applied shear and normal stresses. A view from upslope of the slide movement shows the drainage material overlying the torn geomembrane and the sliding surface below the torn geomembrane (Figure 4). The failure surface is located at a depth of 75–150 mm into the CSL and not at the geomembrane/CSL interface.

**Figure 3. Failed slope and damaged geomembrane.**

The repair of this slope failure delayed the construction for over a month and cost the facility hundreds of thousands of dollars. The slope was repaired by removing the GDL, the geomembrane, and the CSL down to a firm base, which involved the subgrade in some areas. Afterwards, the sideslope liner system was reconstructed, consisting of the CSL and the geomembrane, and then placing the GDL from the bottom to the top of the slope. A different on-site borrow source with a lower plasticity and in situ moisture content was used for the CSL. The CSL was placed in loose lifts a maximum 0.2 m thick with compaction to 95 percent of maximum Standard Proctor dry density. Each lift was kneaded into the underlying lift to help ensure integrity between the lifts.

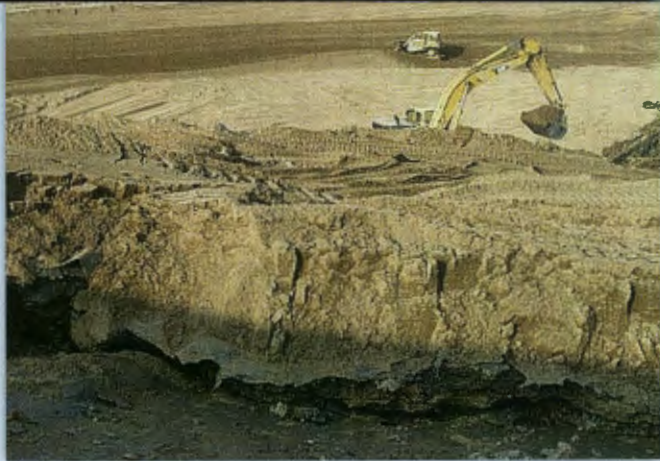
More importantly, Figure 4 shows that the failure surface extends the entire length of the slide because the GDL and geomembrane are missing from upslope of the slide mass to where the slide block stopped. A close look at the torn geomembrane (Figure 5) clearly shows the slide surface occurring below the torn geomembrane, from which it may be concluded that sliding occurred in the compacted CSL first and then the geomembrane tore as a result of this movement.

Figure 4. Slide surface and torn geomembrane.

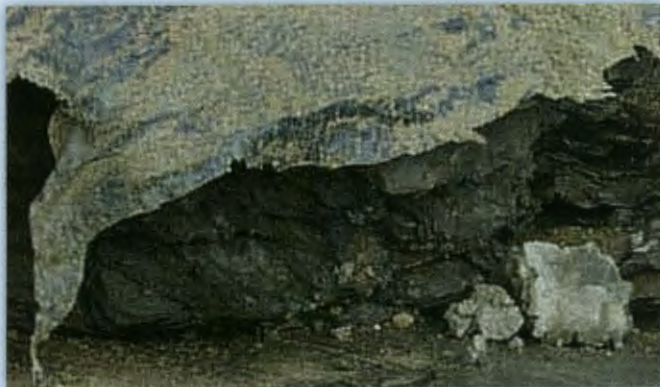
Figure 5. Close-up of torn geomembrane which shows slide surface is below geomembrane/CSL interface.

because the sliding surface was only about 75-150 mm below the top of the compacted CSL. Generally, a lift interface is deeper than that at the top of the compacted CSL, unless some additional material was placed on the top of the last lift so the final CSL thickness meets the regulatory requirement of about 1.5 m or final grade. Figure 5 shows the failure surface is slickensided, having a polished appearance, caused by clay particle reorientation into face-to-face/parallel arrangements. Slickensides occur when large strains or displacements are experienced along a well-defined failure surface.
