ANNUAL INSPECTION REPORT GERALD GENTLEMAN STATION ASH DISPOSAL FACILITY

Prepared By: Golder Associates Inc.
44 Union Boulevard, Suite 300
Lakewood, Colorado 80228

January 11, 2016

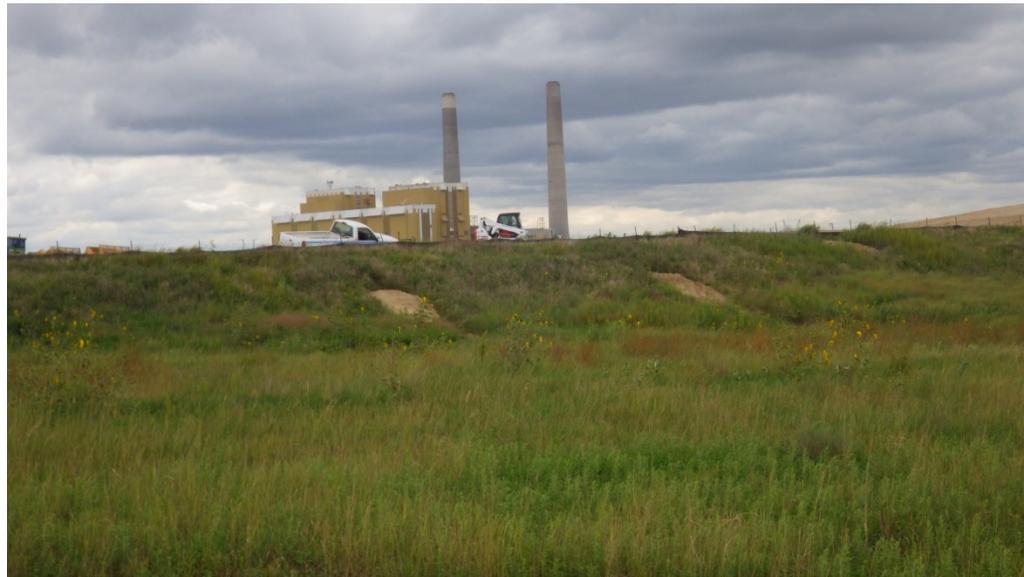
PHOTO 1

Minor erosional gullies were observed on the outer embankment slopes. NPPD has repaired many of the erosion gullies with soil fill, but vegetation has not yet taken hold in the repaired areas. Erosion of the exterior slopes should be monitored and NPPD should continue to perform routine maintenance on the slopes. NPPD should notify Golder of areas that are frequently eroded so that appropriate surface water controls can be developed.

Recently repaired exterior embankment slope.

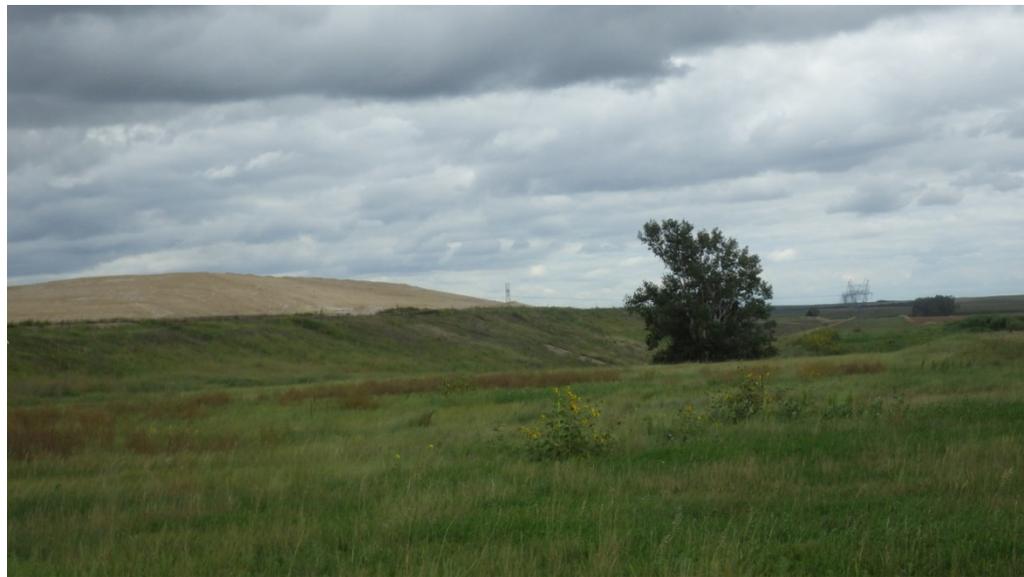
PHOTO 2

Vegetation on south embankment slope.

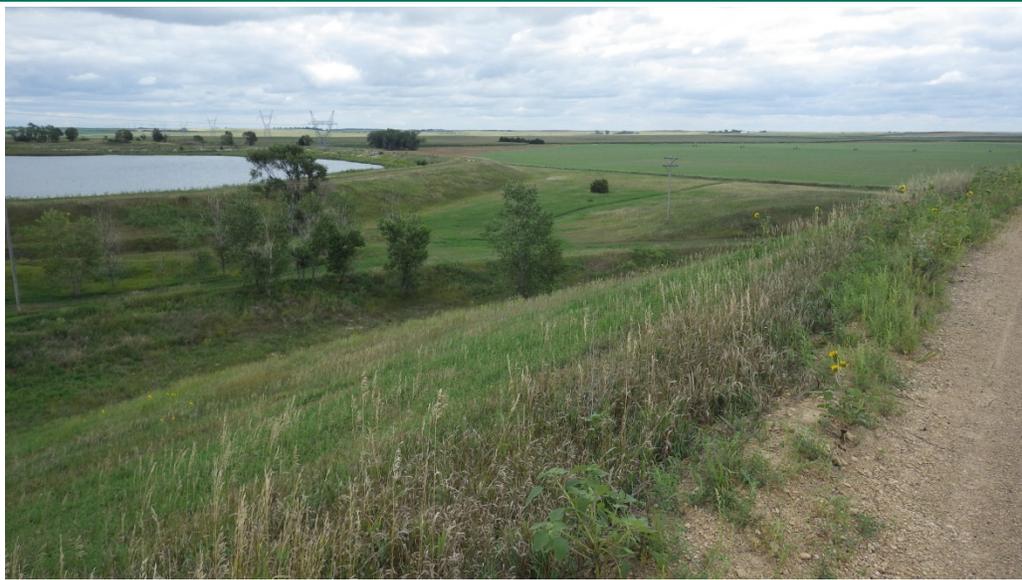
PHOTO 3

Vegetation on the east slope of the disposal facility (looking south).

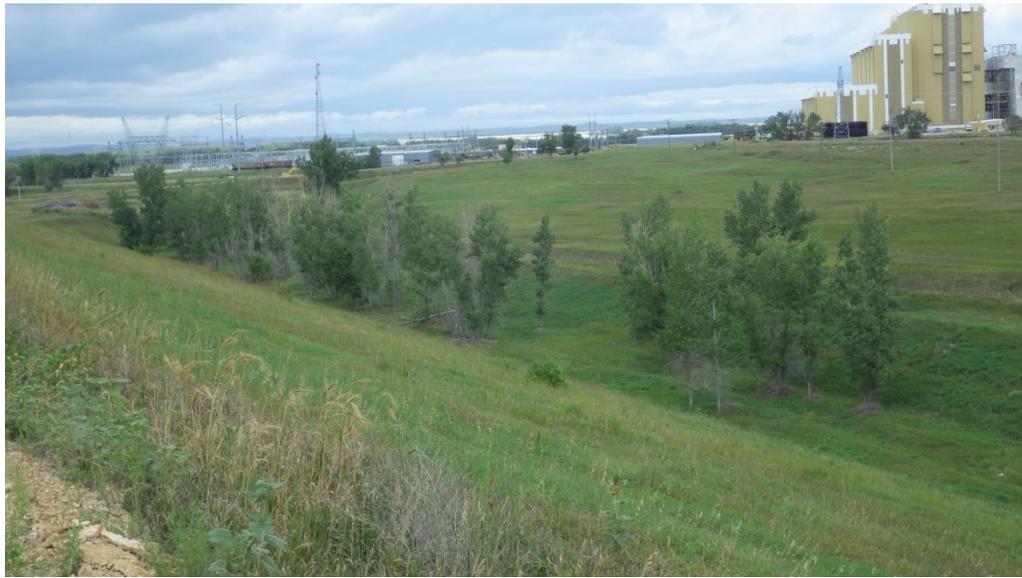
PHOTO 4

Vegetation on the east slope of the disposal facility (looking north).

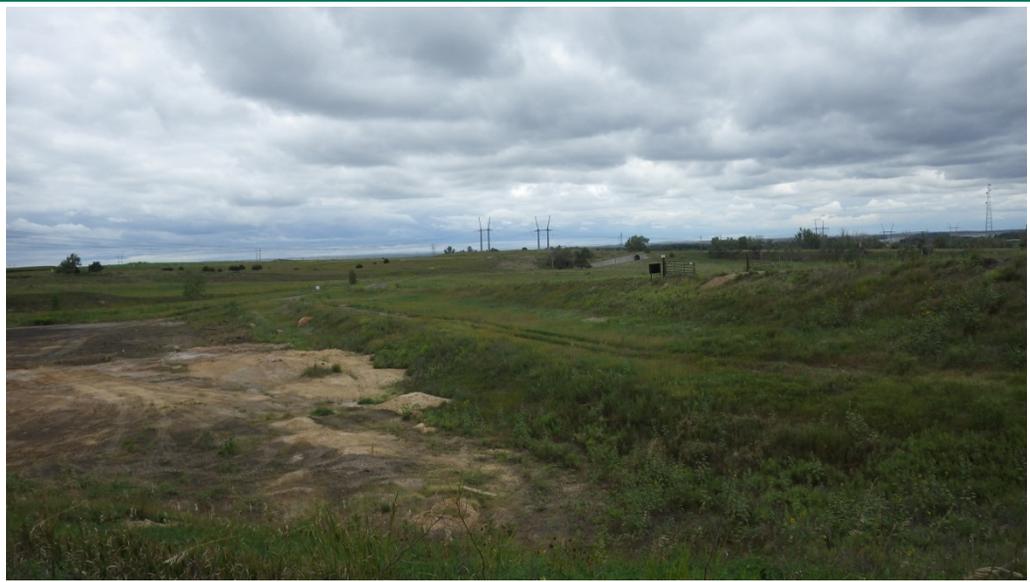
PHOTO 5

Bottom ash disposal area.

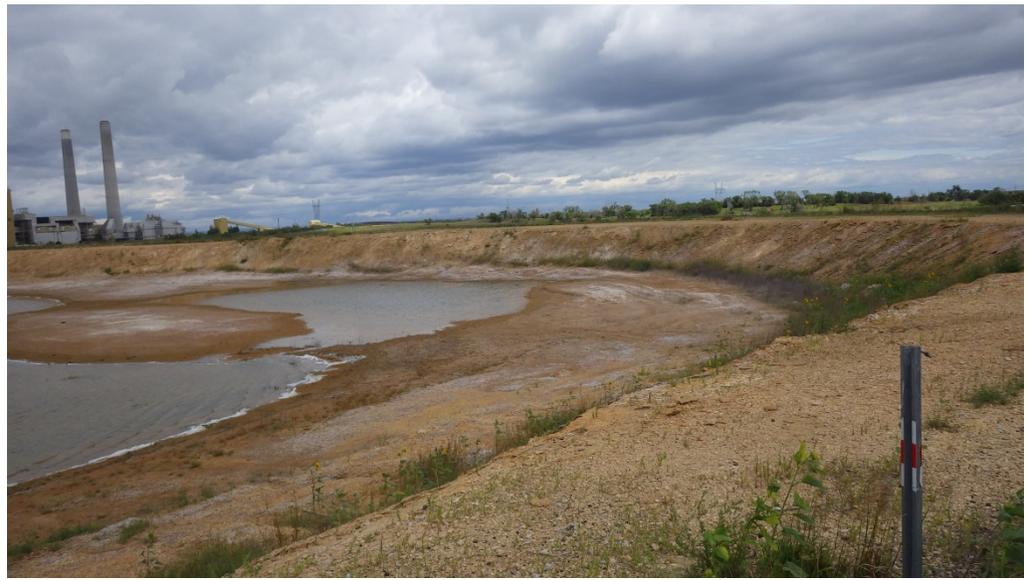
PHOTO 6

Contact water storage area.

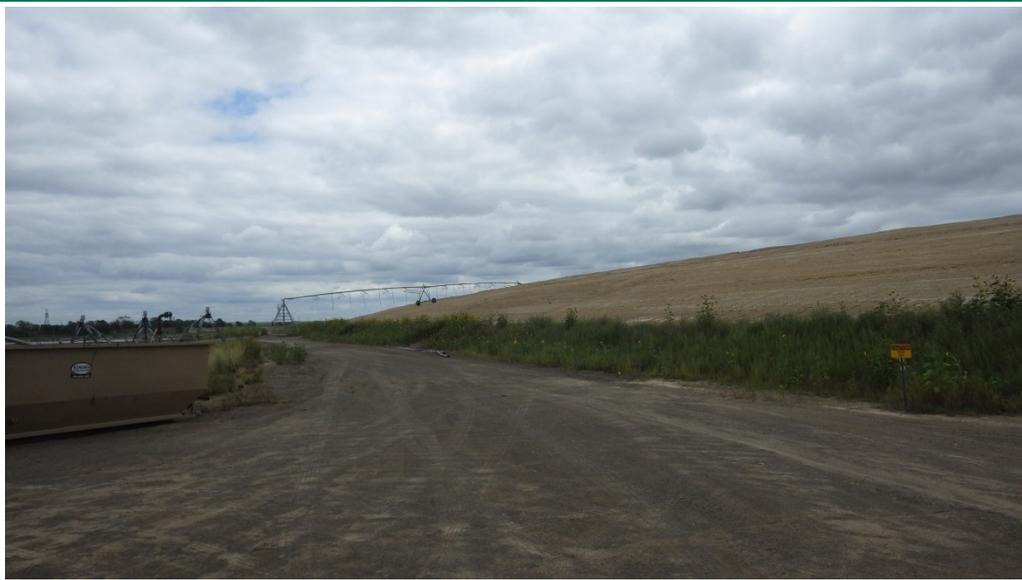
PHOTO 7

Perimeter road and contact water containment berm on north side of facility.

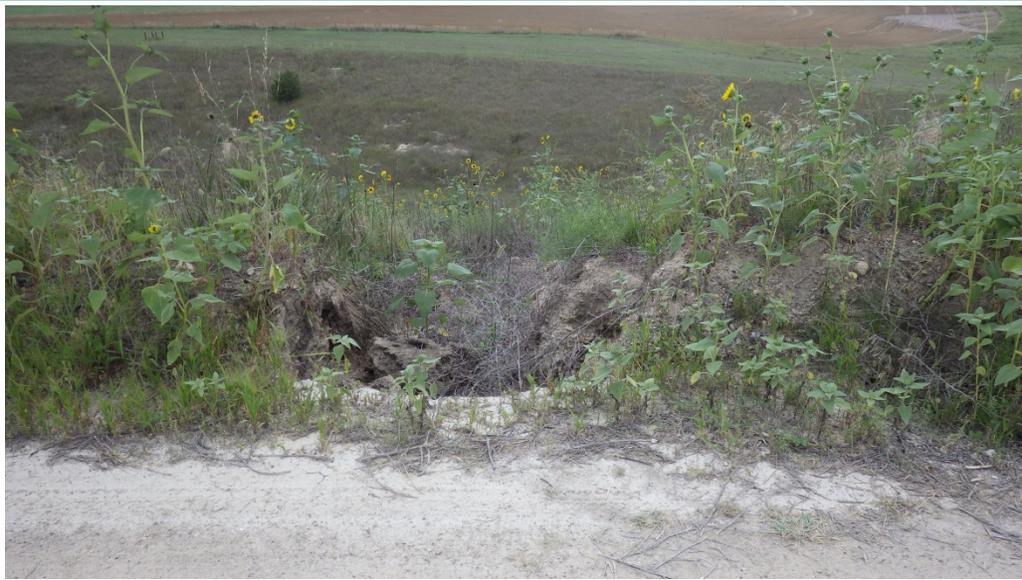
PHOTO 8

Evidence of burrowing animals was observed both along the top of the perimeter road (primarily small rodent holes) and at the toe of the outer slopes (likely badger holes), primarily on the opposite side of the drainage from the disposal facility. NPPD inspects the embankments weekly, and signs of burrowing animals are documented. Animal burrows on the embankment slopes are addressed and repaired as necessary.

Animal burrow on south embankment.

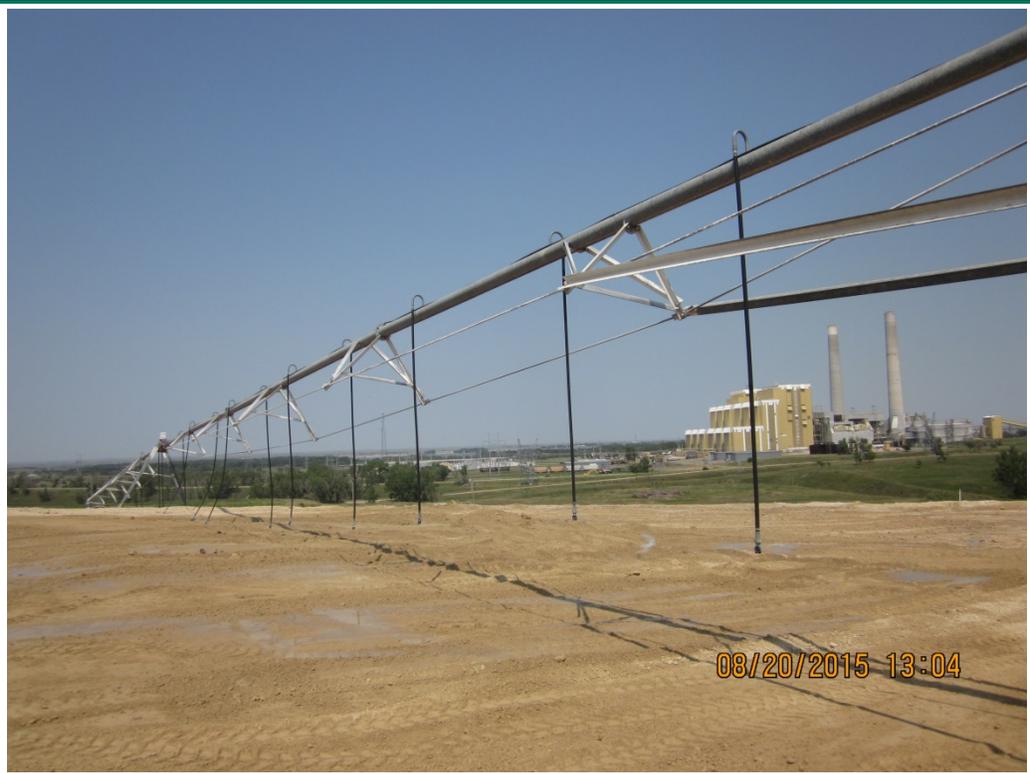
PHOTO 9

Center pivot for dust control on top of Ash Landfill No. 4.

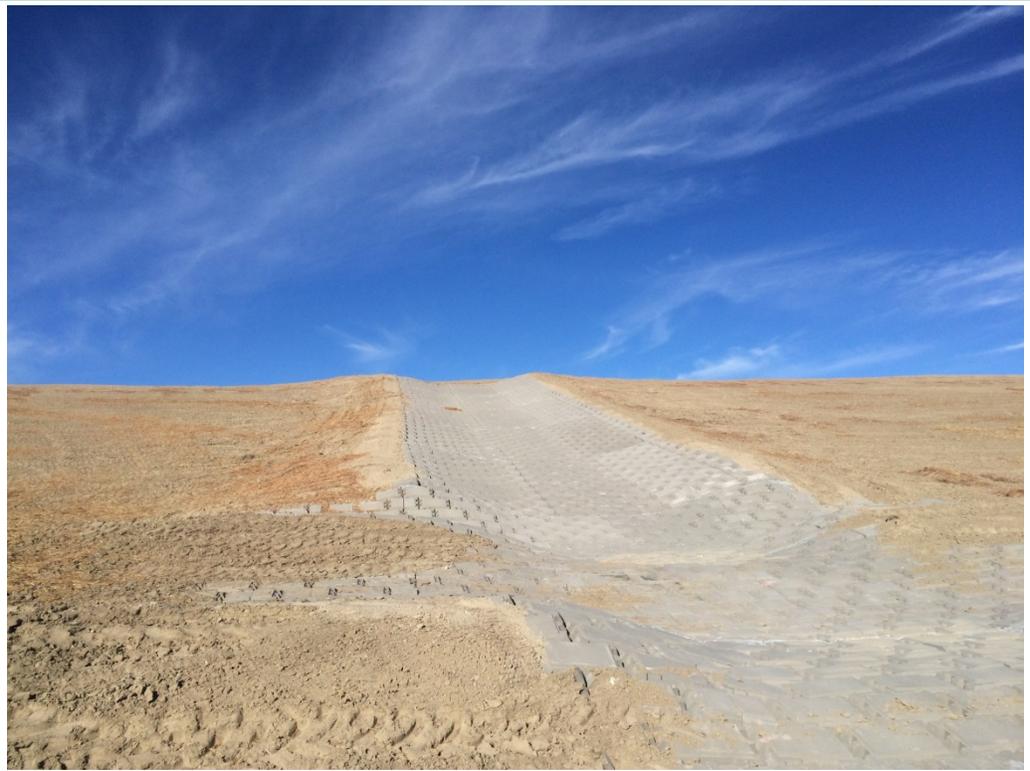
PHOTO 10

South slope of Ash Landfill No. 4 after partial final cover placement and downchute channel construction.
