# REPORT

Datum / <i>Date</i>	Beteckning / <i>Reference</i>	Sida / <i>Page</i>
May 29, 2001	P005566	1 (7)

## Fire test of loadbearing columns

Givent system

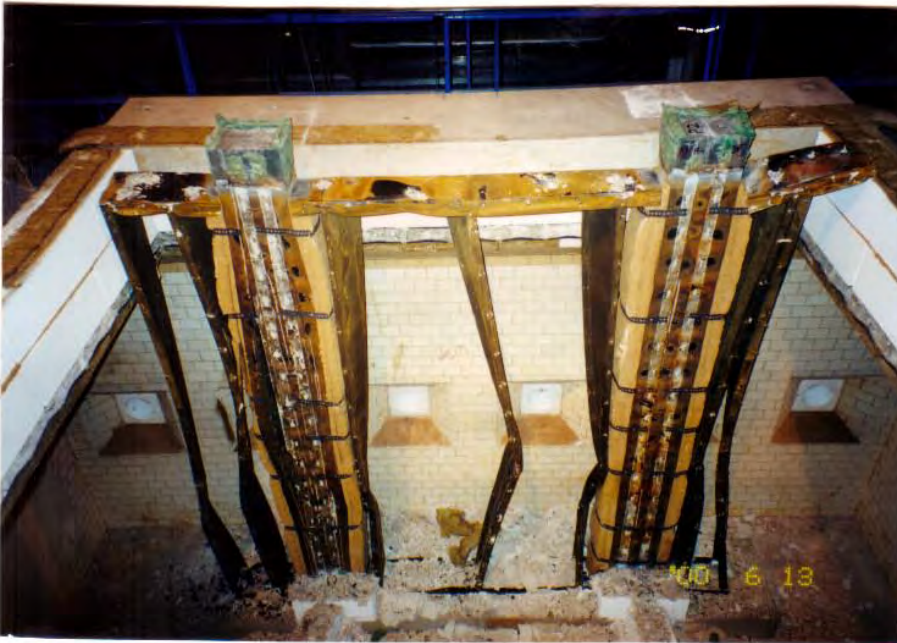
Picture no: 4  
*After the test*

The gypsumboard on the wall has fallen down and the girders has disorted because of the heat. The mineral wool insulation was still on place and looks undamaged.

The columns and the wall  
after the test.

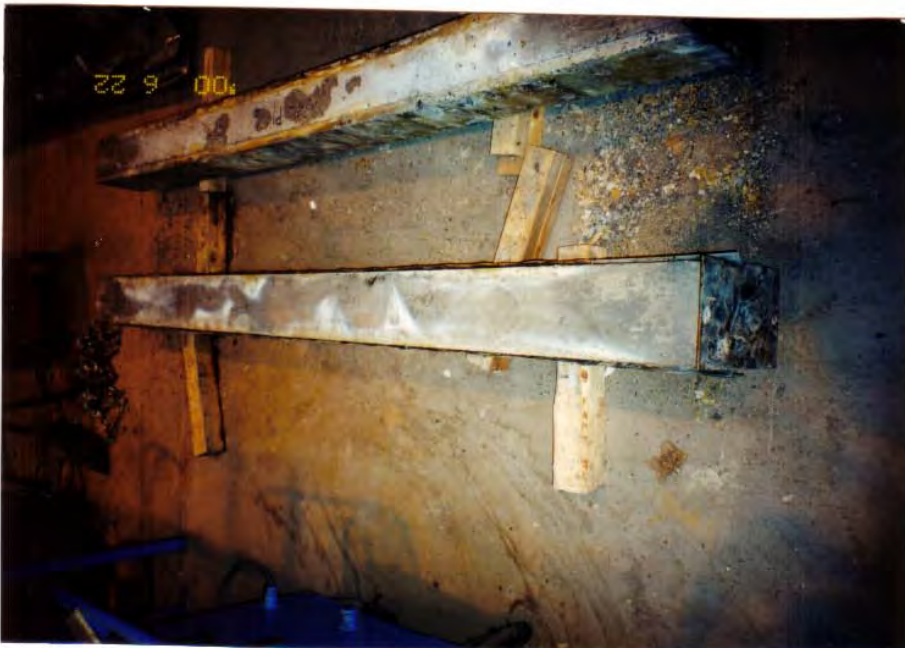
Picture no: 5  
*After the test*

Column type 2: The steel plate was embossed. No damage can be seen at the concrete.

The columns without the  
outer steel profiles.

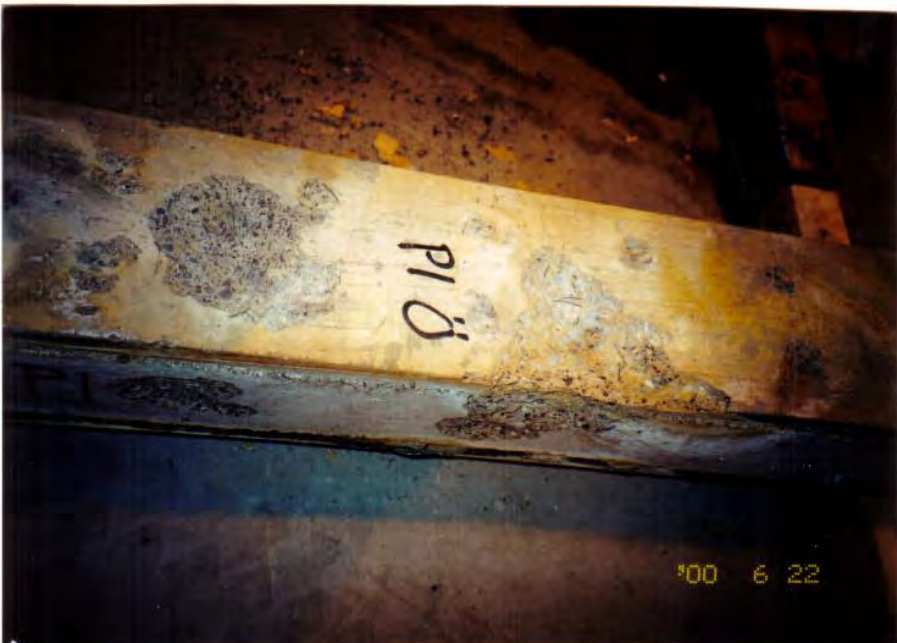
Picture no: 6  
*After the test*

92:40	Small flames occurs from the columns.
105:40	The fire exposed concrete at column type 1 has spalled in a thin layer.
122:30	The columns unloads.
122:30	Test terminates.

Column type 1: The steel plate and the flange at the northern side has split open in the middle. The opening is around 70 mm wide and around 500 mm long. The concrete has spalled in a thin layer in certain spots at the northern and eastern side. Most of the spalling was located in connection to the opening in the steel plate.

Spalling at column type 1.

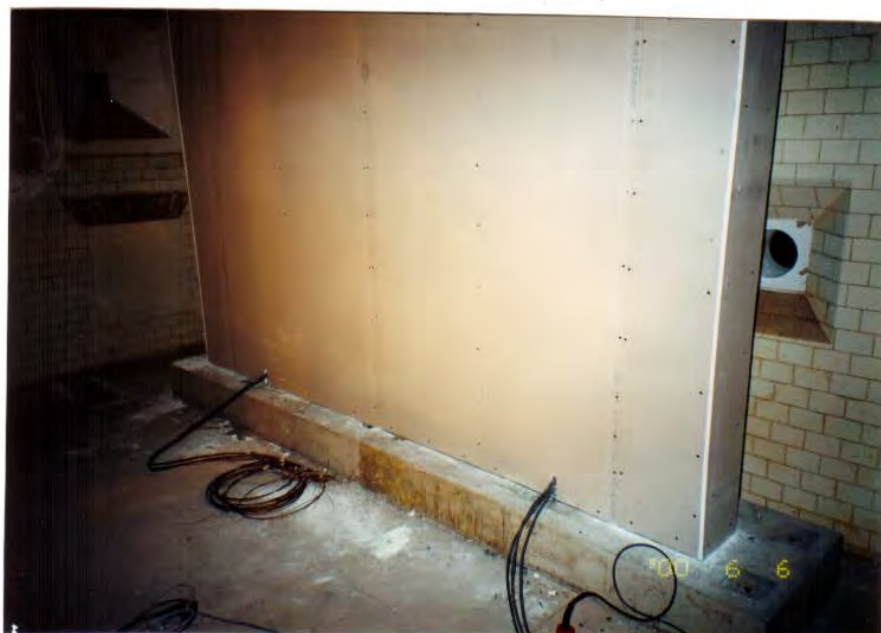
Picture no: 2  
*Before test*

The columns mounted in the  
furnace.
