Inspection Report

Station: Any Station Unit: 0 Report Name: 1-Superheater Secondary Inlet

AREA: Superheater Secondary Inlet

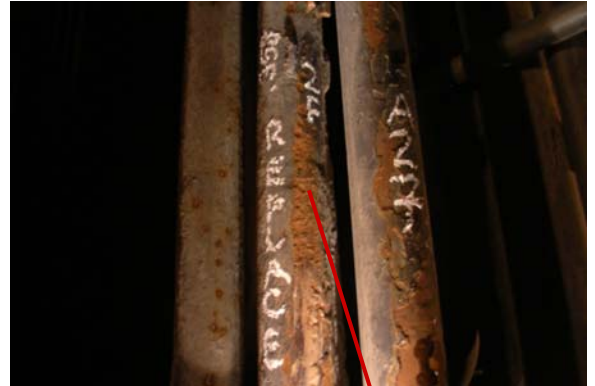
Repair #: 1-a Record:# 21
Action: TUBE REPLACEMENT-P1
Priority #: 1
Inspector: Smith J.

Appearance: Tube Wall Loss

Material: 1.028" ID x .611" MWT x SA-213T22

- Assembly/Tube(UT result)
- A27/2F(0.358)**
- A27/3F(not attainable)**

From the centerline of the lower loop bend, the cut lines will extend upward 2' and horizontally 1'. Note that both tubes have been previously pad weld repaired and the pad welds have washed out wherein tube material is exposed.

It is recommended that the following tubes be replaced for a length of 3' to include one (1) 90 degree lower loop bend:

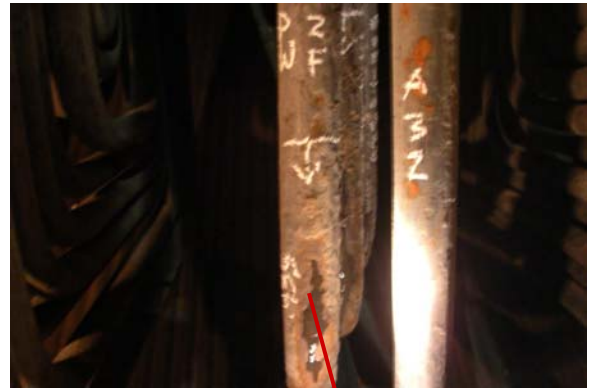
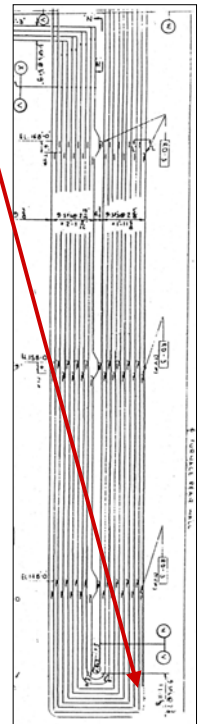
Repair #: 2-a Record:# 20
Action: TUBE RESTORATION WELD-P1
Priority #: 1
Inspector: Smith J.

Appearance: Tube Wall Loss

- A26/2F(0.434)**
- A32/2F(0.435)**
- A32/3F(0.420)**

Restore tubing to MWT by applying 18" x 2" pad welds on the leading edge side of the following assembly/tube(UT result):

The area to be pad welded will begin at the centerline of the lower loop bend and extend upward for a length of 18".

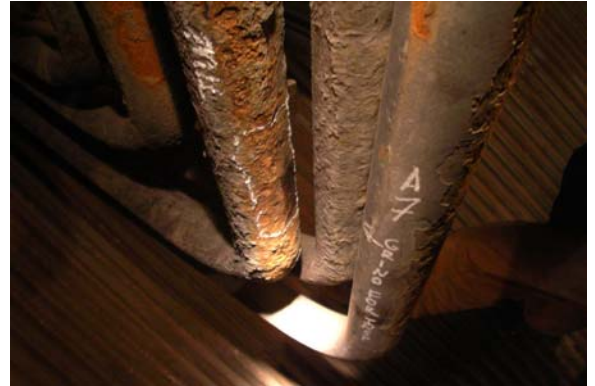
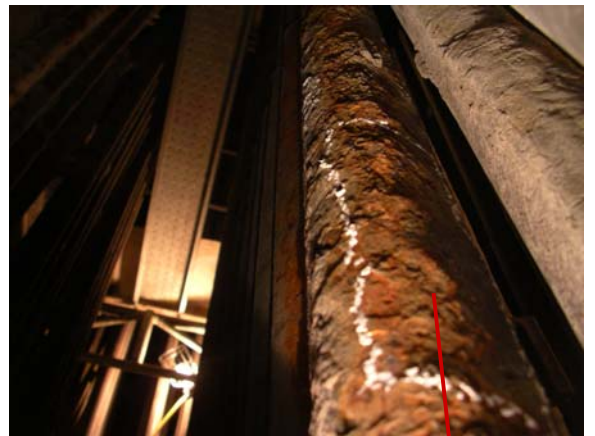
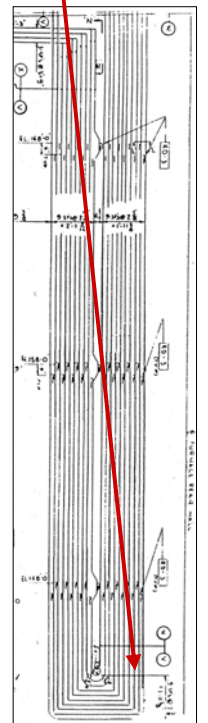
Repair #: 3-a Record:# 15
Action: GRIND FOR INSPECTION-P1
Priority #: 1
Inspector: Smith J.

Appearance: Tube Wall Loss

Grind a 6" x 2" (L x W) area on the leading edge of tube 3F at assembly 7 to a 'white' metal finish and call for re-inspection. As visually identified, a substantial amount of wall loss is evident. Given the current surface texture, UT could not be performed.

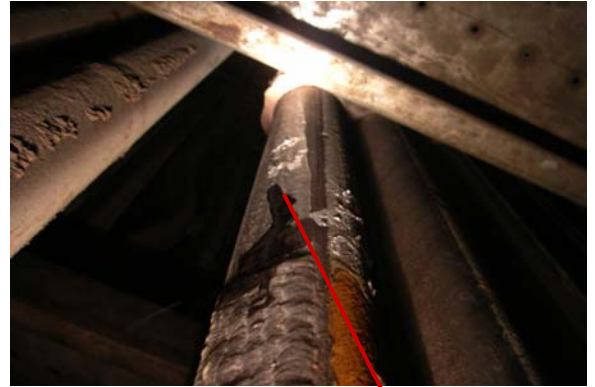
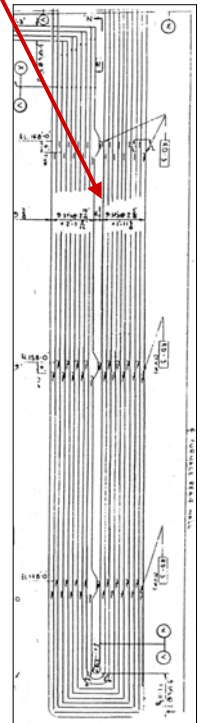
Repair #: 4-a Record:# 48
Action: TUBE RESTORATION WELD-P2
Priority #: 2
Inspector: Smith J.

Cause: Erosion (Soot Blower)
Appearance: Eroded

Restore tube 10F of assembly 18 by applying a 16" pad weld due to a remaining wall thickness of 0.395" (78% of MWT). The pad weld will be applied above an existing pad weld and extend to the split ring casting for the aforementioned length.

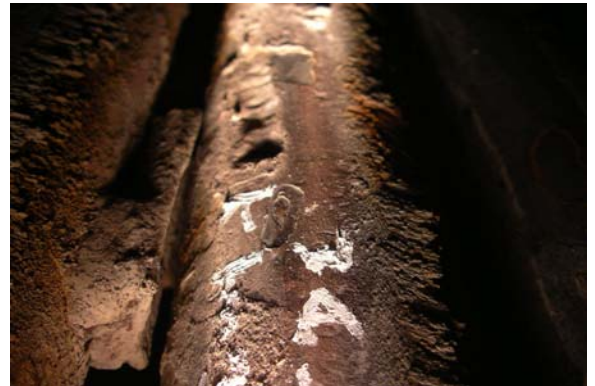
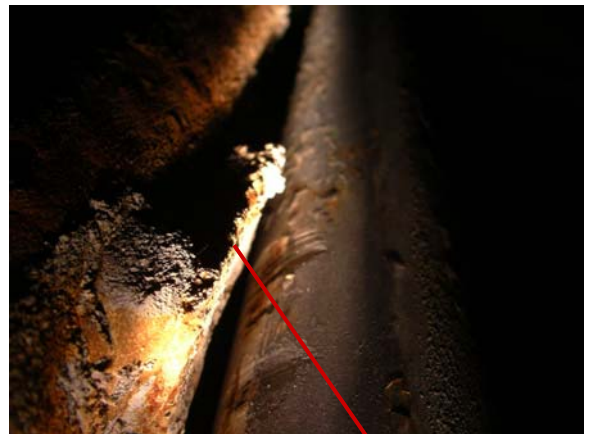
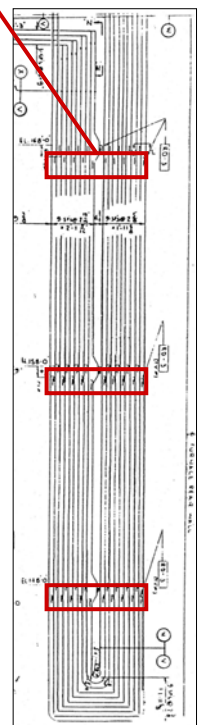
Repair #: 5-a Record:# 5
Action: FLEX TIE REPLACEMENT-P2
Priority #: 2
Inspector: Smith J.

Appearance: Failed/ Cracked Flex Ties

Multiple flex ties throughout assemblies 1 through 56 at elevations 148'0", 158'0", and 168'0" were identified as deficient with the following scenarios:

- (1) Completely failed
- (2) Cracked at the attachment weld
- (3) At the origin of failure, wall loss is present from weld fracture
- (4) Flex tie remnants at failure origin is abrading adjacent tubing
- (5) Tubing is out-of-plane 1 to 2 tube diameter from the centerline of the assemblies

It is recommended that all flex ties be replaced as documented in the spreadsheet at the close of this report. Note the following:

- (1) Install ties using the same rod as the parent material of the tube
- (2) Avoid installing the new tie in the previous location of the existing tie
- (3) Attach new tie a minimum of 3 inches from the previous location to avoid overlap of heat affected zones

As an alternative to flex tie replacement, consider installing split ring castings encompassing tubes 1F through 10F and 10R through 1R of all 56 assemblies at three elevations 149'0", 159'0", and 169'0".

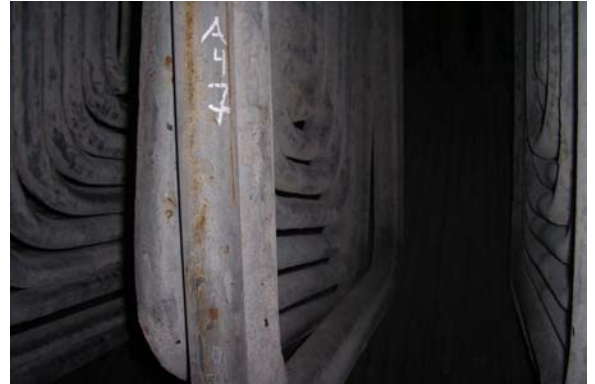
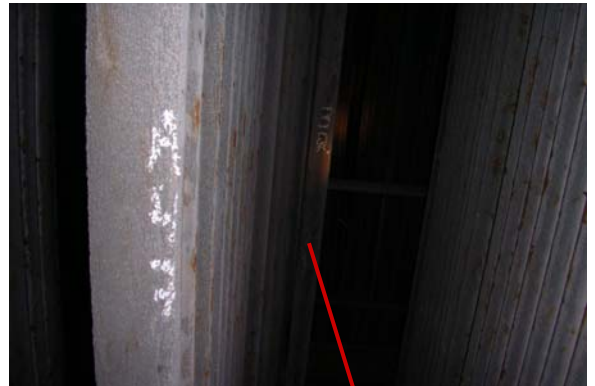
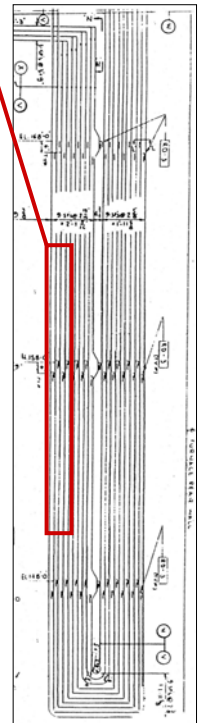
Repair #: 6-a Record:# 22
Action: ALIGN AND ATTACH-P2
Priority #: 2
Inspector: Smith J.

Appearance: Out of Alignment

Located at **assembly 47**, tubes 3F through 3R are out-of-plane from the centerline of the assembly approximately 1 tube diameter at the lower loop section (Elevation 143'0"). At elevation 153'0", tube 3R is bowed out-of-plane an estimated 1 to 1 1/2 tube diameters spanning for a length of 15'+. **It is recommended that the alignment of all tubing be restored; tube replacement may be required to restore the alignment of tube 3R.**

Consider using a 'vise' to re-position tubing and install split ring castings encompassing tubes 1F-10F and 10R-1R at elevations 149', 159' and 169'.

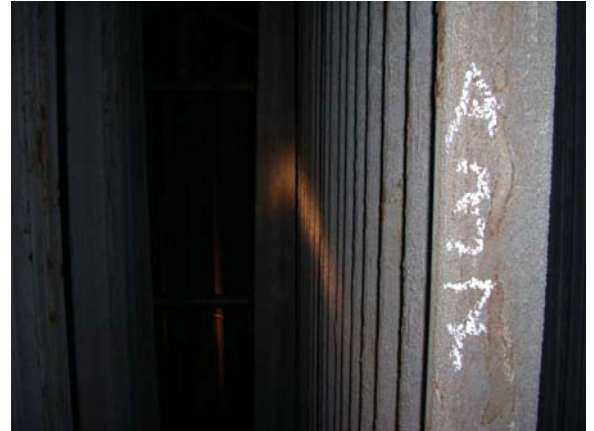
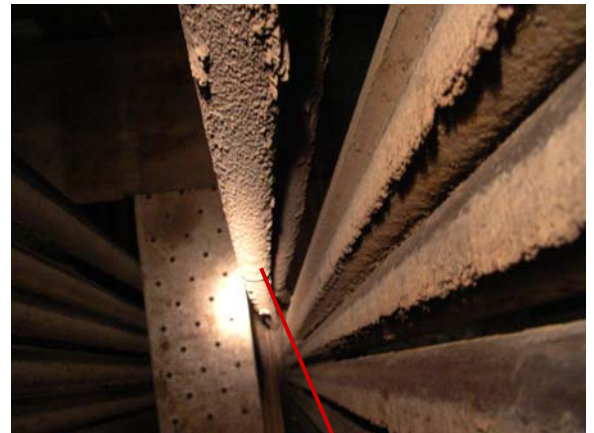
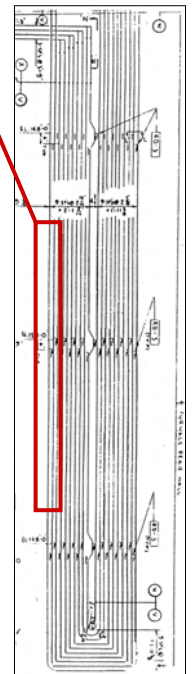
Repair #: 6-b Record:# 33
Action: ALIGN AND ATTACH-P2
Priority #: 2
Inspector: Smith J.

Appearance: Out of Alignment

At elevation 153'0", tubes 1R and 2R of assembly 37 are bowed out-of-plane an estimated 2 tube diameters spanning for a length of 20'+. It is recommended that the alignment of all tubing be restored; tube replacement may be required to restore the alignment of tubes 1R and 2R.

At time of flex tie or split ring casting installation, replacement may be necessary to align tube properly with assembly.

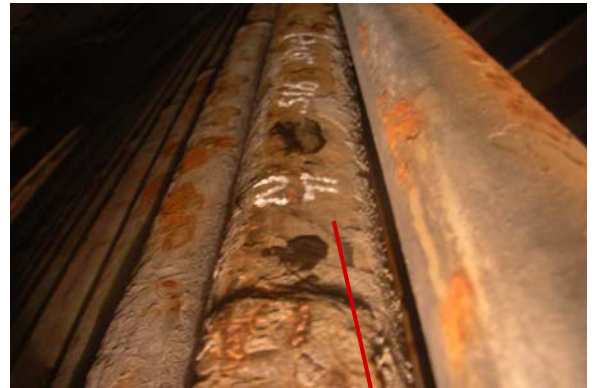
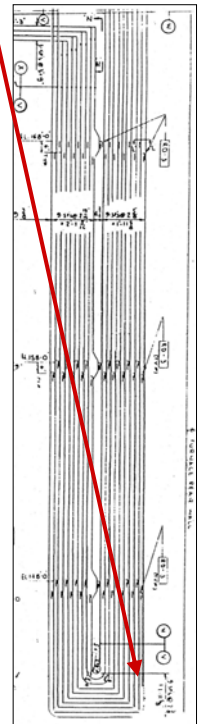
Repair #: 7-a Record:# 12
Action: MONITOR CLOSELY-P2
Priority #: 2
Inspector: Smith J.

Appearance: Tube Wall Loss

- A9/2F(0.516)
- A16/2F(0.504)
- A23/1F(0.539)
- A24/1F(0.530)
- A25/1F(0.529)
- A25/3F(0.490)
- A26/1F(0.537)
- A32/4F(0.528)

Currently, the tubing is within 76% to 85% of MWT as UT verified. Although this threshold is shield criteria, shielding is not recommended. Given the temperatures at this location, the shields are likely to degrade at a much higher rate from thermal fatigue.

During future overhauls, monitor the following SSH inlet tubes for further wall loss:

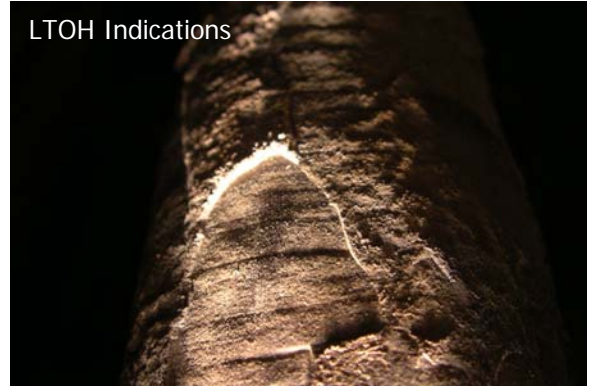
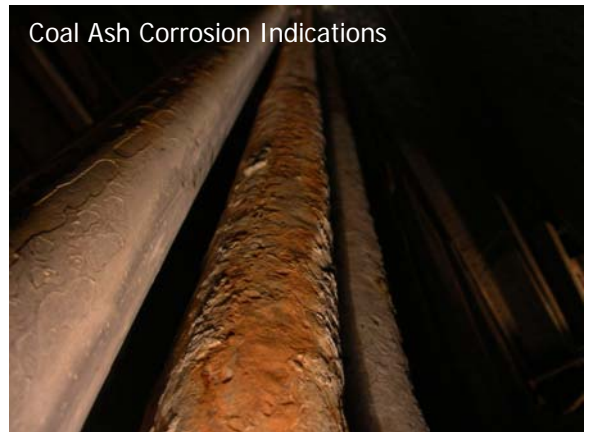
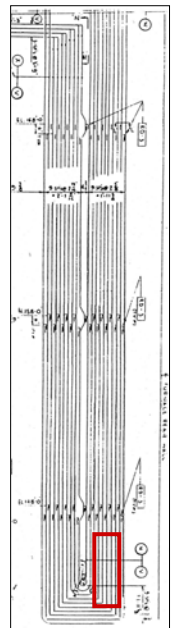
Repair #: 14-a Record:# 17
Action: REMOVE SAMPLE FOR ANALYSIS-P3
Priority #: 3
Inspector: Smith J.

Visual indications of LTOH (long-term overheating) and/or coal ash corrosion were identified on the leading edge of the SSH inlet component. The indications were most prevalent on tubes 2F through 4F at elevation 143'0" on assemblies 5 through 38. It is recommended that three (3) tube samples be removed for a metallurgical analysis condition assessment to verify the indications.

- (1) Have tube surface metal temperatures between 1000F (593C) and 1300F (704C). Maximum corrosion rates occur at 1200F (649C). High metal temperatures are likely to occur in tubes that surround a radiant cavity, are exposed to radiant heat, or contain the hottest steam prior to leaving the flue gas enclosure.
- (2) Have slag type corrosive ash deposits that are strongly bonded to the tube.

trisulfates in the ash deposits when the tube metal temperature is between 1000F (5930C) and 1300F (704C). Certain coals contain constituents, which form ash deposits that are corrosive in the molten form. The corrosion becomes a significant concern when the wall thickness reduces rapidly. The root cause of coal ash corrosion can be verified by determining the corrosiveness of the coal ash and by measuring the tube metal temperature under the ash deposit. Coals with chloride content of less than 0.2% and sulfur content of less than 3.0% have not produced significant corrosion rates. Temporary thermocouples on the tube surface can show whether the metal temperatures are within the range to produce a molten form of deposit. Combustion ash deposits should be removed for chemical and melting point analysis.

The external tube surface may have a thick hard oxide scale which could have an alligator hide appearance. High temperature creep (LTOH) occurs from a relatively continuous extended period of slight overheating above the design metal temperature, a slowly increasing level of temperature or stresses, or from the accumulation of periods of excessive overheating. Wall thickness measurements are necessary to verify that stress levels have not increased due to erosion or corrosion.

An alternative to removing tube samples which are believed to be affected from LTOH is oxide thickness testing. Remaining life of tubing can be predicted by measuring the thickness of the internal oxides on the ID of the tube.

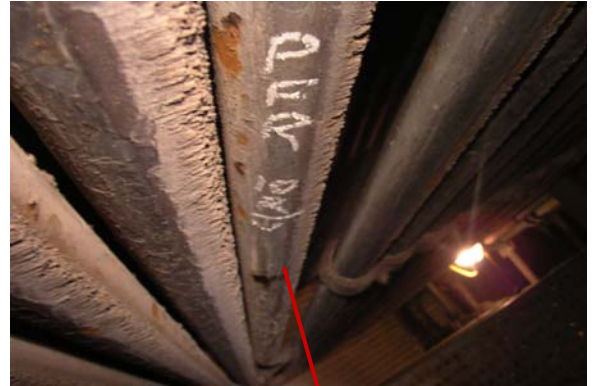
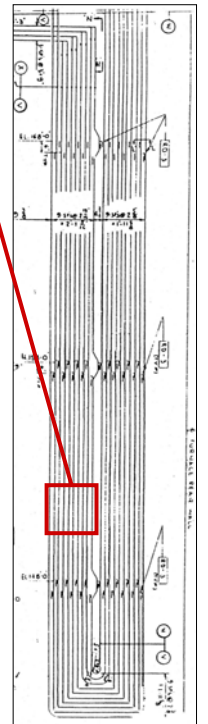
Repair #: 9-a Record:# 38
Action: PLAN FOR FUTURE REPLACEMENT-P3
Priority #: 3
Inspector: Smith J.

Cause: Erosion (Soot Blower)
Appearance: Eroded

Both tubes have been previously pad weld repaired and the pad welds have washed out wherein tubes are approaching base material.

Plan for future replacement of the following tubes within IK-13/14 path:

A47/1R(3' replacement): From the centerline of the blower, cut lines will extend up 18" and down 18"

A54/10R(4'6" replacement): From the centerline of the blower, cut lines will extend up 2'6" and down 2'

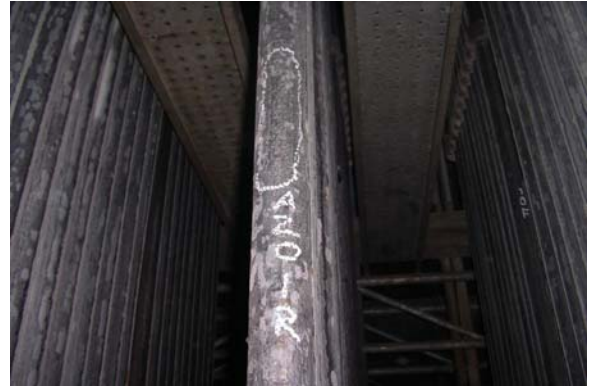
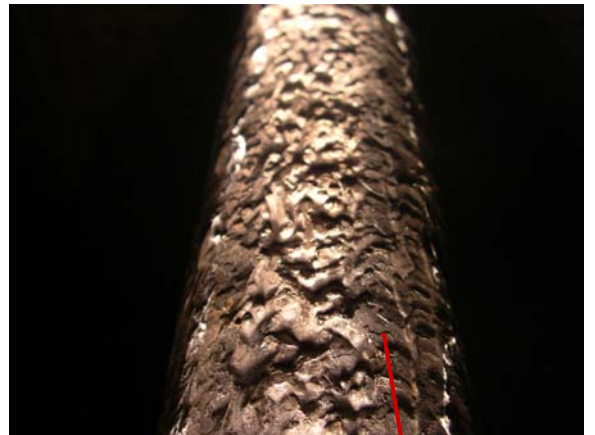
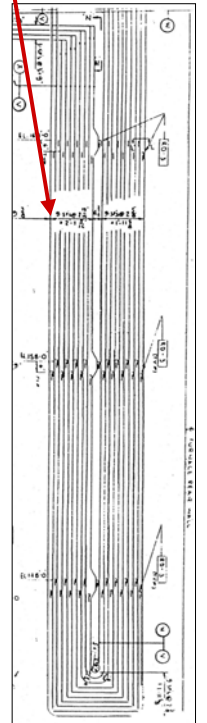
Repair #: 9-b Record:# 44
Action: PLAN FOR FUTURE REPLACEMENT-P3
Priority #: 3
Inspector: Smith J.

Cause: Erosion (Soot Blower)
Appearance: Eroded

Note: The pad weld on the tube has degraded and tube is approaching base material.

Plan for future replacement of the following tubes within IK-15/16 path:

A20/1R(3'6" replacement): From the centerline of the blower, cut lines will extend up 24" and down 18".

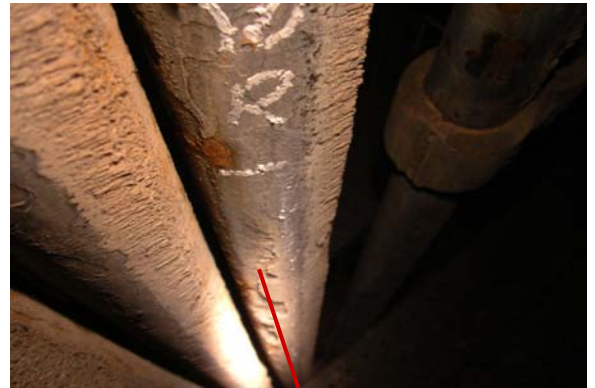
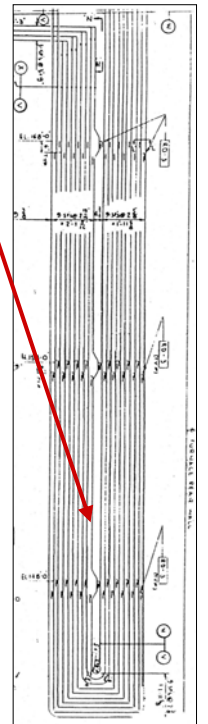
Repair #: 13-a Record:# 37
Action: MONITOR CLOSELY-P3
Priority #: 3
Inspector: Smith J.

Cause: Erosion (Soot Blower)
Appearance: Eroded

- A6/5R(0.610)
- A6/10R(0.575)
- A50/10R(0.569)

No repairs are required at this time; tubing is above 85% of MWT.

Monitor the trailing side of the following tubes within IK-13/14 blower path:

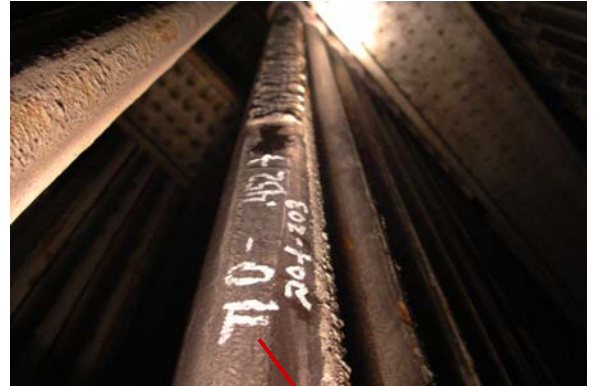
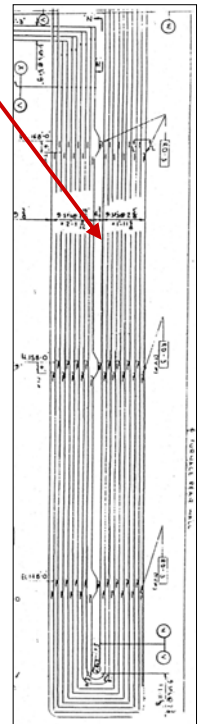
Repair #: 13-b Record:# 46
Action: MONITOR CLOSELY-P3
Priority #: 3
Inspector: Smith J.

Cause: Erosion (Soot Blower)
Appearance: Eroded

- A18/10F(0.452 - below existing pad weld)
- A19/10F(0.440 - above existing pad weld)

During future overhauls, monitor tube 10F of assemblies 1 through 56 for further wall loss from erosion degradation.

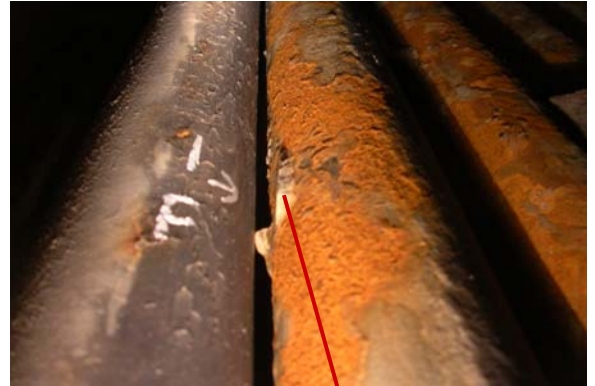
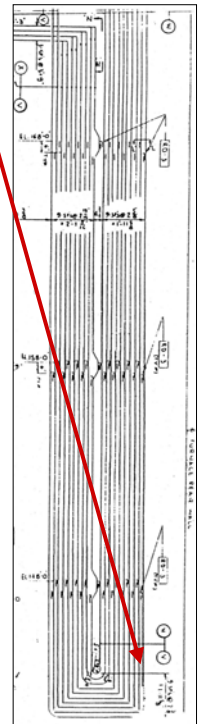
Repair #: 10-a Record:# 1
Action: FLEX TIE REPLACEMENT-P3
Priority #: 3
Inspector: Smith J.

Appearance: Failed/ Cracked Flex Ties

Flex ties were identified as either cracked or failed between tubes 1F through 3F on assemblies 1 through 56 at elevation 143'0". It is recommended that all flex ties at the aforementioned locations be replaced.

- (1) Install ties using the same rod as the parent material of the tube
- (2) Avoid installing the new tie in the previous location of the existing tie
- (3) Attach new tie a minimum of 3 inches from the previous location to avoid overlap of heat affected zones.

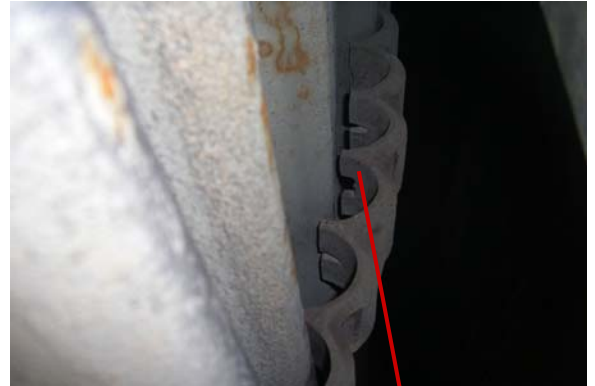
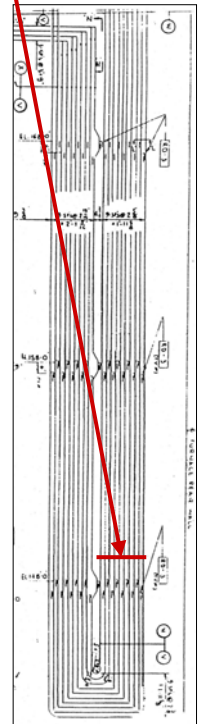
Repair #: 11-a Record:# 31
Action: SPLIT RING CASTING INSTALL-P3
Priority #: 3
Inspector: Smith J.

Appearance: Disengaged from Tubes

The split ring castings at elevation 150' on tubes 1F through 10F are starting to disengage at the following assemblies:

It is recommended that new castings be installed at the aforementioned locations.

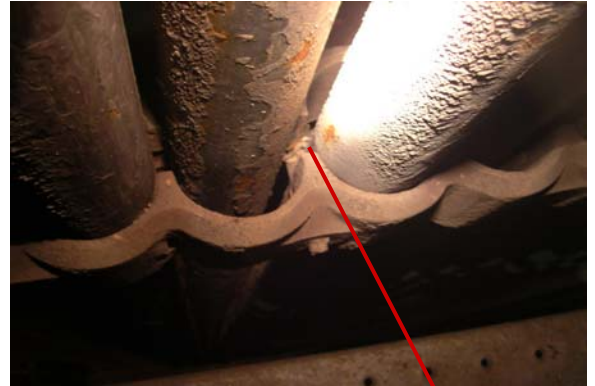
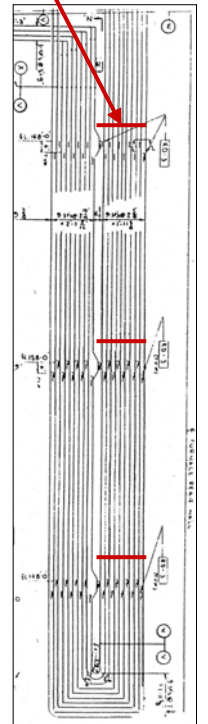
Repair #: 15-a Record:# 35

Appearance: Disengaged from Tubes

Tighten the hardware on the split ring castings which are beginning to extend off tubing at the following locations:

The installation of additional nuts and bolts may be required where missing. Once installed and tightened, apply a tack weld between the bolt and nut to secure position.

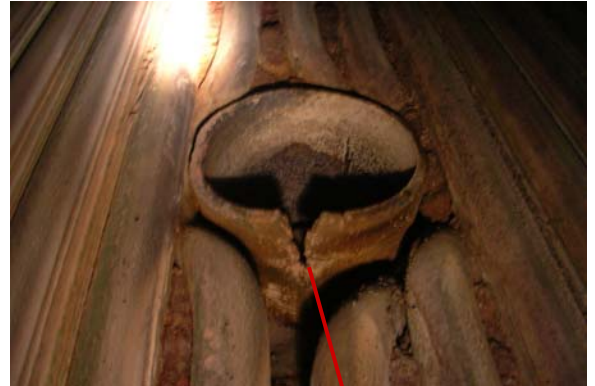
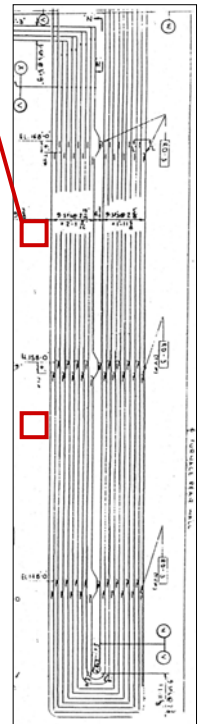
Repair #: 8-a Record:# 49

Appearance: Cracked Blower Sleeve

Weld repair the cracked blower sleeves at the following IK blowers:

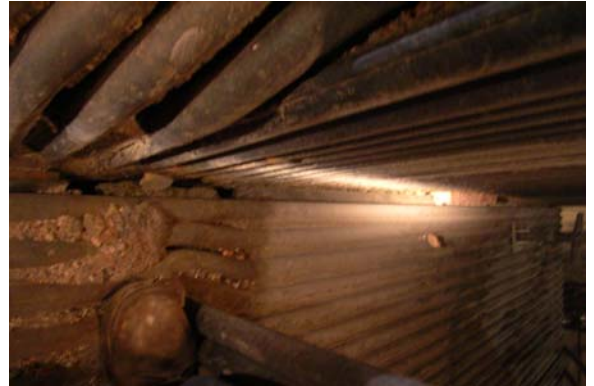
Repair #: 12-a Record:# 23
Action: REFRACTORY INSTALLATION-P3
Priority #: 3
Inspector: Smith J.

The refractory seal between the rear waterwall upper slope and both left and right sidewalls has deteriorated and is no longer present. It is recommended that a new refractory seal be installed at both sidewalls spanning from the rear WW screen tubes to the nose of the deflection arch.

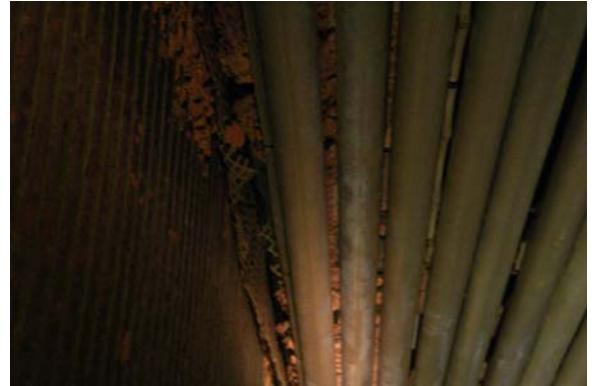
Repair #: 12-b Record:# 53
Action: REFRACTORY INSTALLATION-P3
Priority #: 3
Inspector: Smith J.

The refractory seal between the roof tubes and both left and right sidewalls has deteriorated and is no longer present at various locations. It is recommended that a new refractory seal be installed at both sidewalls spanning from the front WW to the rear WW screen tubes.

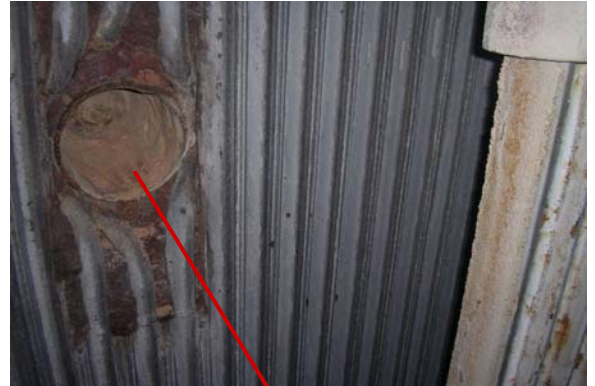
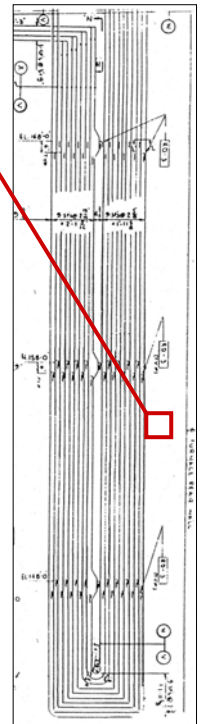
Repair #: 17-a Record:# 28
Action: VERIFY IK BLOWER FUNCTIONALITY-P3
Priority #: 3
Inspector: Smith J.

As interpreted from the fused ash on the leading edge side of the assemblies and the ash accumulation in the blower sleeves, either:

- (1) IK-9/10 blowers are not being used
- (2) IK-9/10 blowers are non-functional

Inquire with operations to determine if blowers are no longer in use.
