STRAIGHT·UP  
INSPECTIONS

# CERTIFICATE OF INSPECTION

Client	J Sample
Address of Property	Sample Street, Tauranga
Inspector	Alistair Simpson
Company	Straight Up Inspections
Position	Director
Qualifications	Builder
Date of Inspection	28 Jan 2019

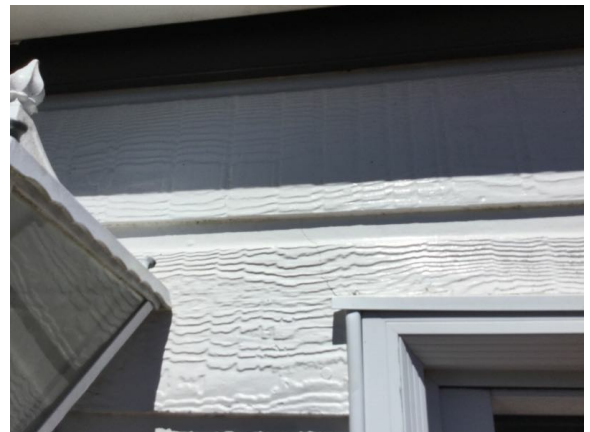
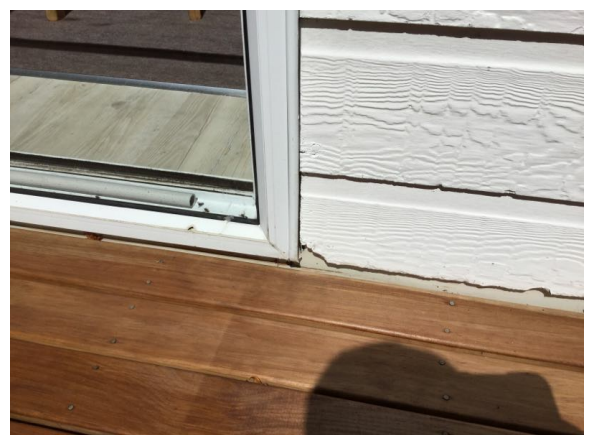
## Exterior - Weatherboard/Plywood Defects

There are two broken weatherboards beside the dining room ranch slider on the northern side of the building. These broken weatherboards can lead to weathertightness issues so should be replaced. Further investigation is required by a licensed building practitioner.

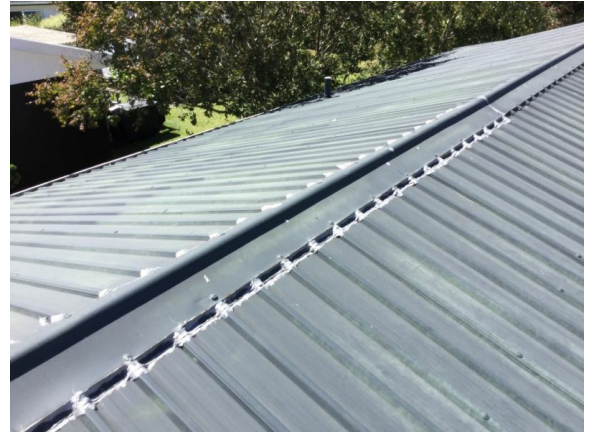
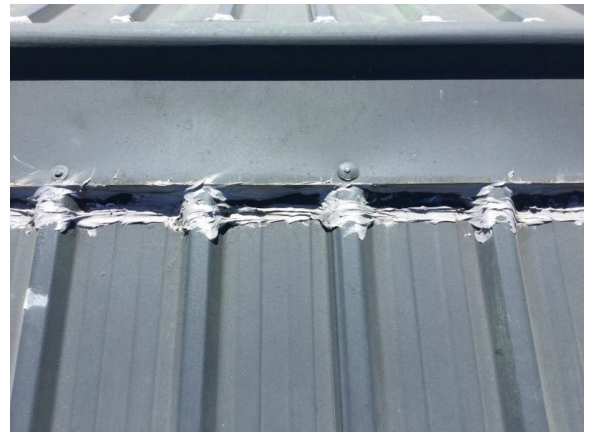
## Roof - Profiled Metal Defects

Silicon repairs have been made to the ridge flashing. This is a temporary fix and the flashing will need to be replaced in time. Further investigation is required by a qualified roofer.

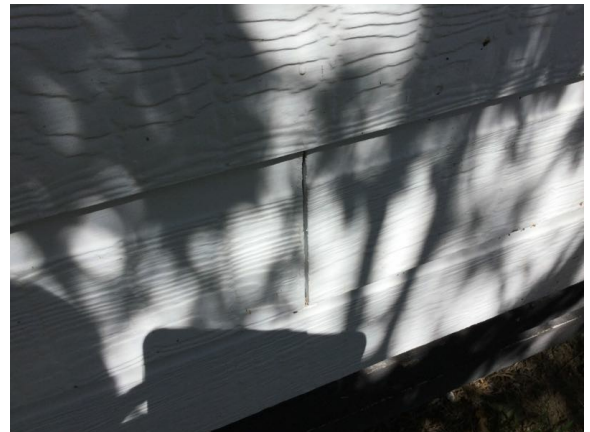
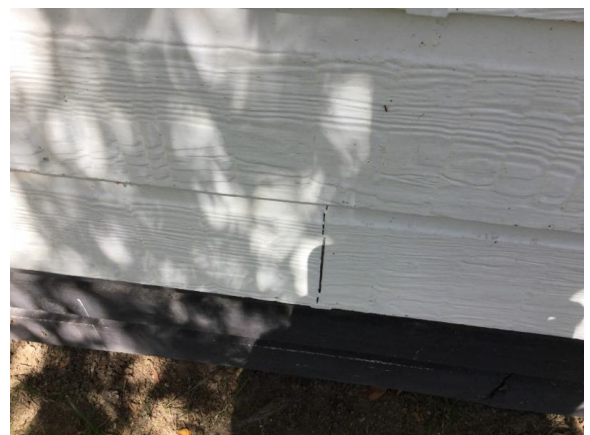
## Exterior - Weatherboard/Plywood Defects

There are several large open joints on the weatherboards on the northern side of the building. The joints are protected by a back flashing although I still recommend sealing them for added protection.

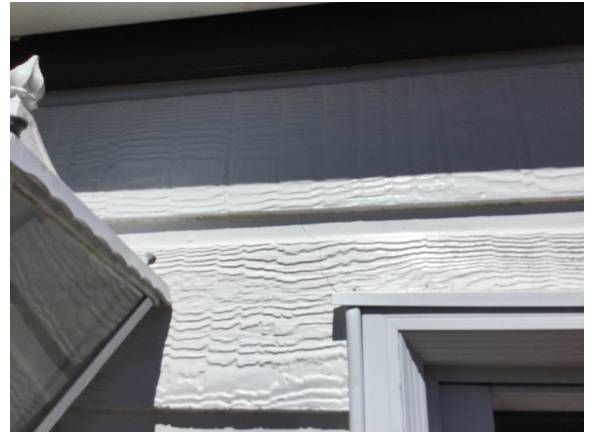
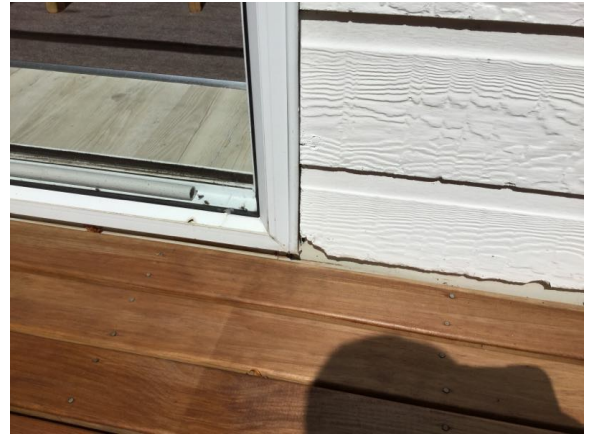
There are two broken weatherboards beside the dining room ranch slider on the northern side of the building. These broken weatherboards can lead to weathertightness issues so should be replaced. Further investigation is required by a licensed building practitioner.

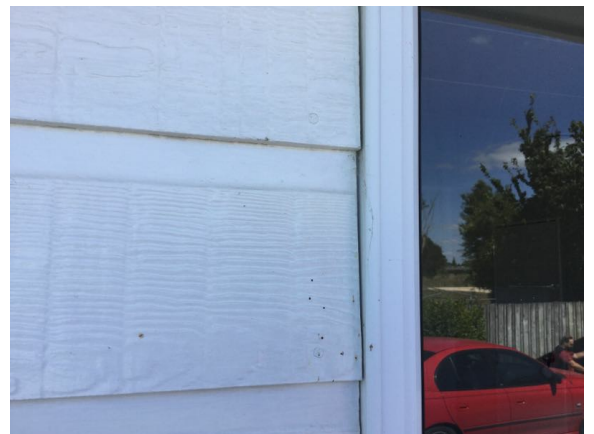
## Exterior - Soaker and Facings

Back flashings have been fitted to the sides of the windows. I recommend sealing the edges to minimise the chance of weather entering the frame.

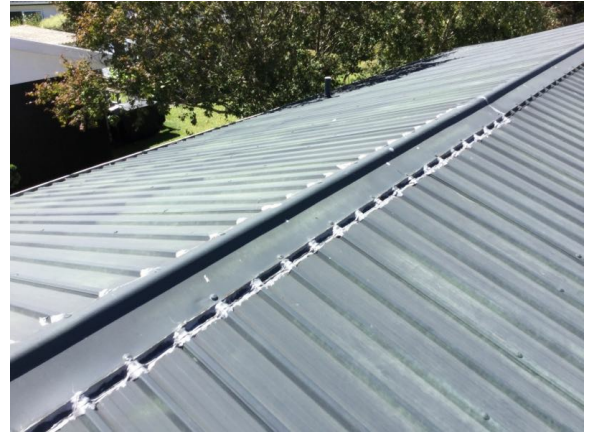
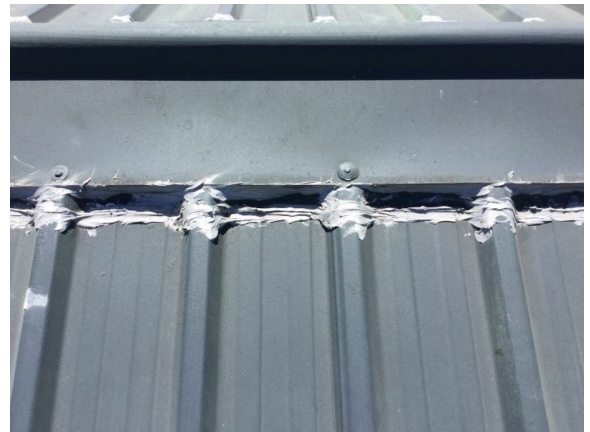
## Roof - Profiled Metal Defects

Silicon repairs have been made to the ridge flashing. This is a temporary fix and the flashing will need to be replaced in time. Further investigation is required by a qualified roofer.

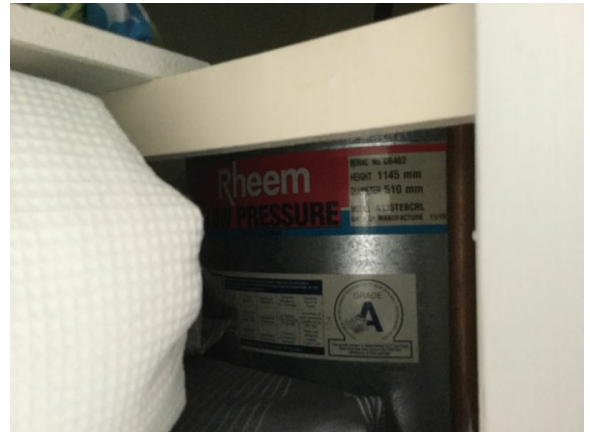
## Services - Hot Water

Low pressure electric hot water cylinder.  
Rheem, 135ltr, 11/1993.

- no seismic straps are fitted

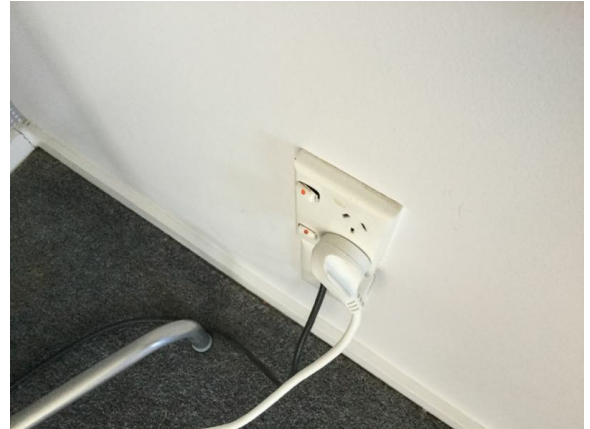
## Lounge - Electrical Switches and Outlets

Light switches: 1  
Double Power outlets: 2  
Broken power outlets: 1  
Phone/Data outlets: 1  
TV outlets: 1

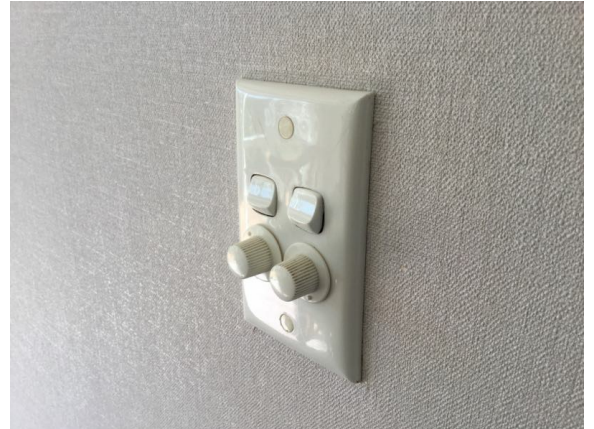
## Dining room - Electrical Switches and Outlets

Broken light switches: 1

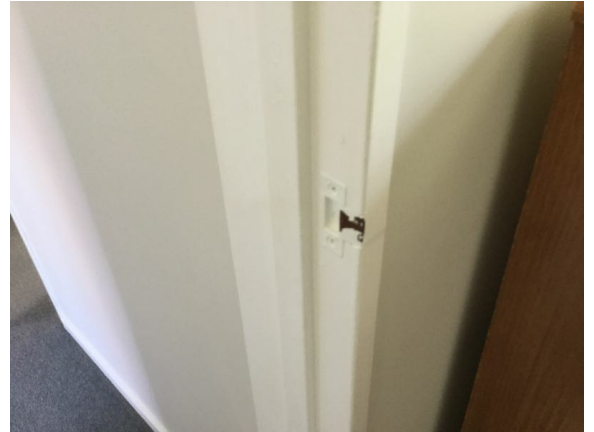
## Bedroom 3 - Door Defects

The door on the western wall doesn't latch closed properly. The striker plate needs to be adjusted.

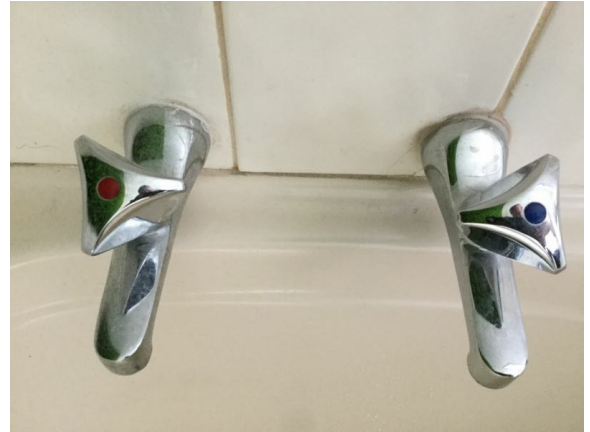
## Bathroom - Bath Defects

Both the hot and cold taps are loose and the tile on the left hand side of the cold tap is cracked.
