Complaint Summary # SUMM-13396

**Basic**SUMMARY NUMBER  
SUMM-13396SITE  
Mirandola**COMPLAINT INFORMATION**COMPLAINT NUMBER  
2020-00788

Blood leak from around outer edge of D130 Arterial filter. This was noticed pre-bypass and under no pressure. 1 filter is available for investigation

PRODUCT PART NUMBER  
03492PRODUCT DESCRIPTION  
D130 DIDEKO KIDS PH SUBPRODUCT LOT  
1907030115

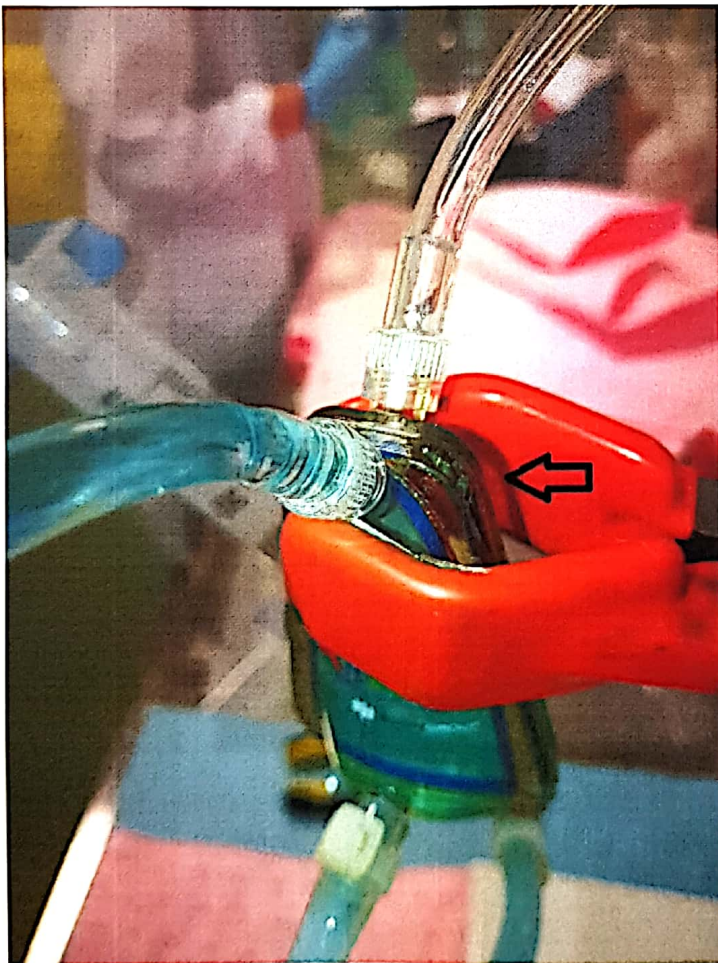
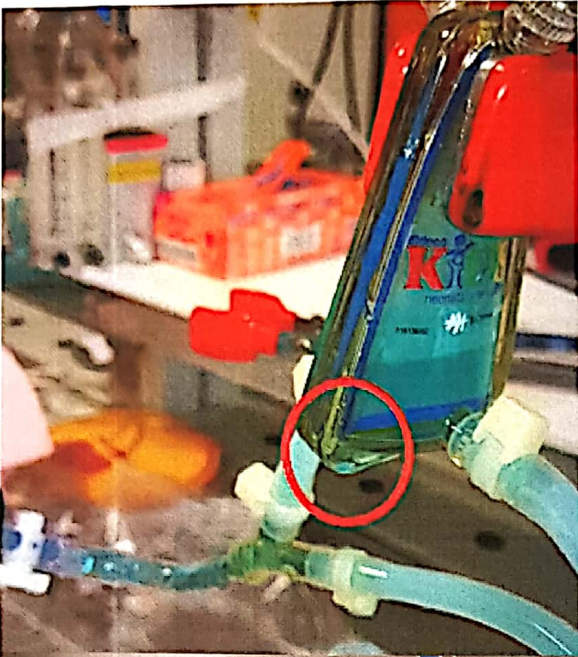
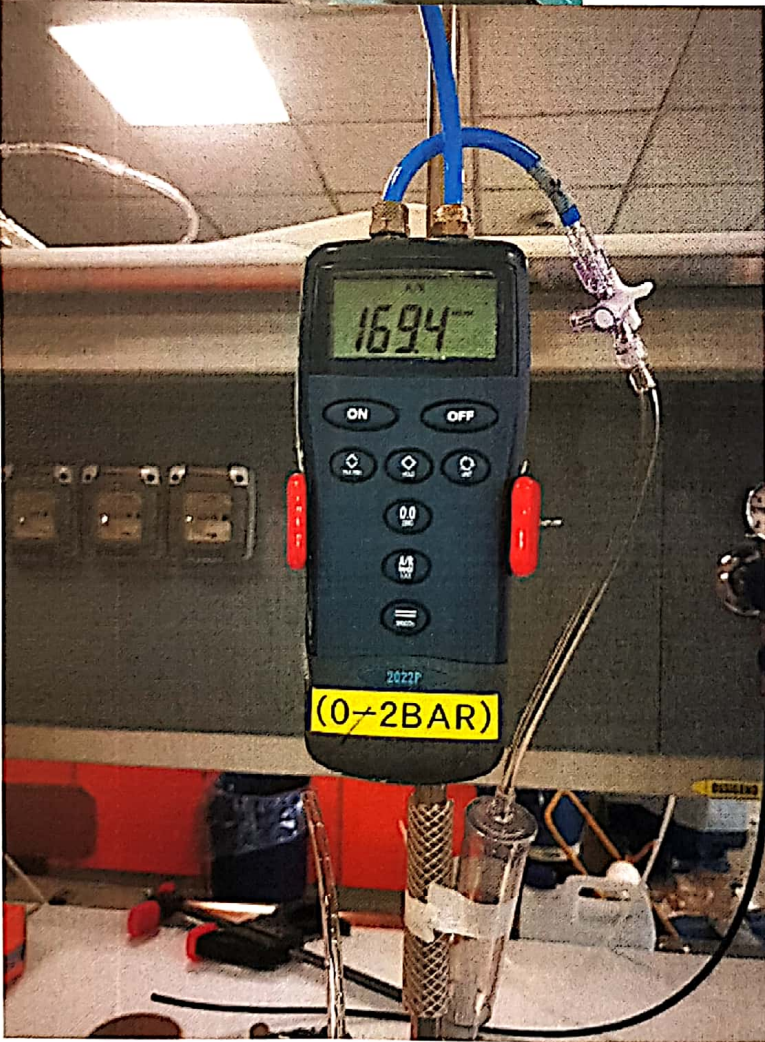
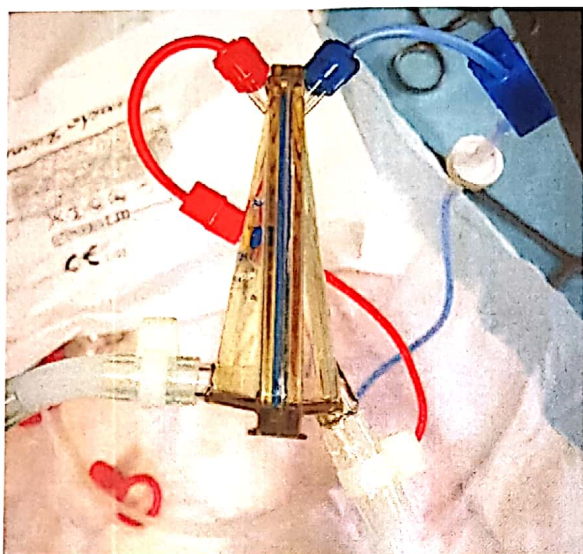
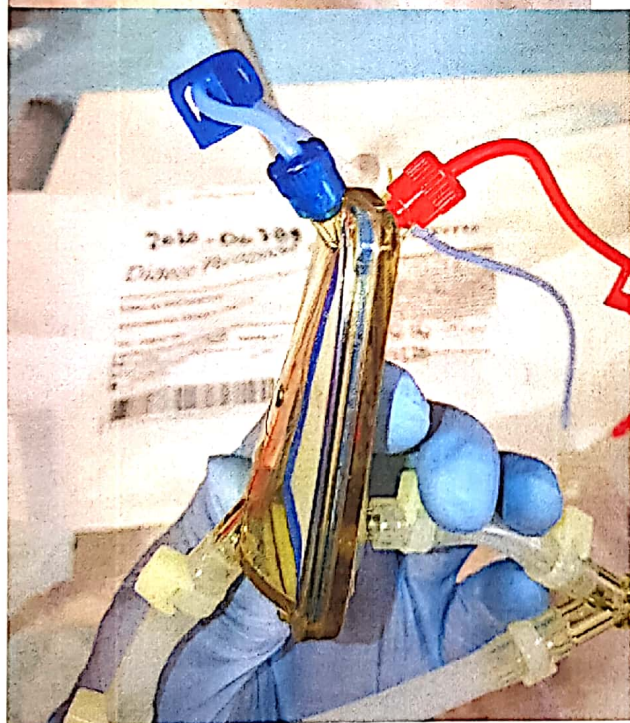
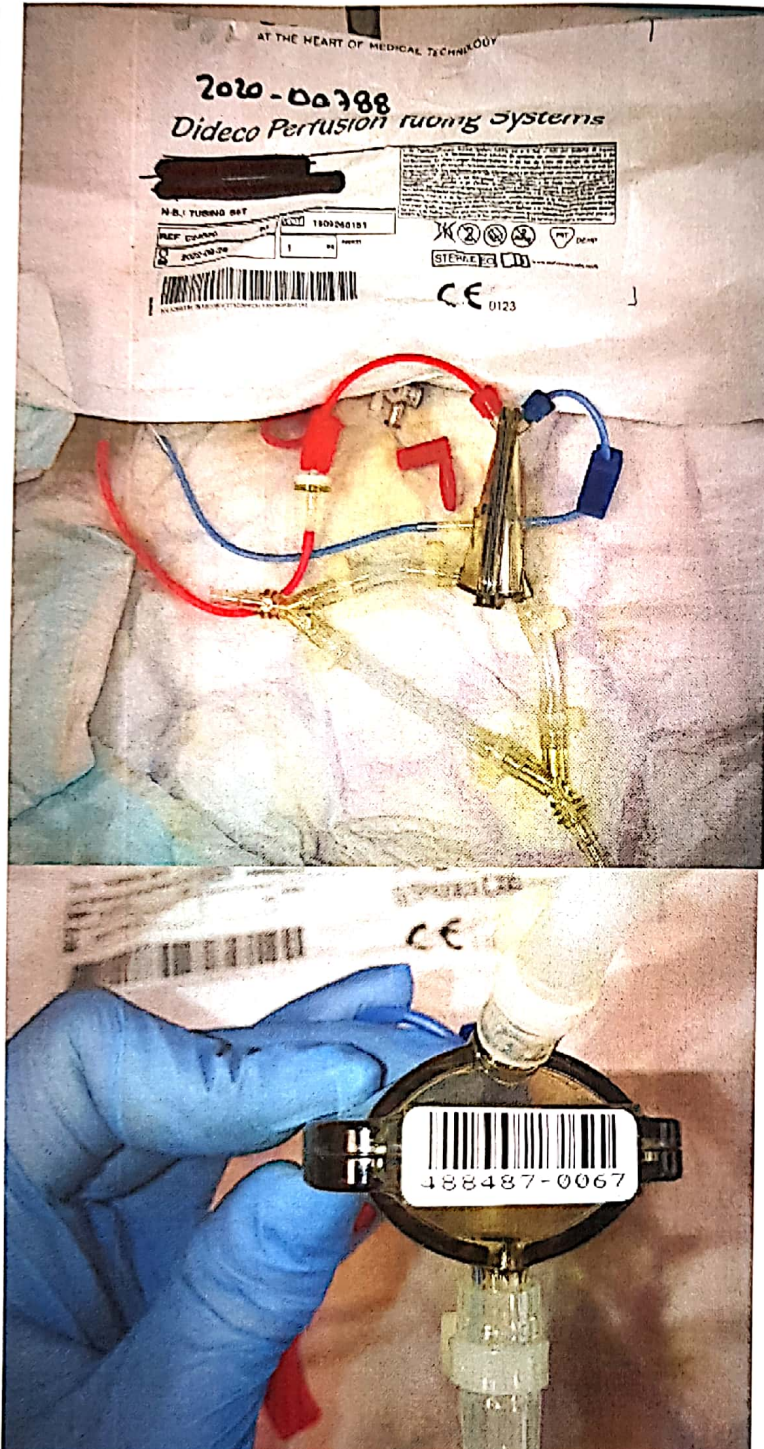
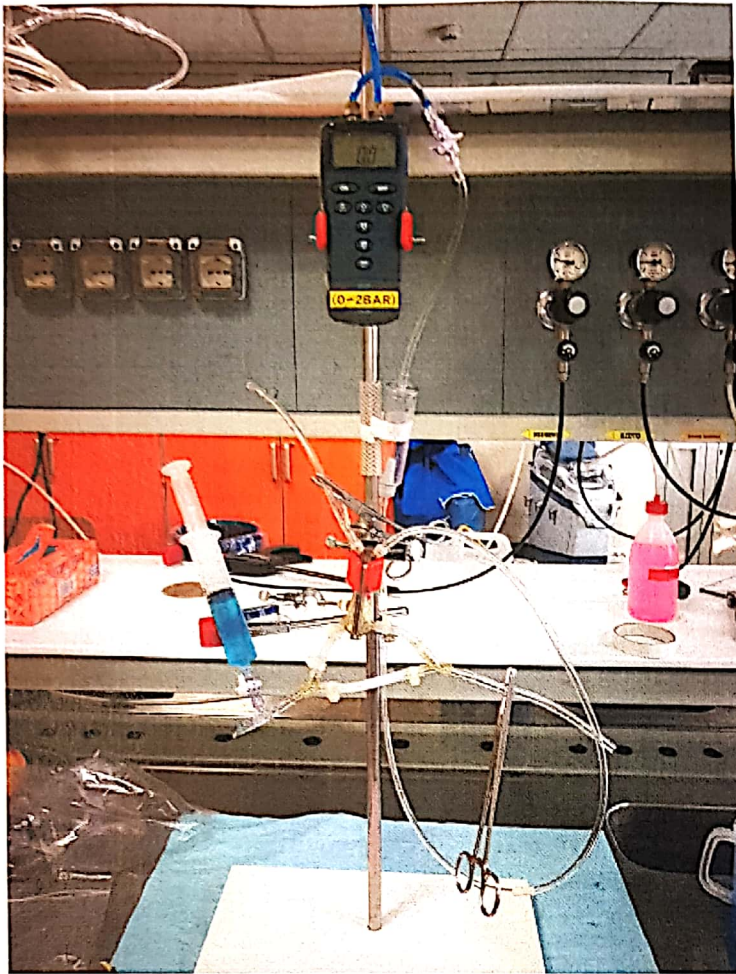
No blood residues were detected along the perimeter of the device when visually inspected.

No cracked area nor any non-conforming material were identified.

In the early filling phase, blue dye solution was observed to be dripping from welding profile of tested device at internal pressure value of 169,4 mBar, as outlined in enclosed pictures.

The reported failure was reproduced during internal lab testing.

Based on collected evidences, the occurred issue was classified as leakage from welding profile.

Non conformity report NCR-MIR-2019-0157 has been Issued to address this failure.

Based on investigation root cause analysis and investigation findings, corrective actions are under evaluation in collaboration with the external supplier of the blue o-ring.
