SUMMARY REPORT

Thursday, March 26, 2020

RE: 123 Abc St, Abcd, NJ 07XXX

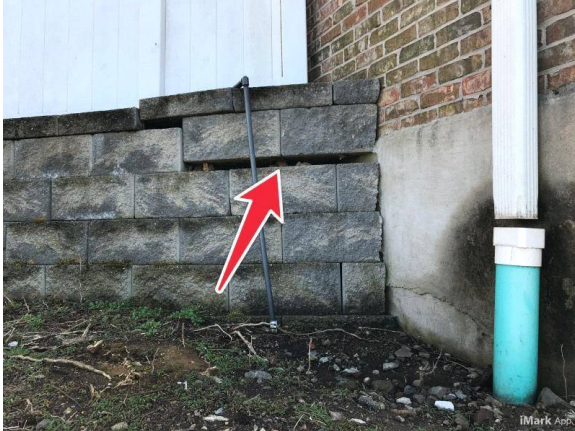
2. Settlement leads to make separation of the stacked precast concrete - Repair.

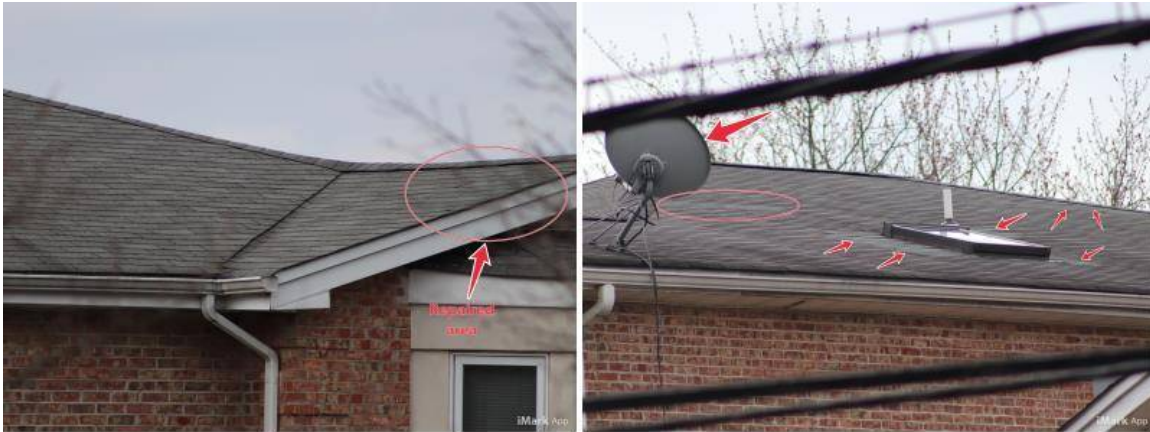
4. Many area has been repaired or replaced in the past. Roof appears to be at or near the end of its useful life - Replacement is recommended at this time. **Sign of poor drying roof** - stains on the surface of roof are good indication of deteriorating roof covering due to debris and moisture retention. Keep up with maintenance by cleaning. Recommend remove unused dish antenna to prevent further damage.

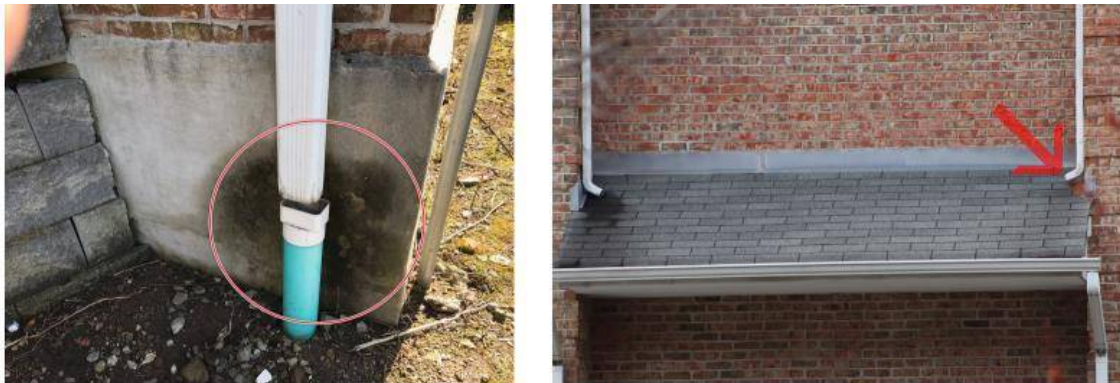
5. Aluminum type gutter & Downspout system used. Downspout is disconnected from underground drainage adaptor lead to leaking - Repair. Upper roof downspout discharged at lower roof - Extend downspout from upper roof to lower roof gutter to avoid excessive granular decay on lower roof.

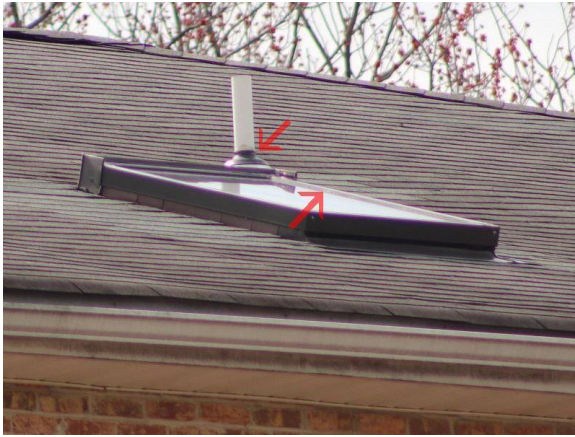
6. Silicone caulking on the skylight glass pane and stack vent neoprene was observed. Have a qualified roof contractor evaluate no leaking.

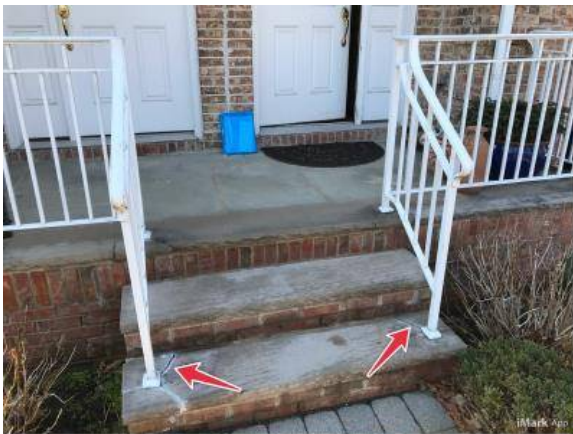
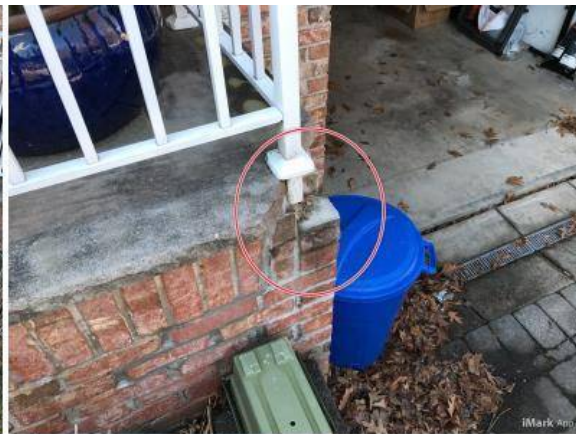
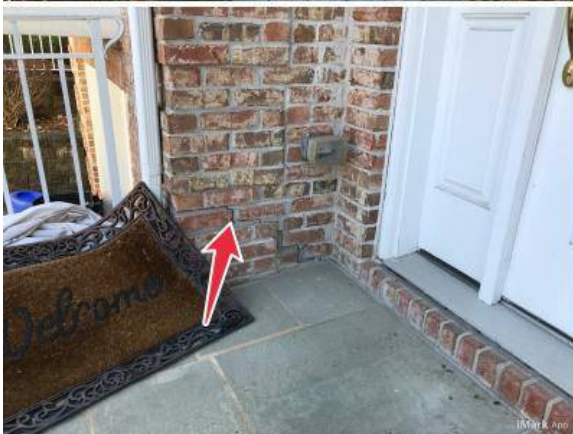
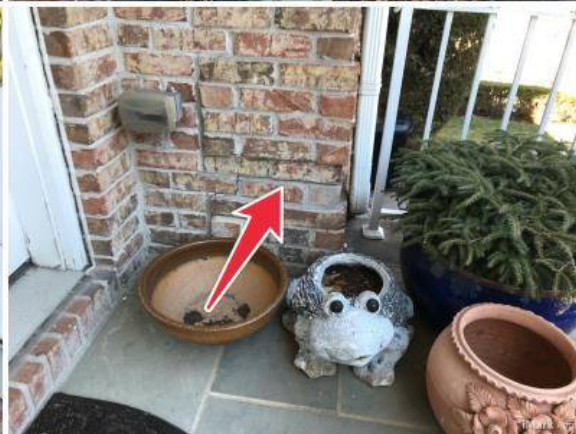
7. Cracked steps were noted - Repair and/or seal the crack to prevent further damages. Minor landing settlement observed and leads brick wall cracks - Have a qualified masonry contractor evaluate further.

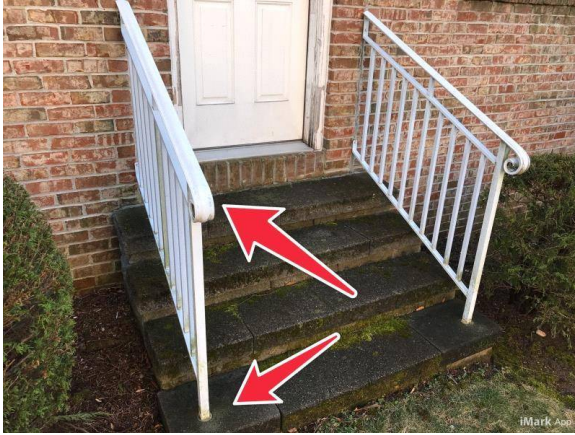
8. The railing is loose - Repairs are necessary for safety.

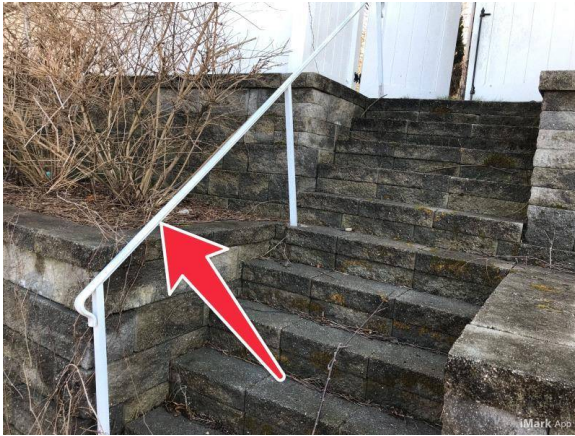
9. Loosen handrail should be repaired for safety.

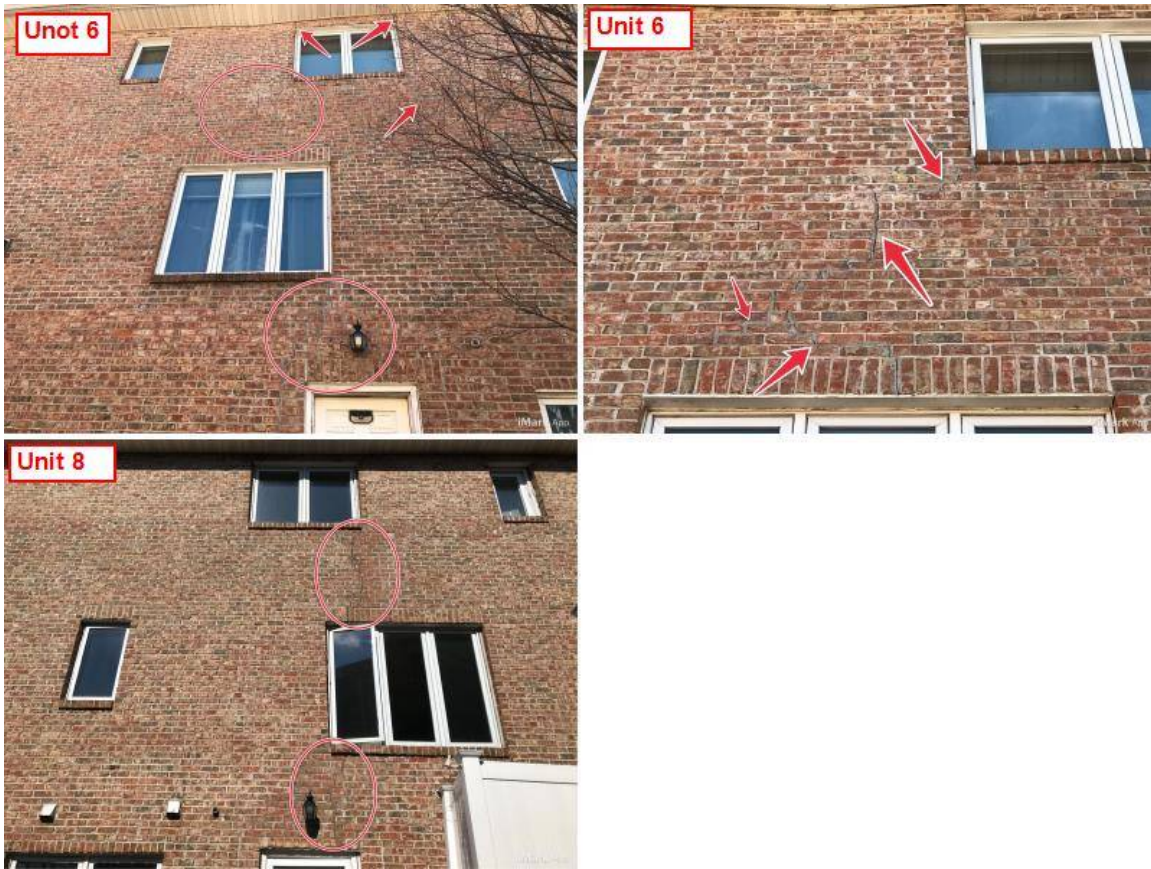
1. **This house was built near the end of steep hill and above the fill area. A portion of the building on the fill area easily settled by differential settlement leads to settlement cracks on the structure(Refer to exterior siding section on Exterior chapter). Consult with a qualified geological engineer highly recommended.**

10. **Settlement cracks noted at left and right of this building. The cracks were repaired in the past. However, some cracks are developed after repairing(Refer to the site section on Site chapter). The inspector could not determine settlement is finished or not at this time. Have a qualified structure engineer evaluate further **HIGHLY** recommended at this time.**

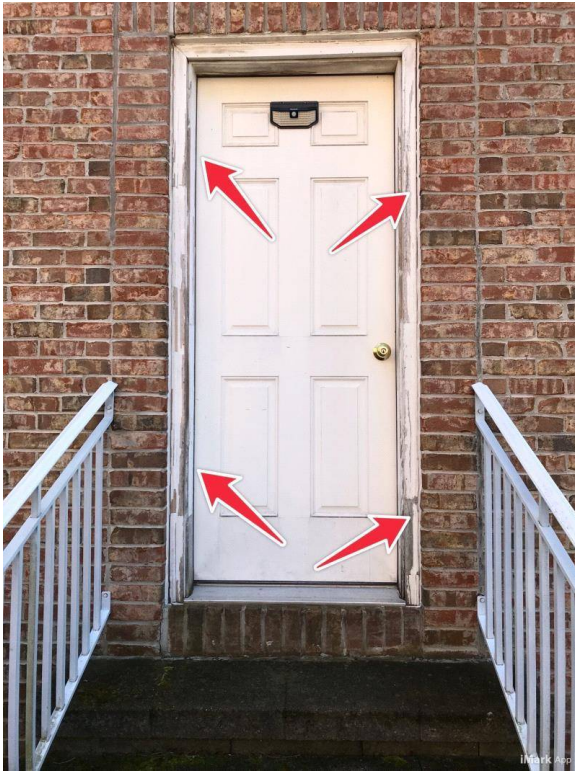
12. Peeling paints noted on the door frames. Scraping and painting is needed.

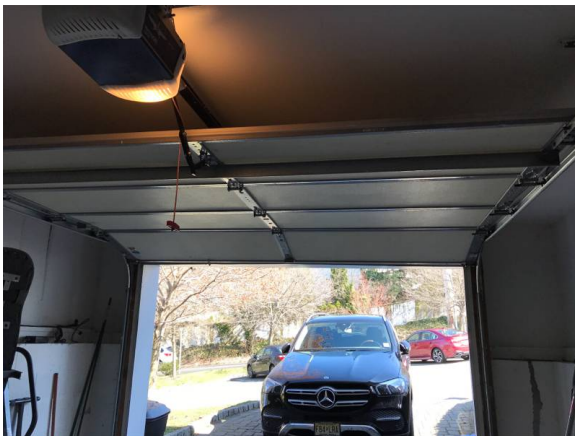
13. Automatic reverse feature: Not operational at this time. Note: All overhead doors should have fully operational auto-reverse function.

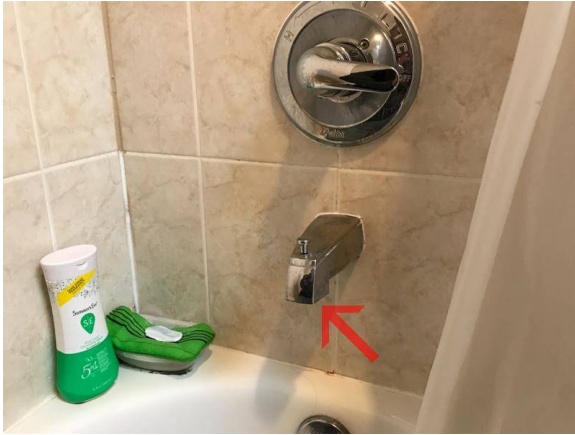
1. **Constant dripping was observed at the tub spout in the master bathroom and hallway bathroom** - Replace washer or faucet if necessary.

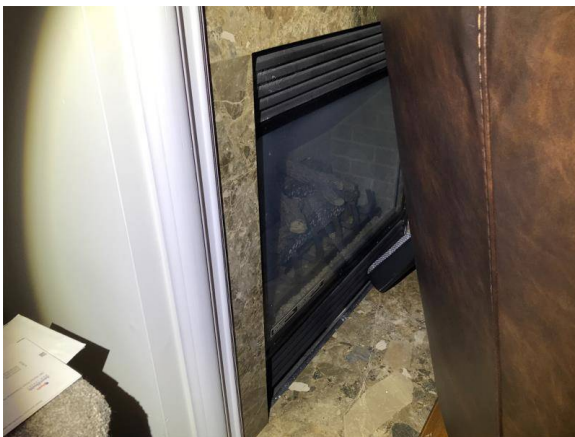
3. Location: Living Room, Gas fired burner and gas logs are not evaluated - They should be installed according to manufacturing specifications. Investigate further.

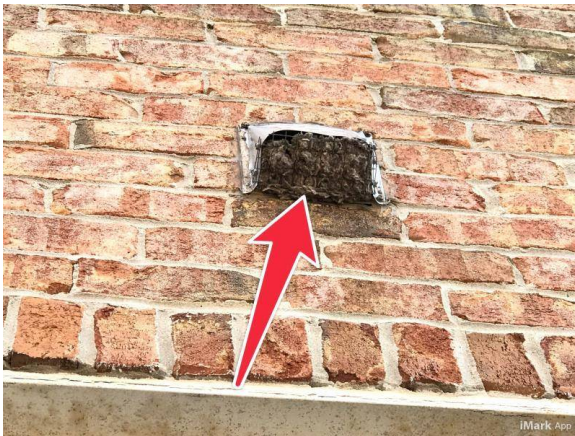
5. Based on the condition of the dryer hood at rear exterior wall, it is highly likely that the dryer vent is dirty and clogged with lint. Recommend cleaning at this time.

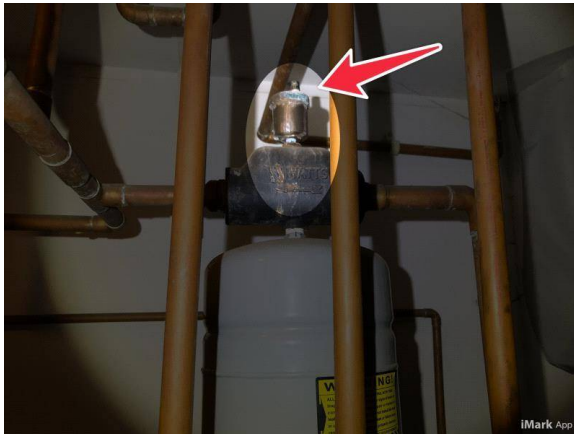
2. Heavy rust or leaking air-vent observed - Replace.

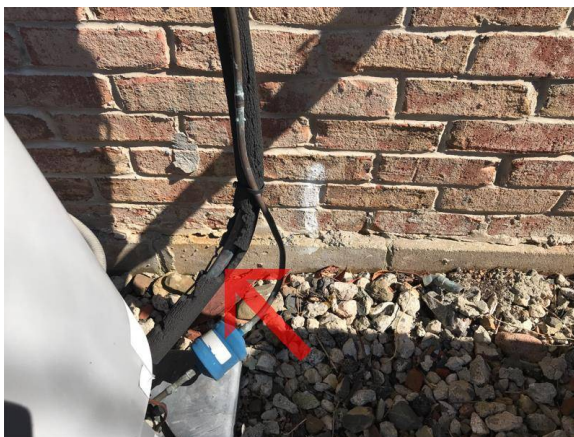
3. Electrical disconnect present. Insulation on the refrigeration line is worn/missing - Replacement is recommended. Mounting is satisfactory.

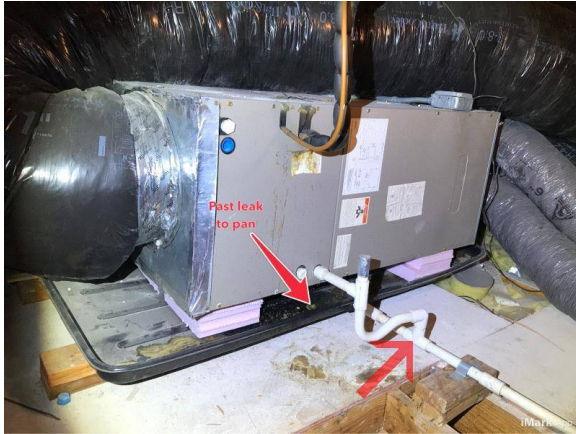
4. Condensate drain line and overflow drain line are connected together. Each one of these lines should be separately run to an exterior location. These lines provide a path for condensate to be deposited safely outside the home. If condensate drain line becomes clogged the evaporator pan will fill up and condensate will overflow onto the ceiling. Separation of this lines must be continuous or overflow protection can not be assured. Evaporator unit has leaked in the past as evidenced by rust stains in its auxiliary drain pan. Recommend to have the system serviced by

AC professional before cooling season.

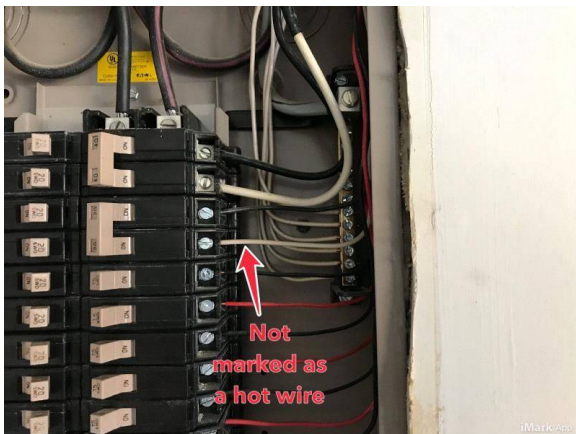
7. White wire used for hot wire but not marked as hot wire, black color. **Safety Hazard.** Consult with a licensed electrician.

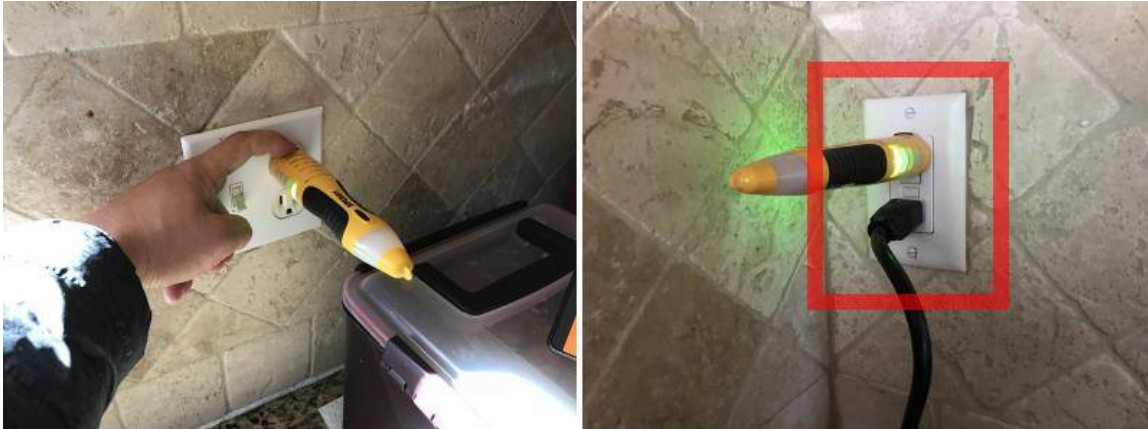
8. At least one of the GFCI protected receptacles tested did not break the current flow or reset as required. **Unsafe.** Have a licensed electrician repair or replace. In the KITCHEN.

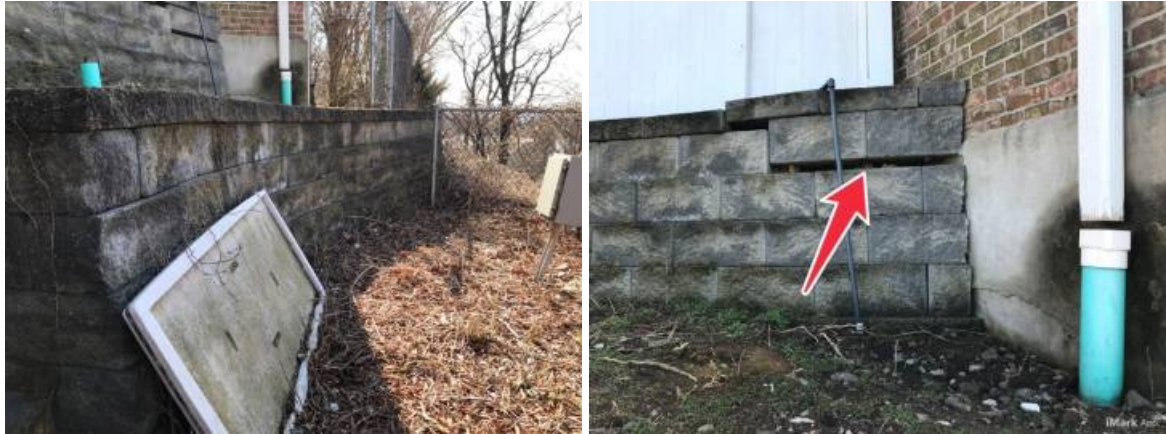
Settlement leads to make separation of the stacked precast concrete - Repair.

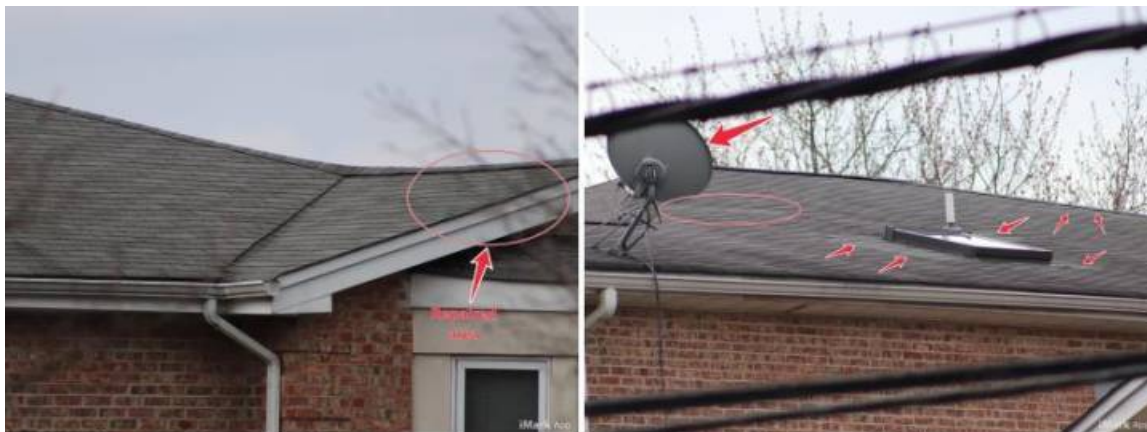
Many area has been repaired or replaced in the past. Roof appears to be at or near the end of its useful life - Replacement is recommended at this time. Sign of poor drying roof - stains on the surface of roof are good indication of deteriorating roof covering due to debris and moisture retention. Keep up with maintenance by cleaning. Recommend remove unused dish antenna to prevent further damage.

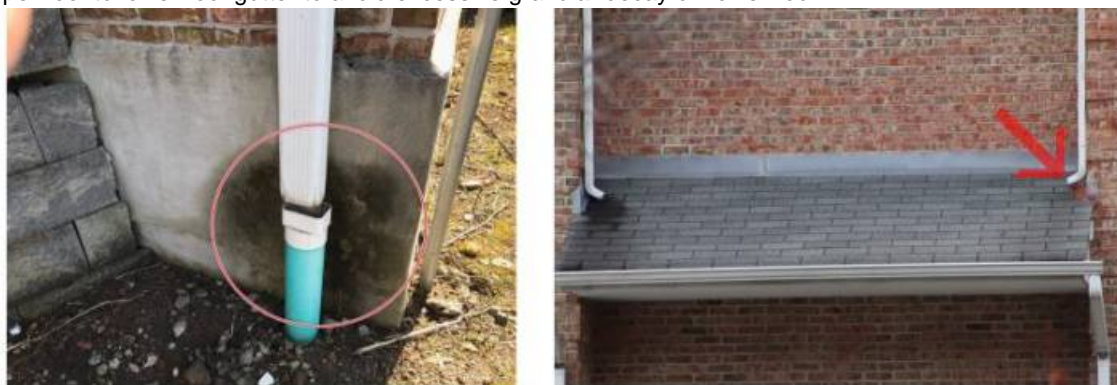
Aluminum type gutter & Downspout system used. Downspout is disconnected from underground drainage adaptor lead to leaking - Repair. Upper roof downspout discharged at lower roof - Extend downspout from upper roof to lower roof gutter to avoid excessive granular decay on lower roof.

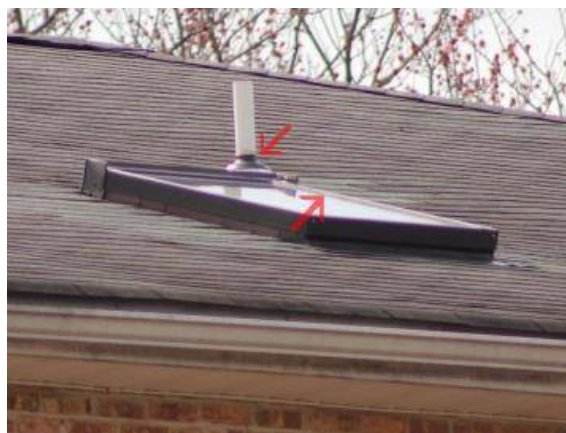
Silicone caulking on the skylight glass pane and stack vent neoprene was observed. Have a qualified roof contractor evaluate no leaking.

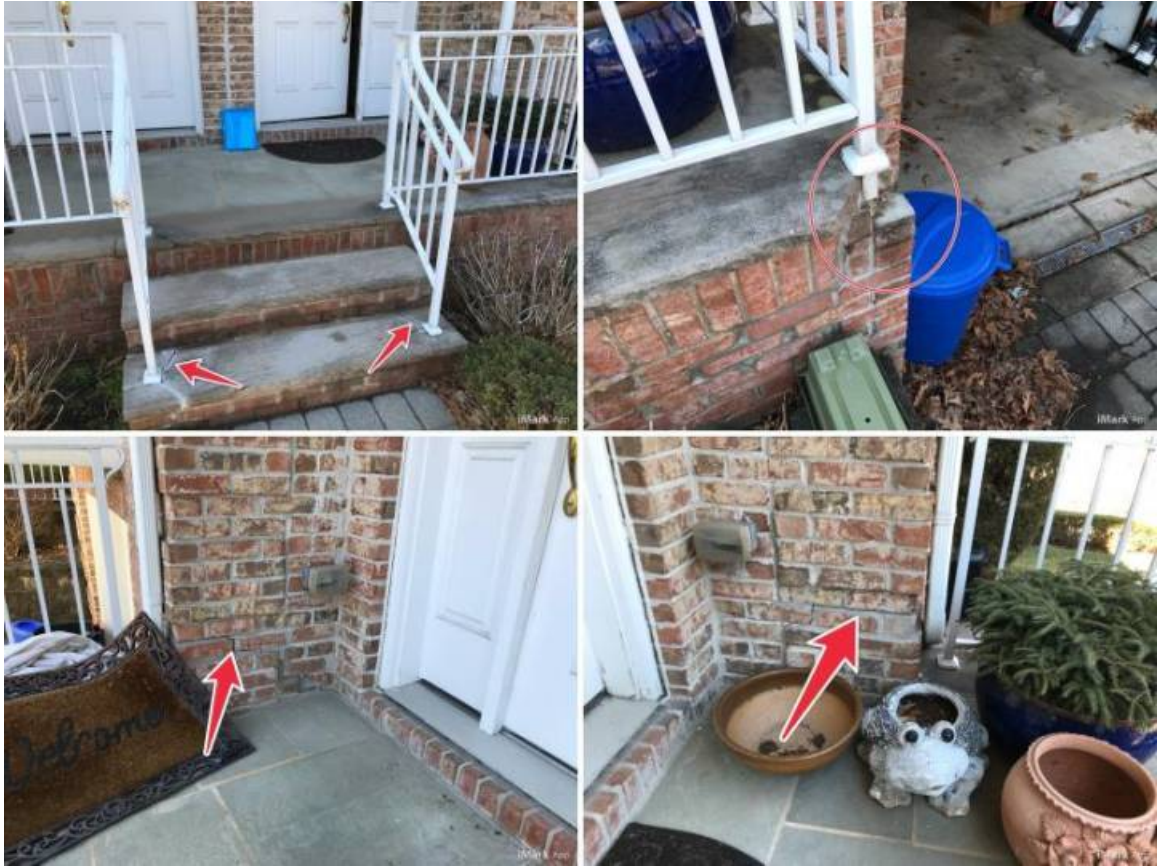
Cracked steps were noted - Repair and/or seal the crack to prevent further damages. Minor landing settlement observed and leads brick wall cracks - Have a qualified masonry contractor evaluate further.

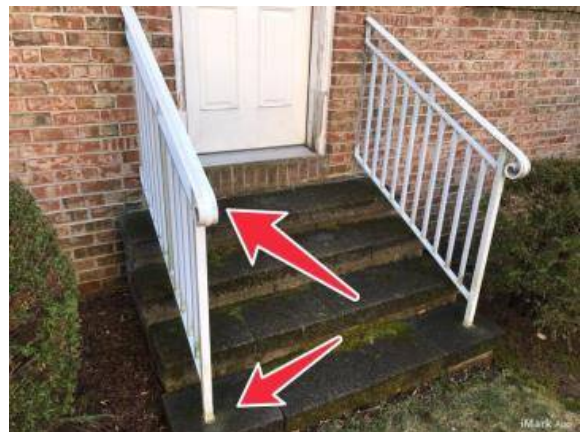
The railing is loose - Repairs are necessary for safety.

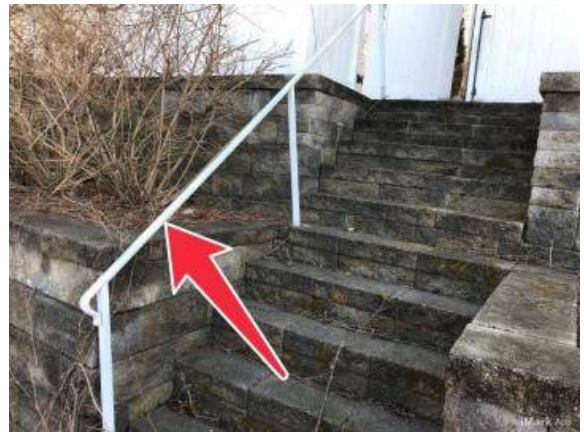
Loosen handrail should be repaired for safety.

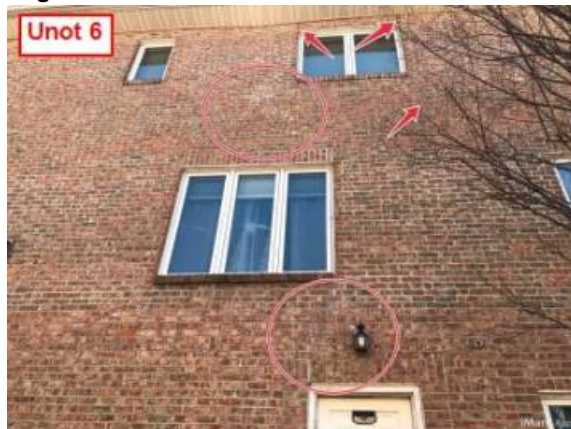
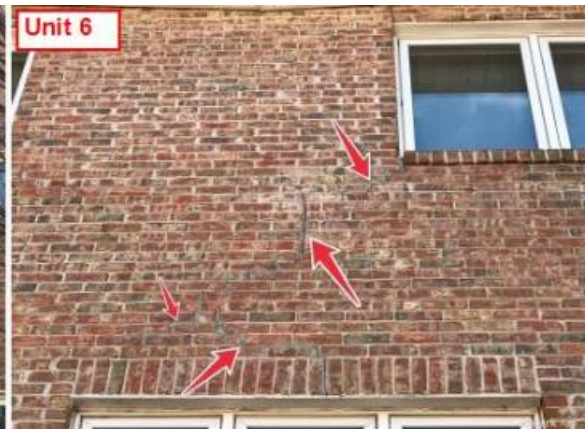
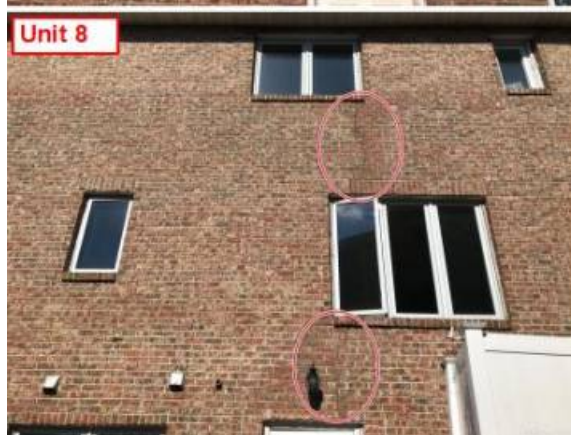
This house was built near the end of steep hill and above the fill area. A portion of the building on the fill area easily settled by differential settlement leads to settlement cracks on the structure(Refer to exterior siding section on Exterior chapter). Consult with a qualified geological engineer highly recommended.

Settlement cracks noted at left and right of this building. The cracks were repaired in the past. However, some cracks are developed after repairing (Refer to the site section on Site chapter). The inspector could not determine settlement is finished or not at this time. Have a qualified structure engineer evaluate further **HIGHLY recommended at this time.**

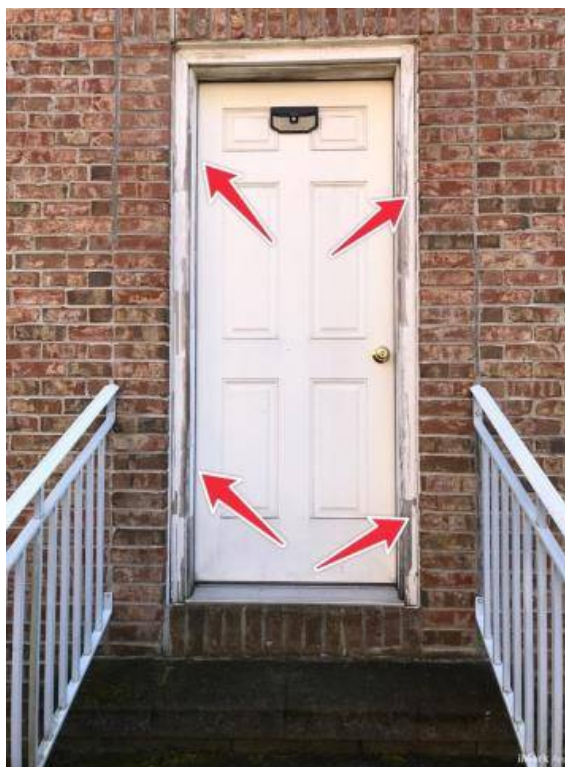
Peeling paints noted on the door frames. Scraping and painting is needed.

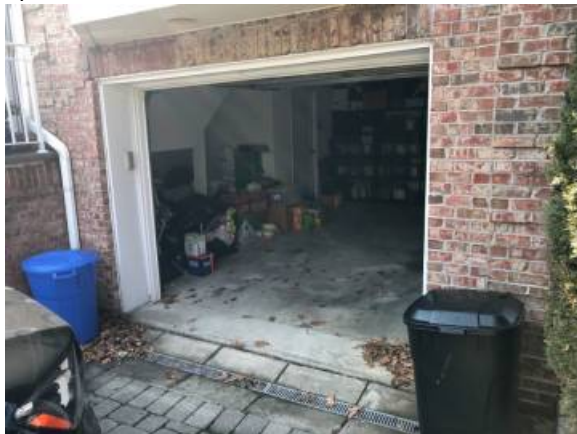
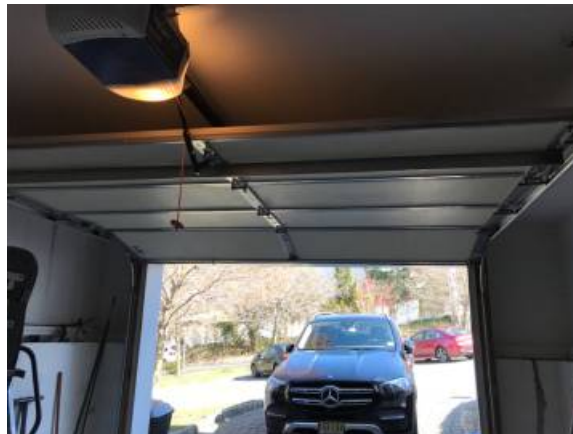
Automatic reverse feature: Not operational at this time. Note: All overhead doors should have fully operational auto-reverse function.

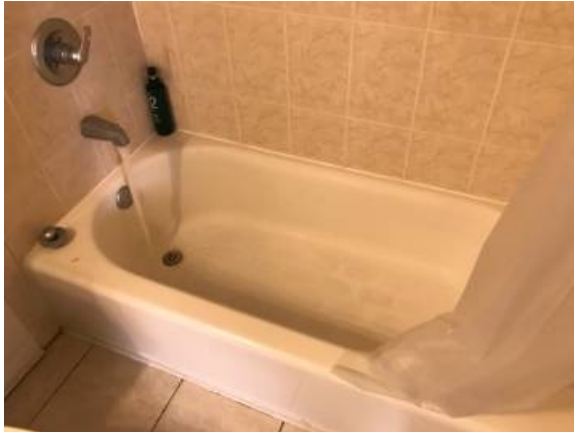
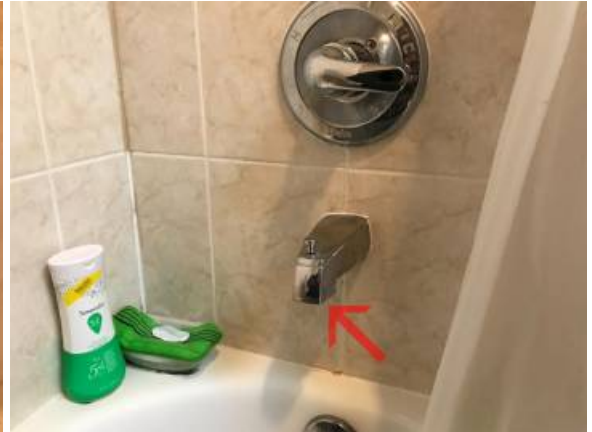
Constant dripping was observed at the tub spout in the master bathroom and hallway bathroom - Replace washer or faucet if necessary.

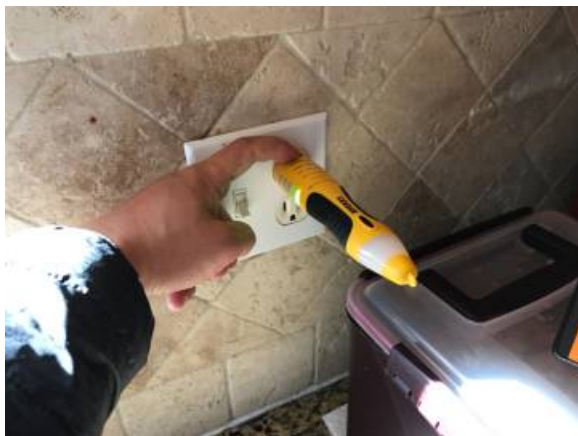
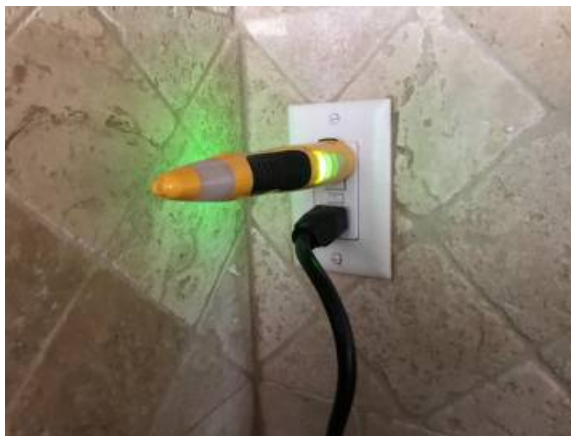
Inoperative GFCI (Ground Fault Circuit Interrupter) receptacle was noted - Replacement needed at this time for safety.

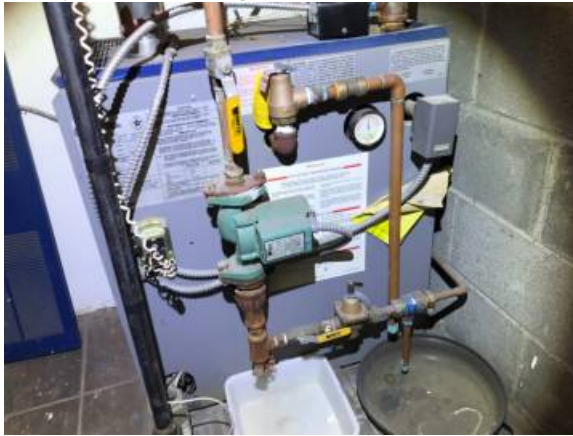
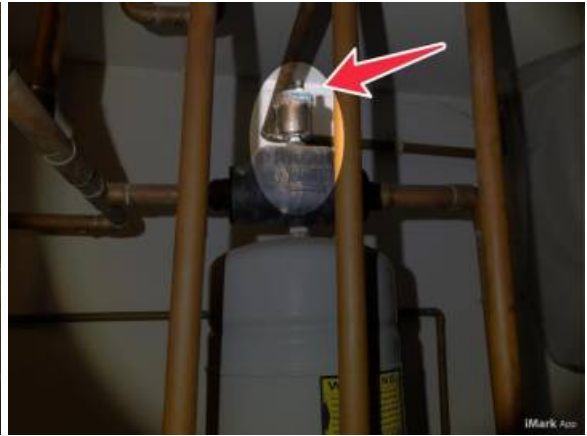
Heavy rust or leaking air-vent observed - Replace.

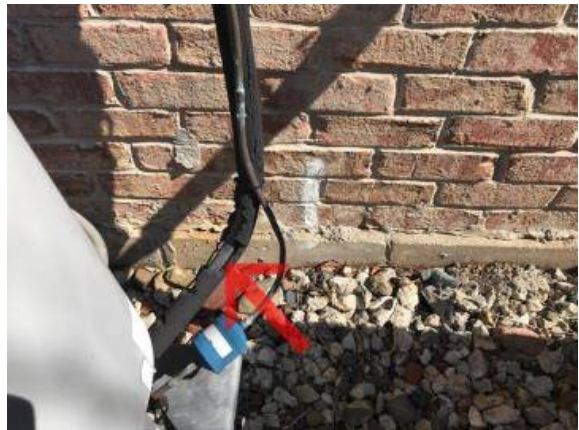
Electrical disconnect present. Insulation on the refrigeration line is worn/missing - Replacement is recommended. Mounting is satisfactory.

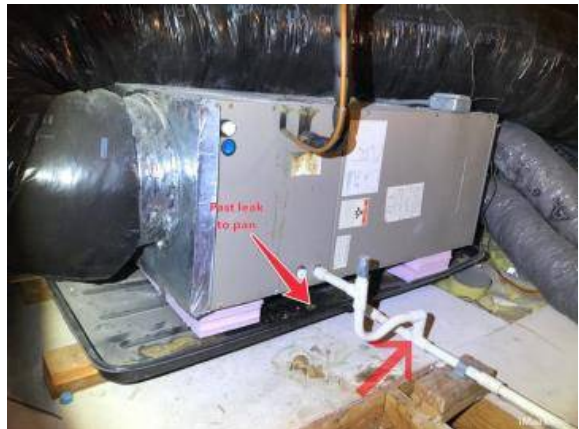
Condensate drain line and overflow drain line are connected together. Each one of these lines should be separately run to an exterior location. These lines provide a path for condensate to be deposited safely outside the home. If condensate drain line becomes clogged the evaporator pan will fill up and condensate will overflow onto the ceiling. Separation of this lines must be continuous or overflow protection can not be assured. Evaporator unit has leaked in the past as evidenced by rust stains in its auxiliary drain pan. Recommend to have the system serviced by AC professional before cooling season.

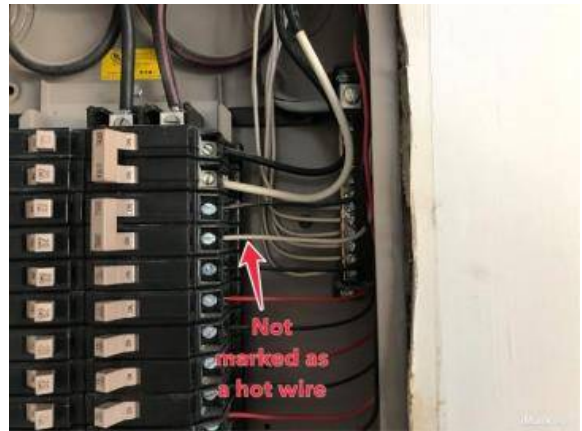
White wire used for hot wire but not marked as hot wire, black color. **Safety Hazard**. Consult with a licensed electrician.

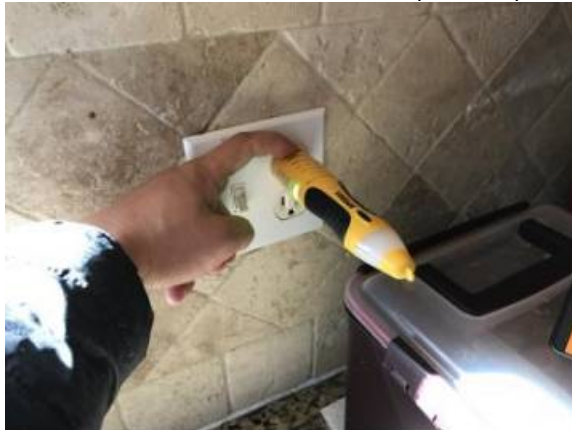
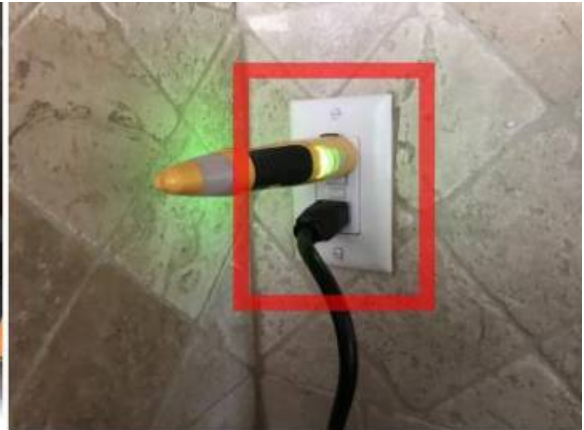
At least one of the GFCI protected receptacles tested did not break the current flow or reset as required. **Unsafe**. Have a licensed electrician repair or replace. In the KITCHEN.
