SUMMARY REPORT

Tuesday, June 16, 2020

RE: 123 Abc St, Abcd, NJ 07000

Confidential Property Condition Report

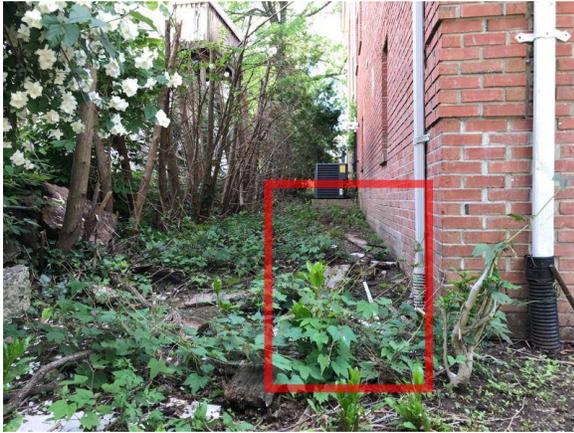
1. There are some areas of the lot that may allow water to interfere with the foundation. The soil along the foundation should be pitched away from the building at a minimum of 1/2 inch per foot and extend at least 10 feet away from the foundation. Improper pitch may lead to moisture intrusion to the basement or foundation(Refer to the Basement Walls Condition Section on the Foundation and Structure Chapter). Recommend re-grading the lot. Property slopes: Front to rear.

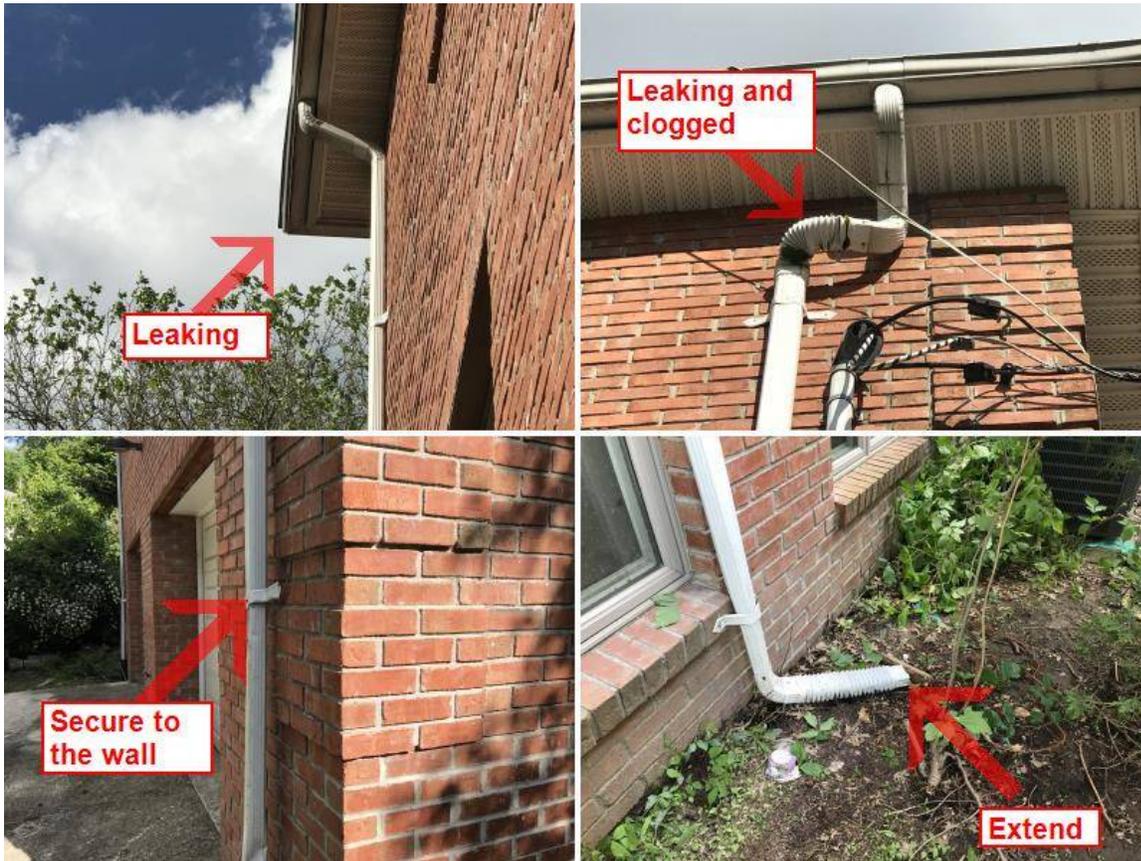
4. Aluminum type gutter & Downspout system used. Debris noted in gutter - Keep gutters clean and no blocking. Loose gutter or downspout noted - Secure as needed. **Clogged and leaked downspout noted** - Repair. Downspout discharging location too close to the foundation wall - Installation of downspout extensions at least 6 feet would help carry the water further away from the foundation. Gutter has seams. It is prone to water leaking - Recommend install seamless one piece gutter system.

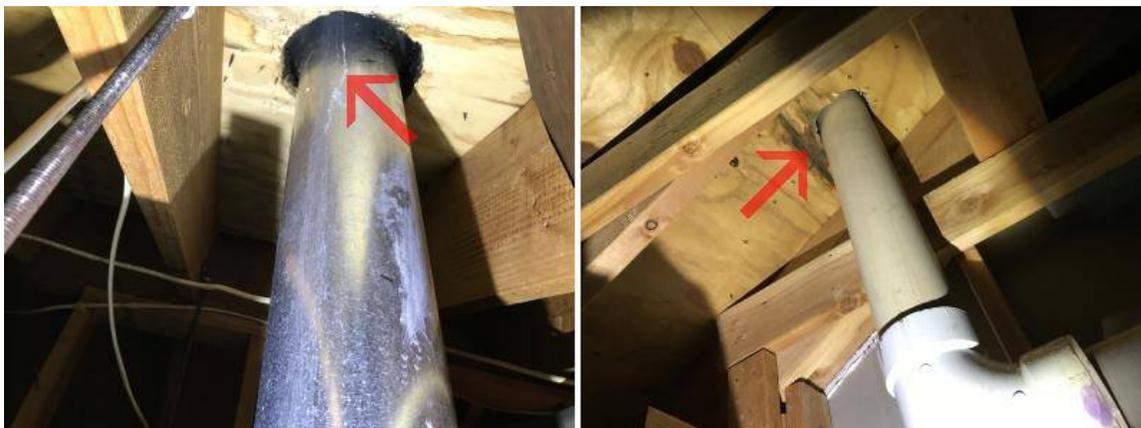
5. Installed neoprene seal was worn, or deteriorated - Replacement as needed. **Sign of leak under plumbing stack, sign of the leakage on furnace flue vent surface noted** - Have a qualified roof contractor evaluate all roof penetration further.

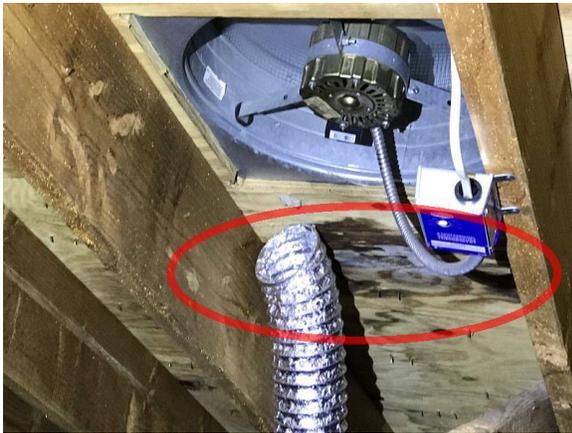
7. There is at least one bathroom, kitchen ventilation fan which discharging moisture laden air to the attic. It is preferable to direct all vent openings to the outside so that additional moisture is not introduced into the attic space and insulation.

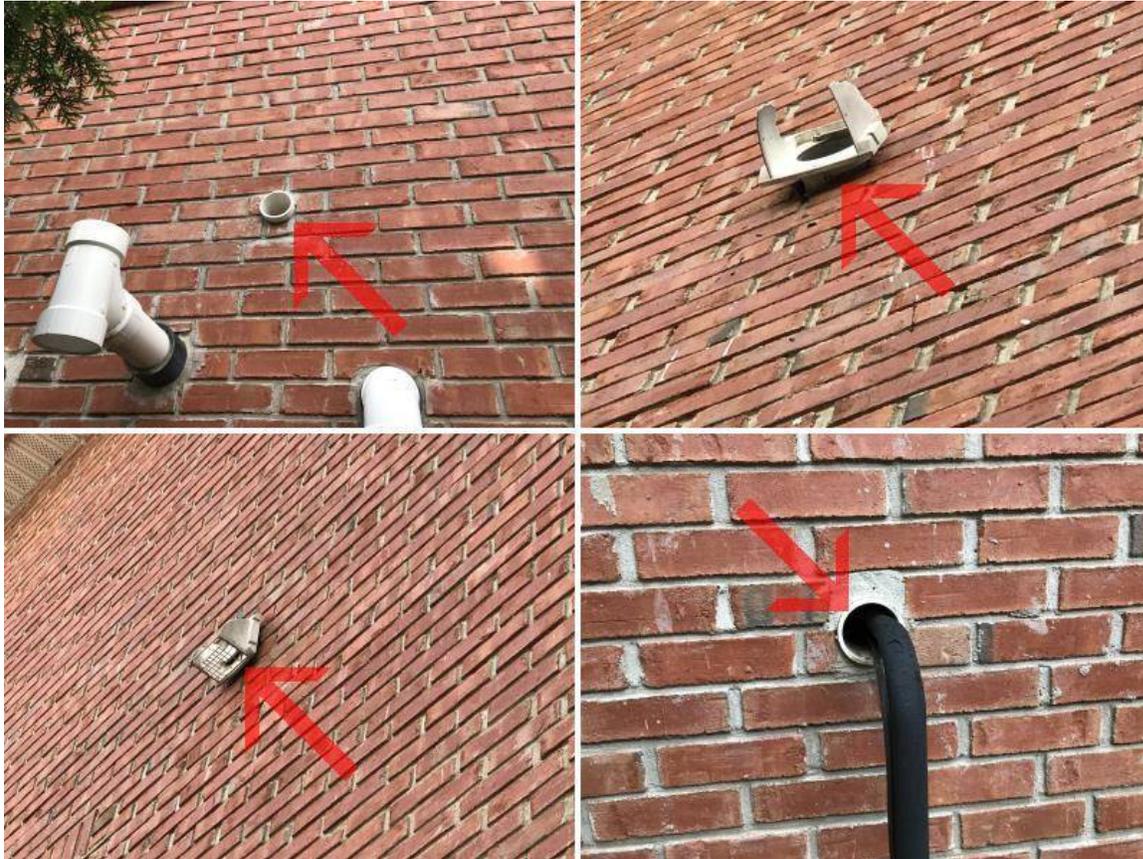
8. (1) Recommendations: Seal all gaps to prevent moisture intrusion and further damage between Stucco and wood/brick wall. Monitor all gaps.

(2) **Missing Weep holes.** Modern masonry veneer walls are provided with weep holes to allow water which reaches the back of masonry units to drain out of wall system. When rain accompanies high winds, air enters the weep holes and pressurizes the space behind the masonry wall, and less water moving into and through the masonry. Install weep holes at the bottom section of the wall.

- (3) Damaged dryer vent or exhaust vent hood should be replaced.
- (4) Loose or missing mortar observed on the front left exterior walls - Repair.

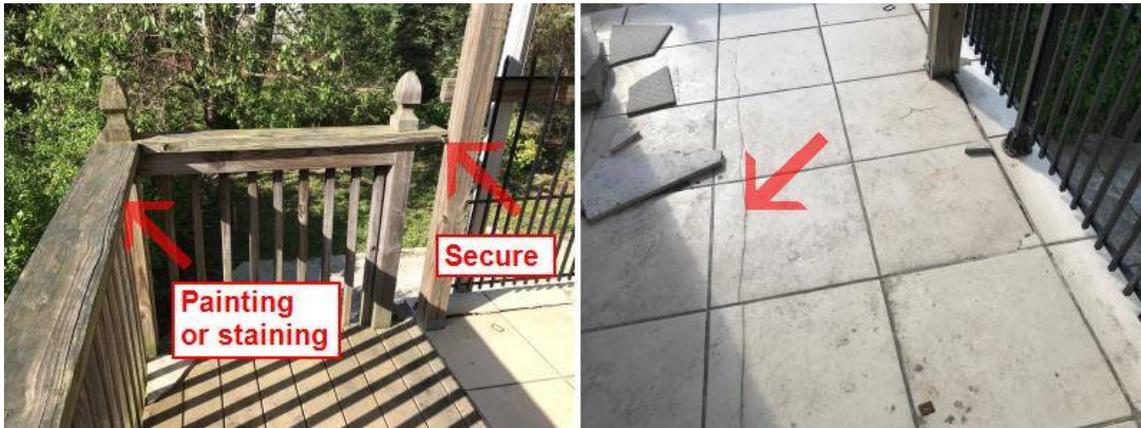
10. Railing: **Loose railing viewed**, **safety hazard** - Repairs are necessary at this time. **Painting be advised on handrail/guardrail to prevent water/insect damage.** Cracked tiles noted - Replace.

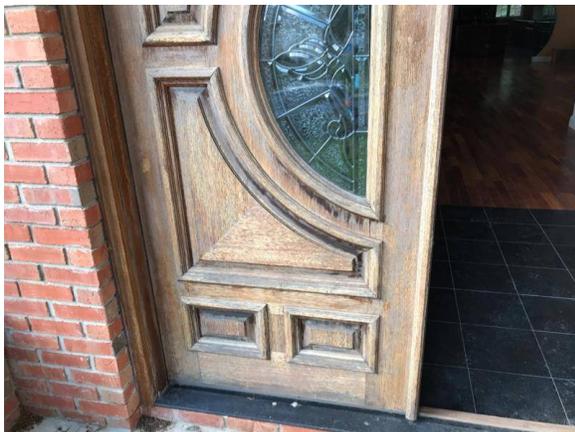
11. Wood door. Re-staining of the door to protect from weather be advised.

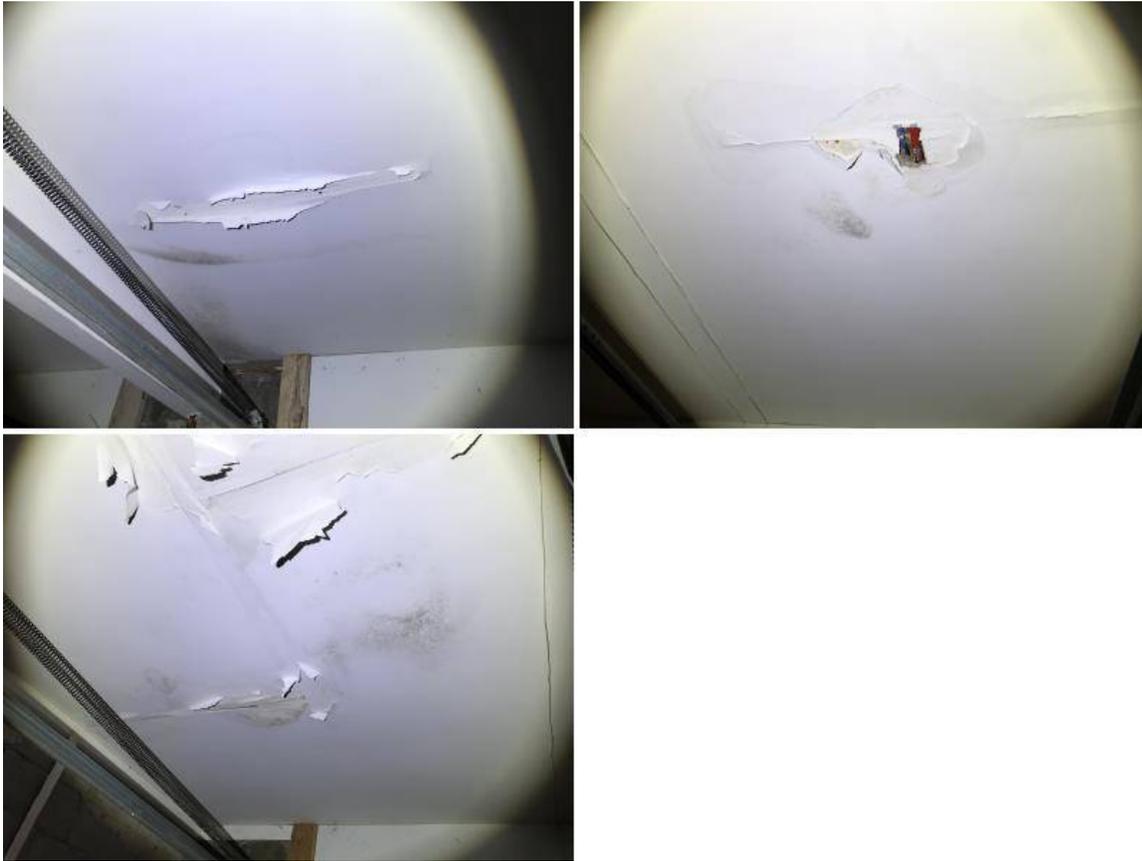
12. **Water stain and damaged section noted. Observable mold viewed on the drywall ceiling.** It appears that there was water leaking from the PEX water lines in the past. Have a licensed plumber evaluate further after removing damaged drywall section.

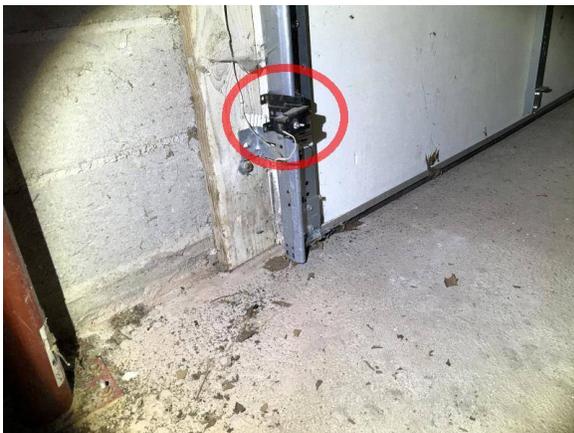
13. Eye sensor are installed too high from the floor. It should be installed 4-6" - Adjustment needed.

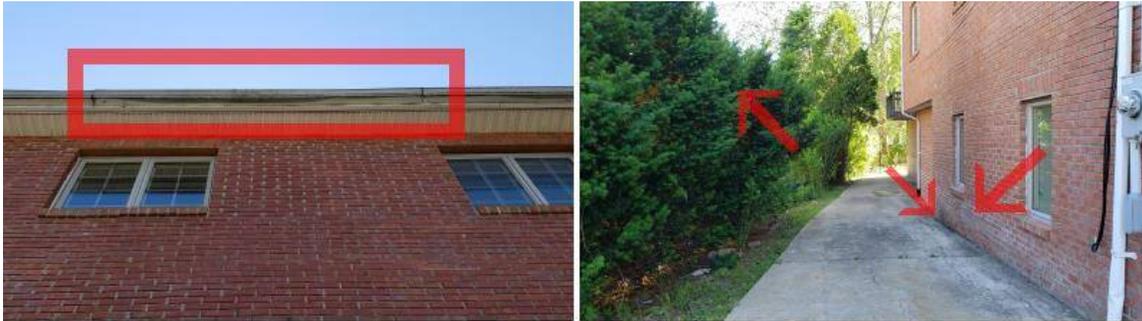
16. (2) Moisture issue on the left walls appears relating with gutter overflowing or leaking at the gutter seams. Dropped water was splashed and was absorbed by the exterior bricks or intruded through the cracked mortar. Tree shadows prevented reducing or blocking dry of the wall and accelerated moisture issue. Mortar re-pointing job was done recently by a contractor. **Trim the trees to increase dry potential and remove damaged drywalls and evaluate further.** Also **clean or remove all mold infested drywall by a licensed mold remediation contractor.**

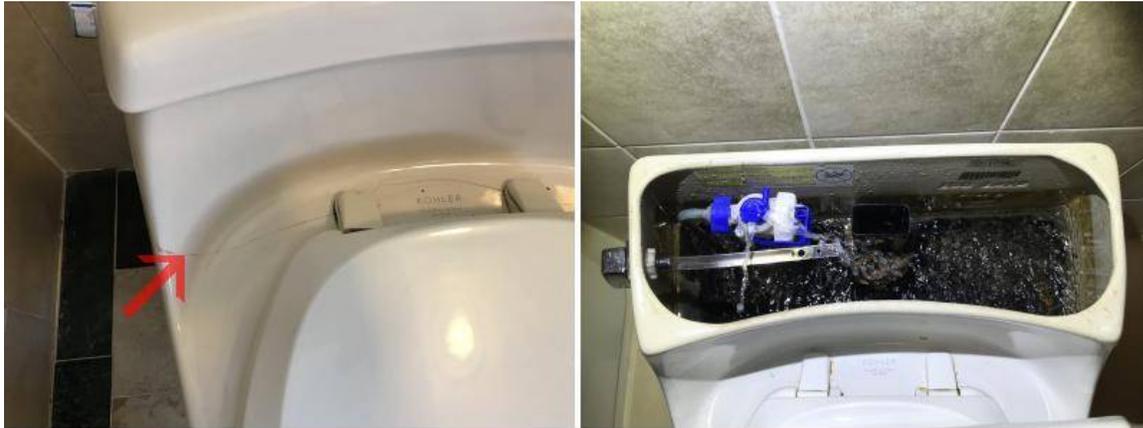
5. Minor plumbing repairs will be needed to restore proper operation in the hallway bathroom. Need repair. Cracked bowl noted in the master bathroom - Replace.

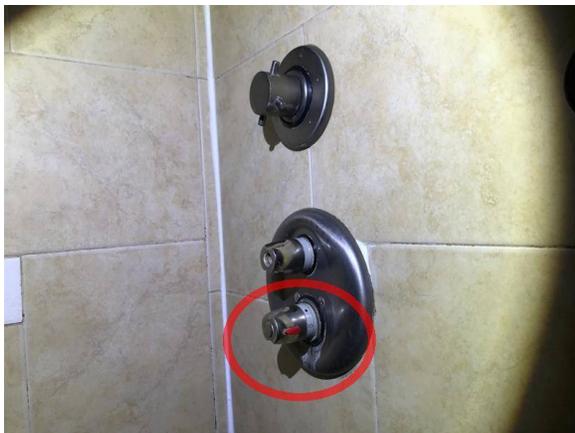
6. **Minor leakage is noted at faucet in the master bathroom - Repair.**

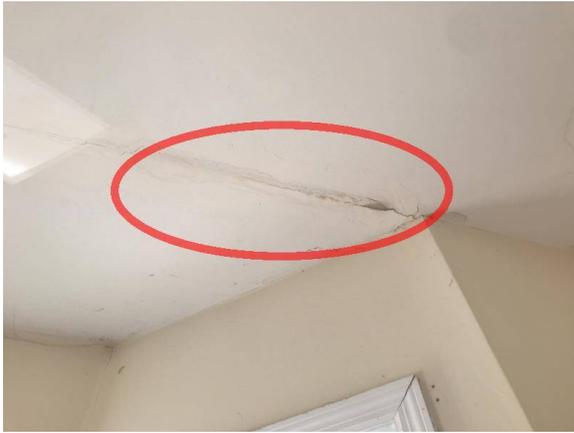
7. **Water stains noted** but does not appear current. It appears balcony water penetrated through cracked tiles, door sill or corner of the wall. It is very important that flashing and counter flashing at every corner should be properly installed at the balcony. Have a qualified balcony contractor evaluate further.

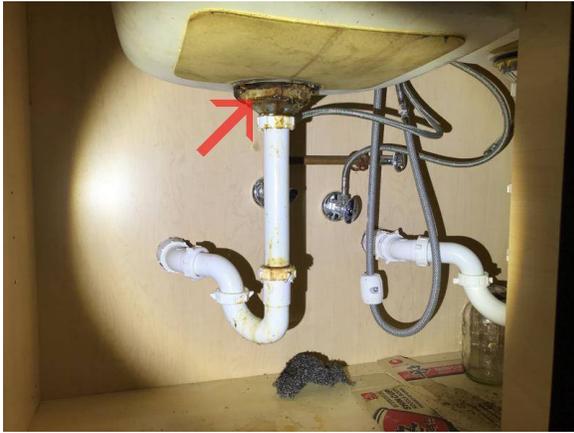
10. **Leakage is noted at the drain line** - Repairs are necessary.

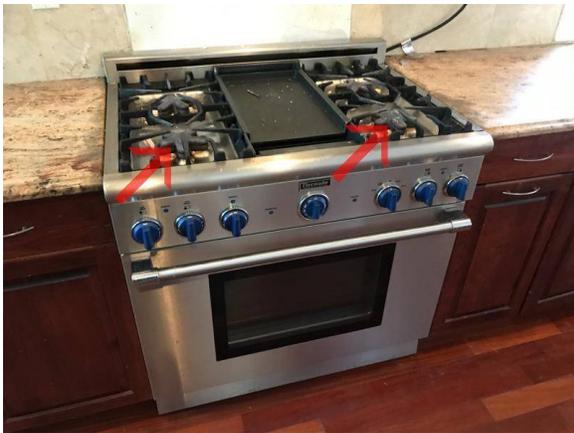
11. Gas. The stove burners are not all working properly - Clean or repair the defective burners.

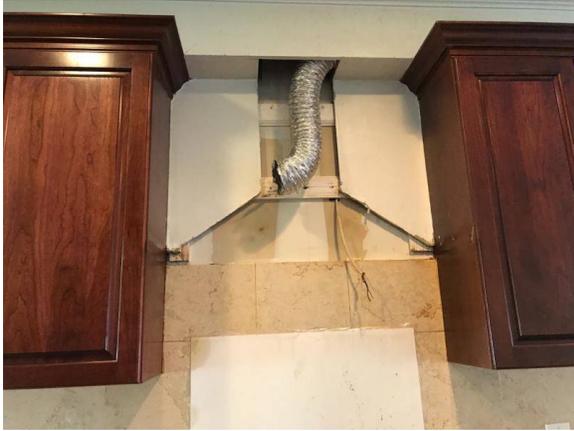
12. External ventilation is provided. No fan/hood presented - Installation of fan/hood is recommended.

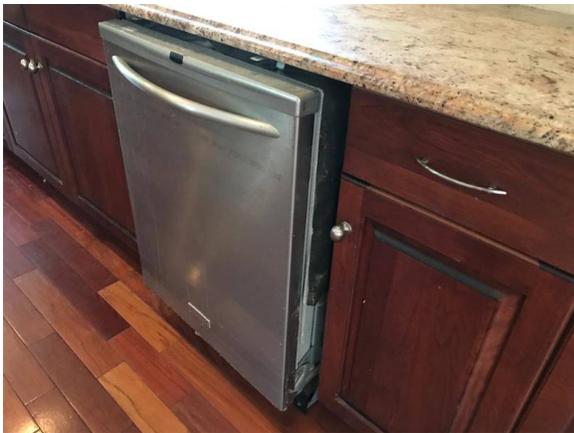
13. The dishwasher is not operational - Repair or replacement is recommended.

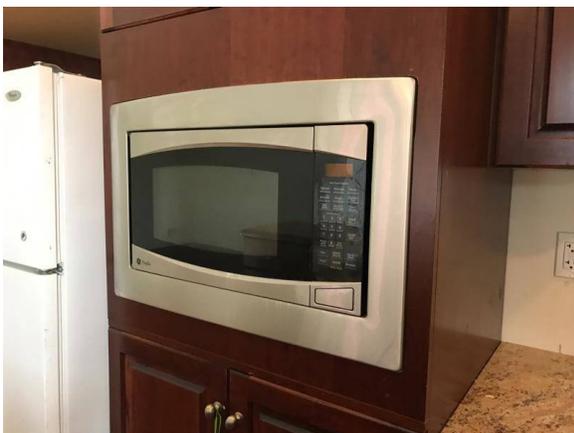
14. Not working - Further evaluation recommended.

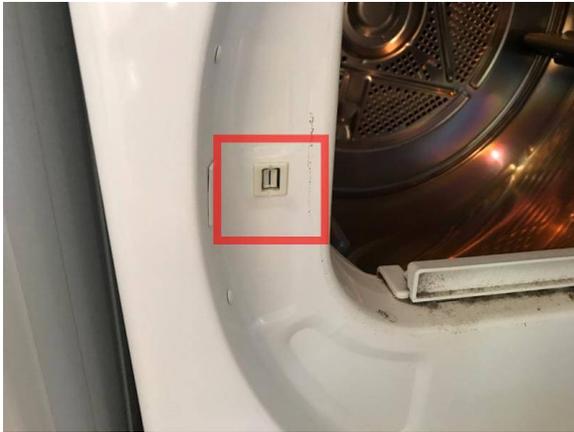
17. Gas. Inoperative at the time of the inspection die to door lock switch defect - Repair.

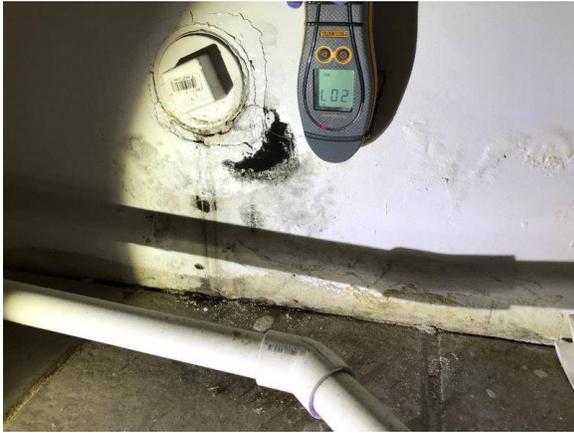
1. **Leaks noted on the utility room wall.** Moisture meter reading indicates high level of moisture around plumbing plug. **Mold growing also indicates moisture issue.** Remove damaged drywall and have a licensed plumber evaluate further.

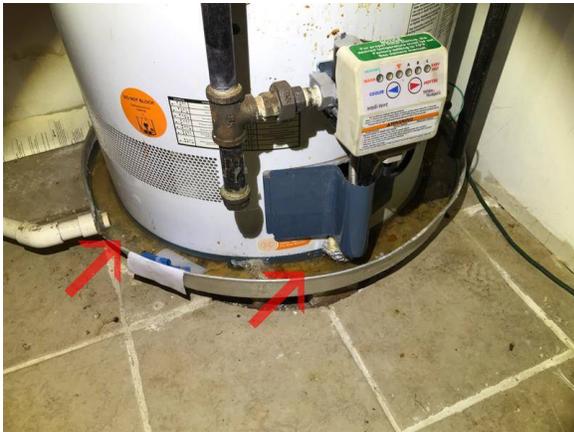
3. **The unit is end of the life due to tank leaking - Replace.**

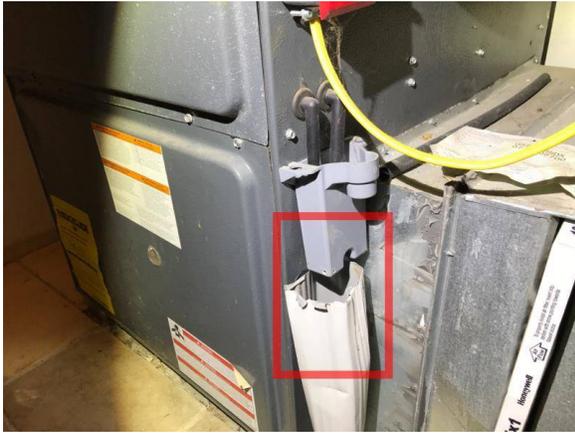
4. Condensate drain line missing. It should be discharged proper location. Have a licensed plumber install a drain line.

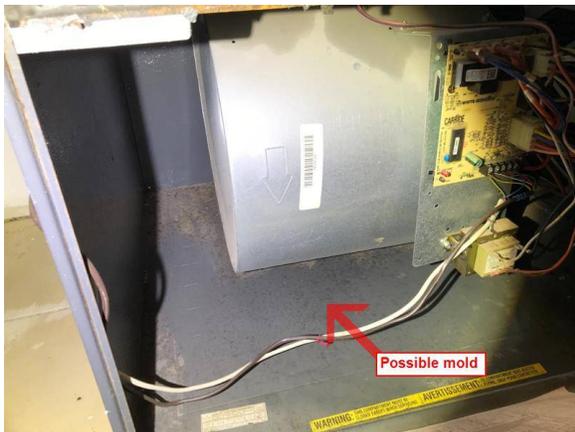
5. Filter installed is loose. Secure in place. **Mold suspicious observed** - Have a licensed mold examiner evaluate further recommended.

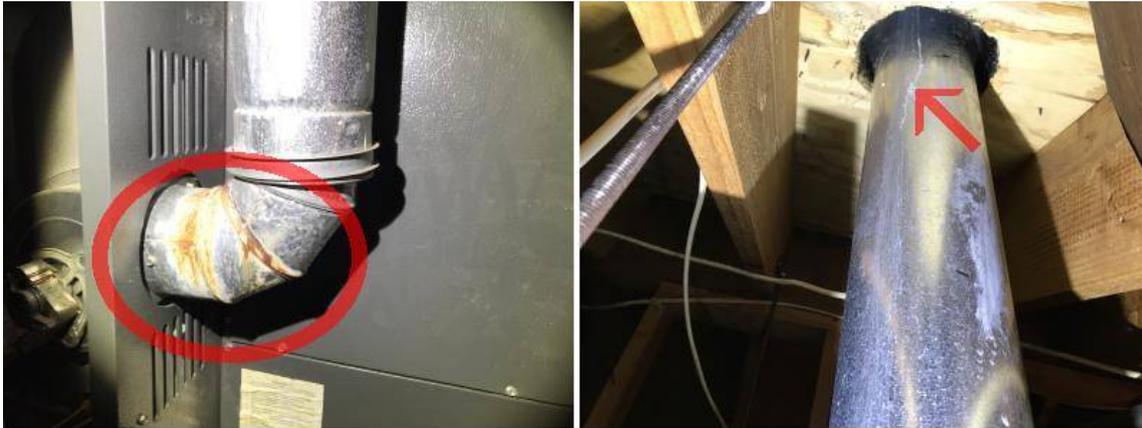
6. **Rusted vent flue and sign of water leaking from the roof were observed.** Have a qualified roof contractor inspect roof flashing (Refer to roof exposed flashing section)

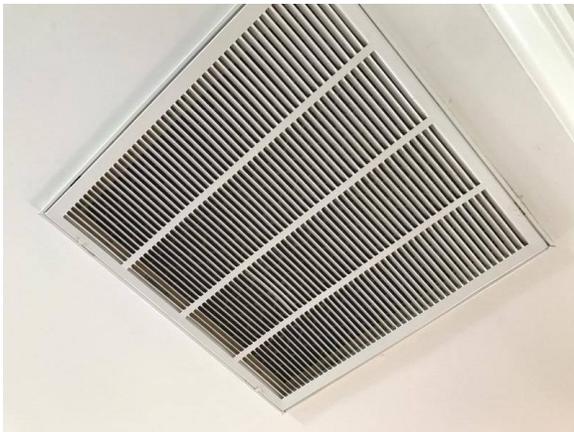
7. Dirty filters reduce airflow and increase cost of operation for heating. Replacement recommended at this time.

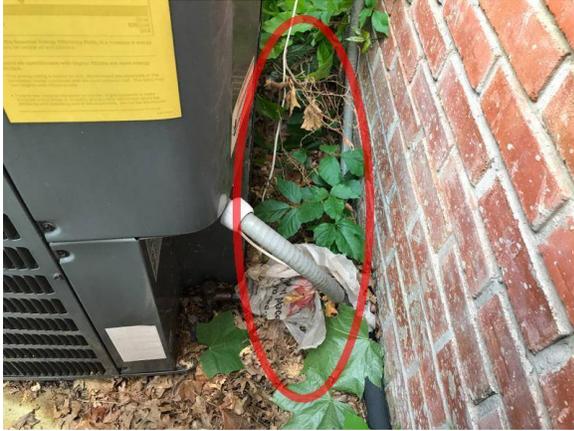
8. **Recommend clearing foliage from unit; Not enough clearance.**

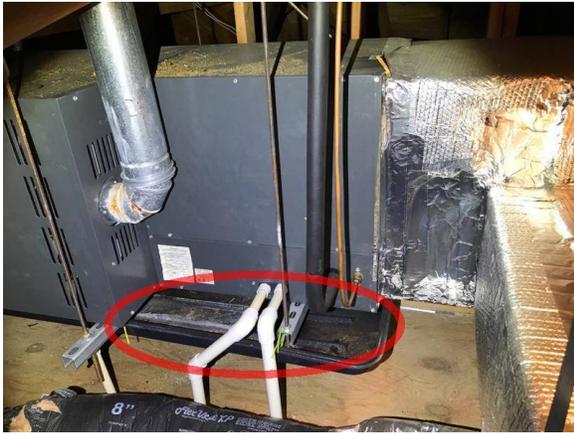
9. Evaporator unit has leaked in the past as evidenced by rust stains in its auxiliary drain pan. Recommend to have the system serviced by AC professional before cooling season.

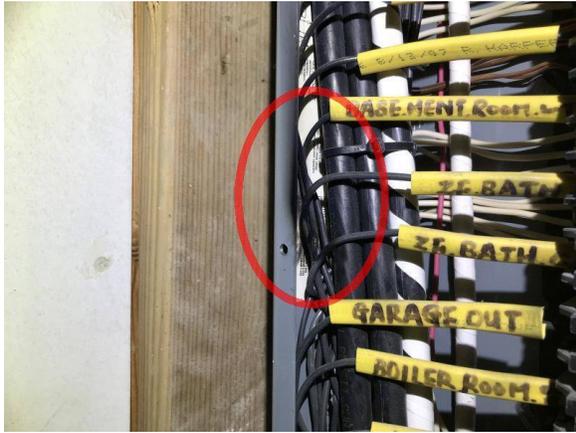
10. **When close the dead front cover, the screw(left middle) damaged a wire insulation due to tight and less clearance.** Sign of electric arc was remained on the panel. Also the breaker which the insulation damaged be tripped manually for safety. **Have a licensed electrician repair IMMEDIATELY FOR SAFETY.**

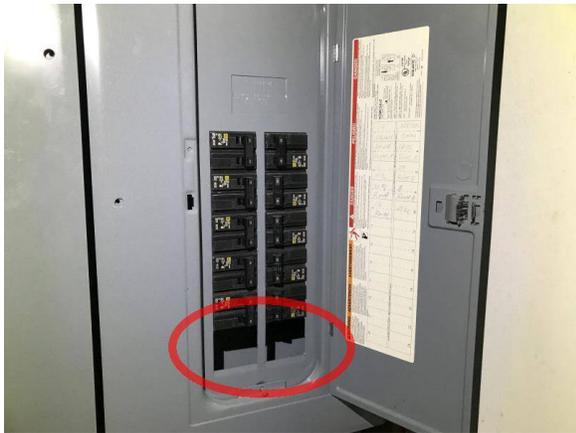
11. **Missing knock-out filler observed. SAFETY HAZARD** - Install knock-out filler for safety.

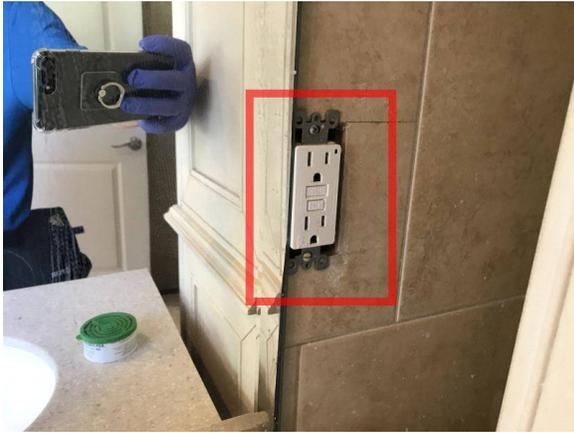
12. **Missing or Damaged receptacle cover noted** at the master bathroom - Replace.

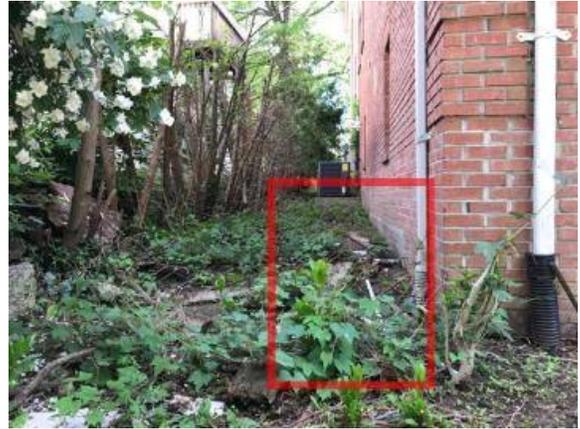
There are some areas of the lot that may allow water to interfere with the foundation. The soil along the foundation should be pitched away from the building at a minimum of 1/2 inch per foot and extend at least 10 feet away from the foundation. Improper pitch may lead to moisture intrusion to the basement or foundation(Refer to the Basement Walls Condition Section on the Foundation and Structure Chapter). Recommend re-grading the lot. Property slopes: Front to rear.

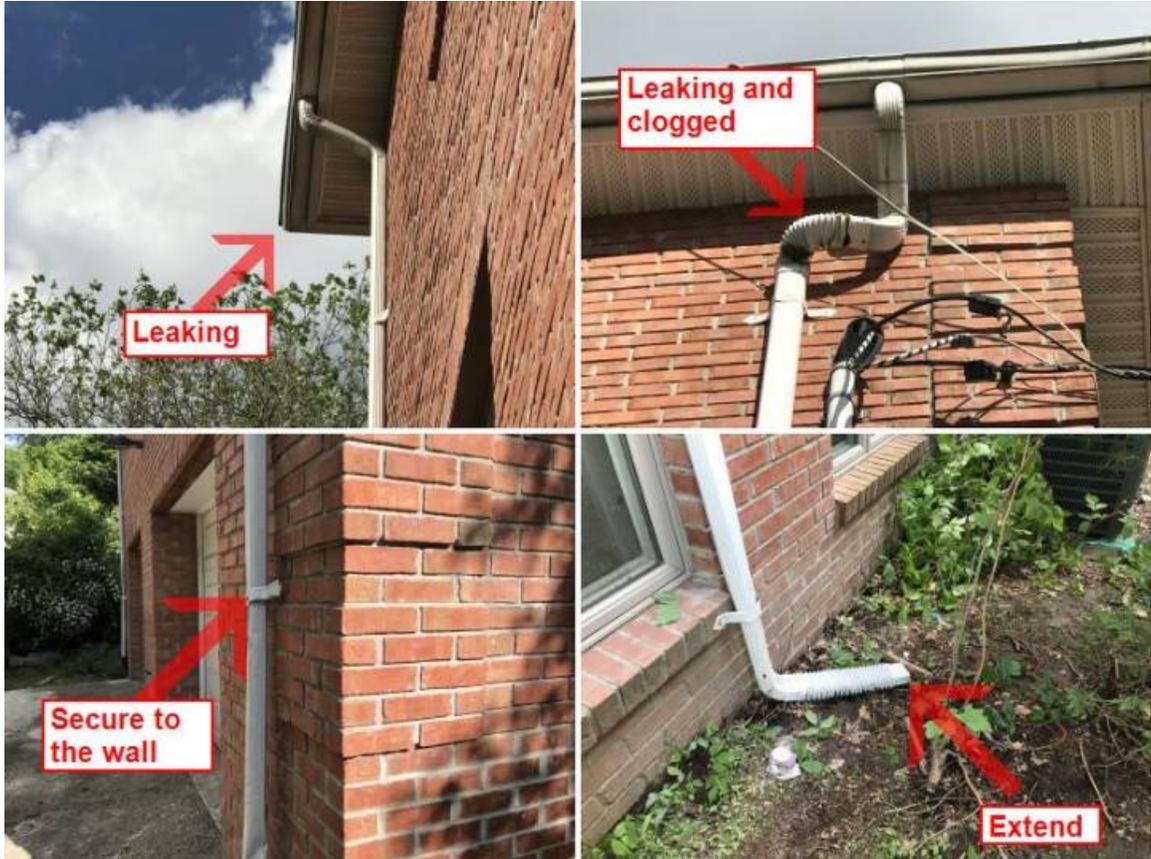
Aluminum type gutter & Downspout system used. Debris noted in gutter - Keep gutters clean and no blocking. Loose gutter or downspout noted - Secure as needed. **Clogged and leaked downspout noted** - Repair. Downspout discharging location too close to the foundation wall - Installation of downspout extensions at least 6 feet would help carry the water further away from the foundation. Gutter has seams. It is prone to water leaking - Recommend install seamless one piece gutter system.

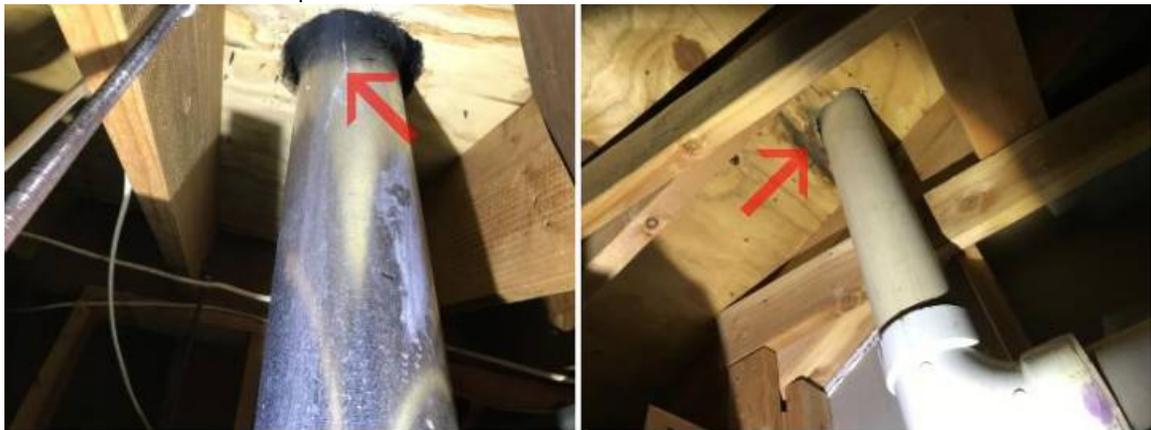
Installed neoprene seal was worn, or deteriorated - Replacement as needed. **Sign of leak under plumbing stack, sign of the leakage on furnace flue vent surface noted** - Have a qualified roof contractor evaluate all roof penetration further.

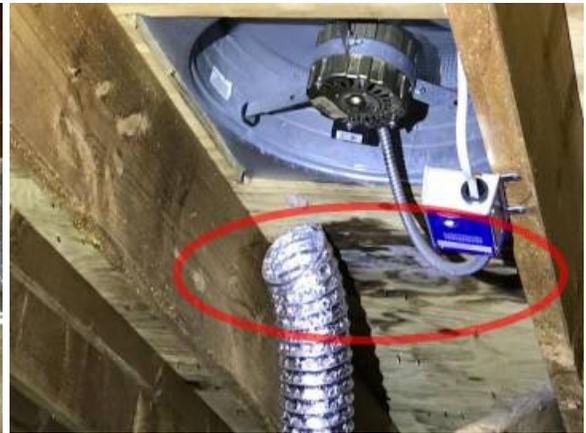
There is at least one bathroom, kitchen ventilation fan which discharging moisture laden air to the attic. It is preferable to direct all vent openings to the outside so that additional moisture is not introduced into the attic space and insulation.

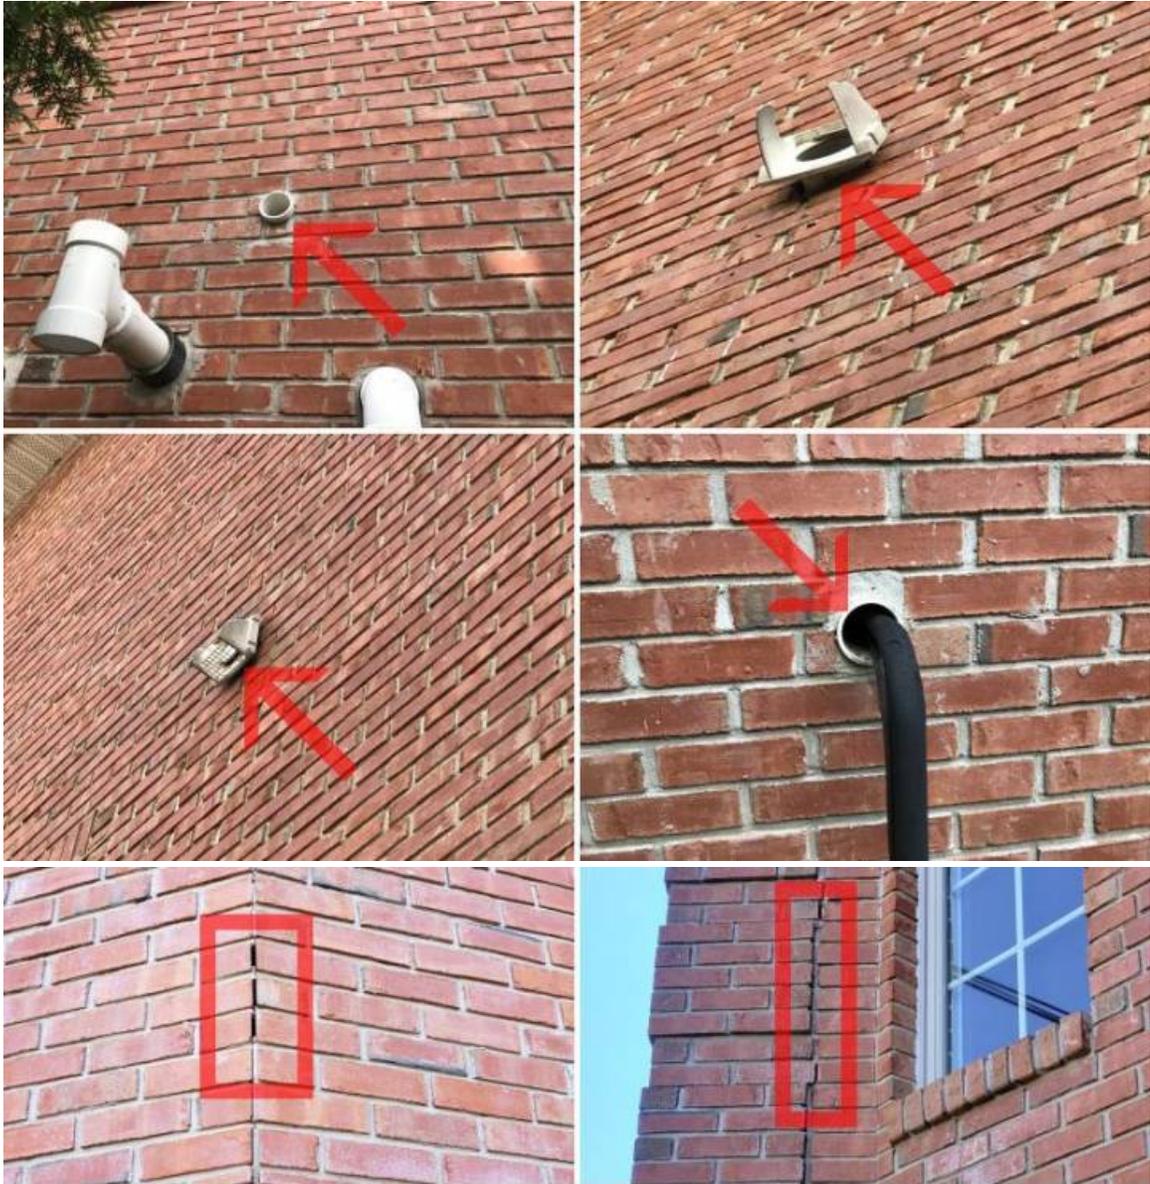
- (1) Recommendations: Seal all gaps to prevent moisture intrusion and further damage between Stucco and wood/brick wall. Monitor all gaps.
- (2) **Missing Weep holes.** Modern masonry veneer walls are provided with weep holes to allow water which reaches the back of masonry units to drain out of wall system. When rain accompanies high winds, air enters the weep holes and pressurizes the space behind the masonry wall, and less water moving into and through the masonry. Install weep holes at the bottom section of the wall.
- (3) Damaged dryer vent or exhaust vent hood should be replaced.
- (4) Loose or missing mortar observed on the front left exterior walls - Repair.

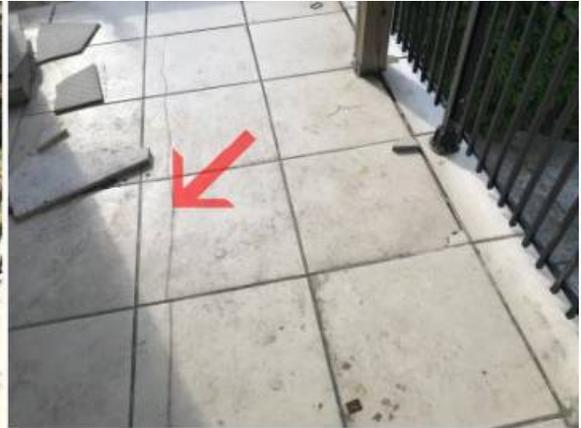
CONDITION:
Railing: **Loose railing viewed, safety hazard** - Repairs are necessary at this time. Painting be advised on handrail/guardrail to prevent water/insect damage. Cracked tiles noted - Replace.

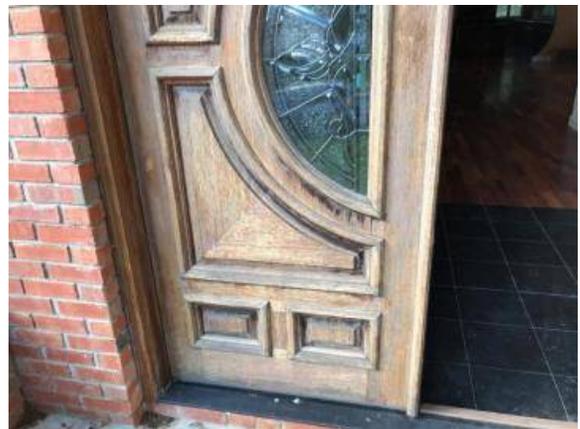
Wood door. Re-staining of the door to protect from weather be advised.

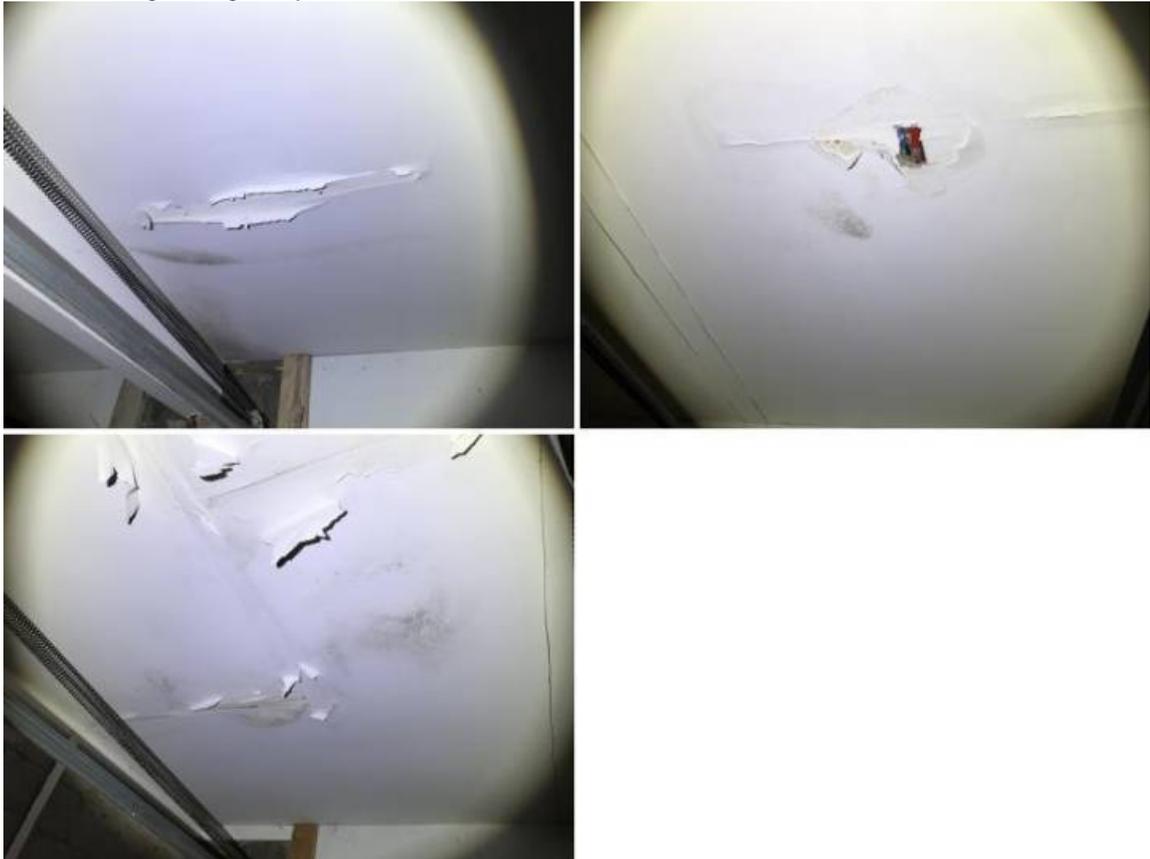
Water stain and damaged section noted. Observable mold viewed on the drywall ceiling. It appears that there was water leaking from the PEX water lines in the past. Have a licensed plumber evaluate further after removing damaged drywall section.

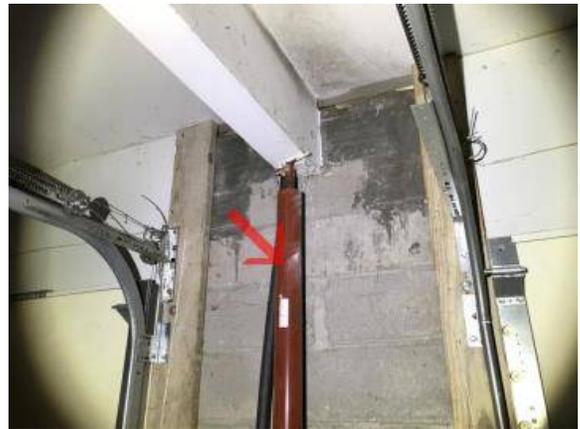
Temporary steel J-post being used permanent post - Evaluate by a qualified structural contractor recommended.

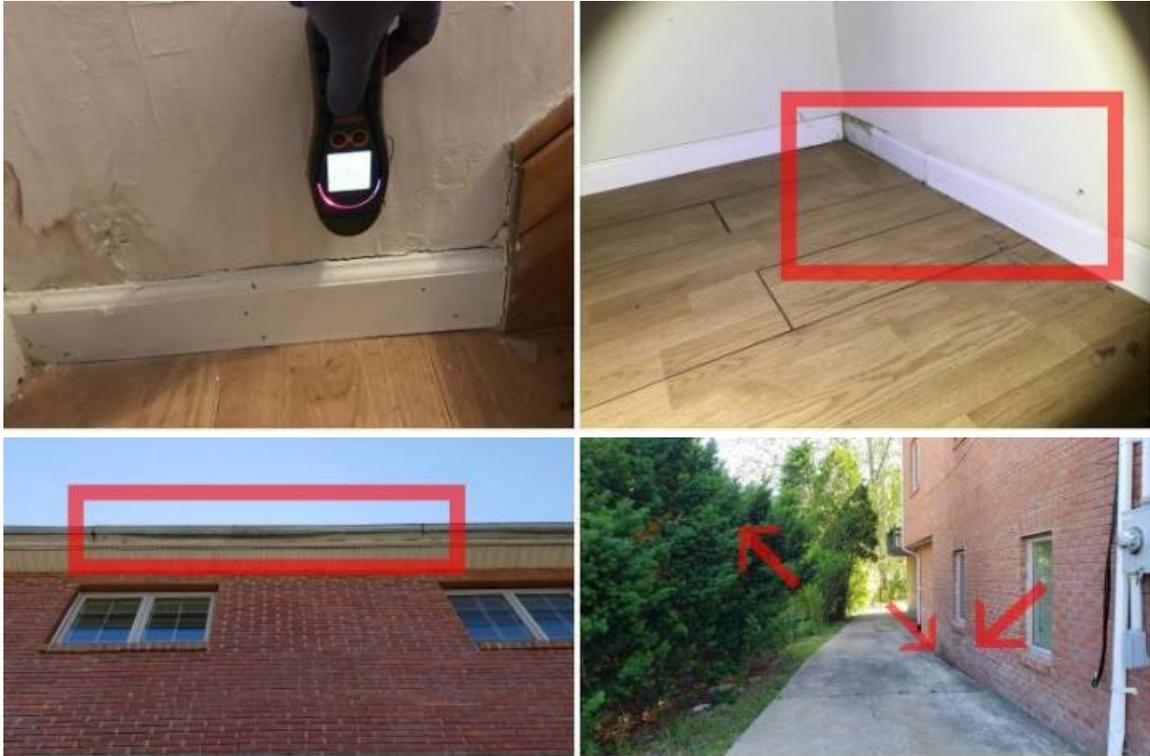
(2) Moisture issue on the left walls appears relating with gutter overflowing or leaking at the gutter seams. Dropped water was splashed and was absorbed by the exterior bricks or intruded through the cracked mortar. Tree shadows prevented reducing or blocking dry of the wall and accelerated moisture issue. Mortar re-pointing job was done recently by a contractor. **Trim the trees to increase dry potential and remove damaged drywalls and evaluate further.** Also **clean or remove all mold infested drywall by a licensed mold remediation contractor.**

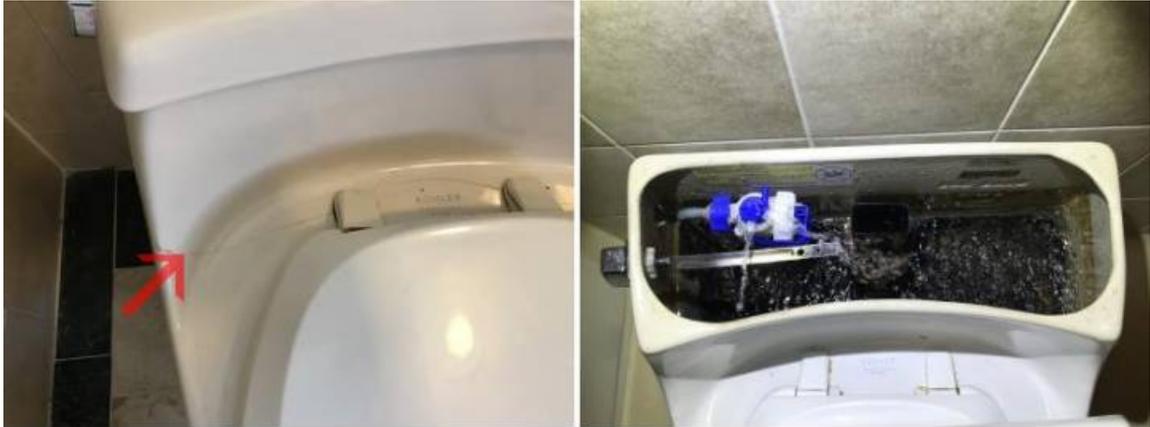
Minor plumbing repairs will be needed to restore proper operation in the hallway bathroom. Need repair. Cracked bowl noted in the master bathroom - Replace.

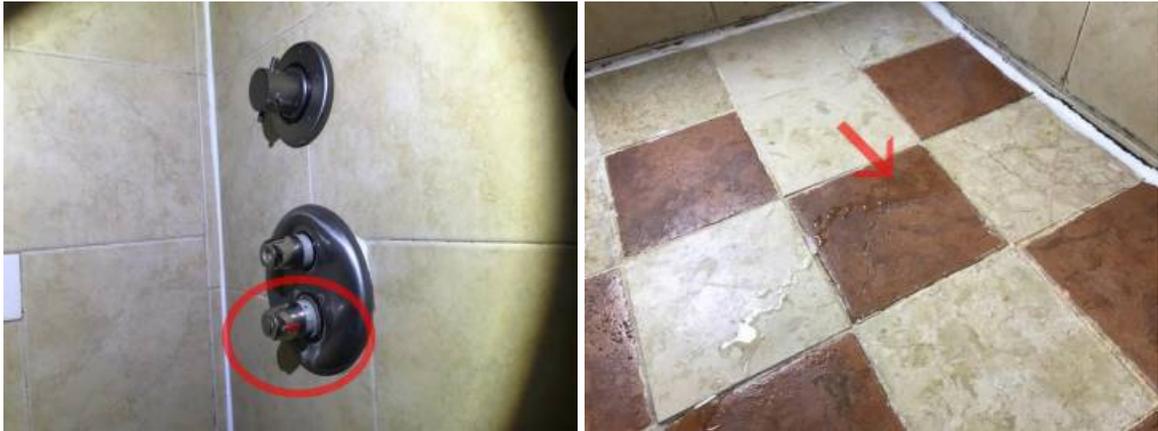
Minor leakage is noted at faucet in the master bathroom - Repair.

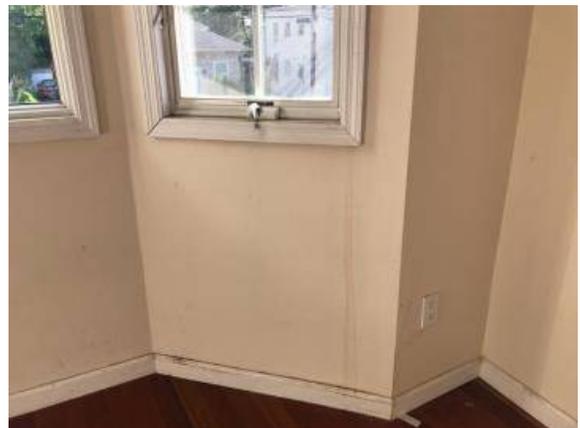
Water stains noted but does not appear current. Recommend to have the stain painted so that future incident would be easily identified.

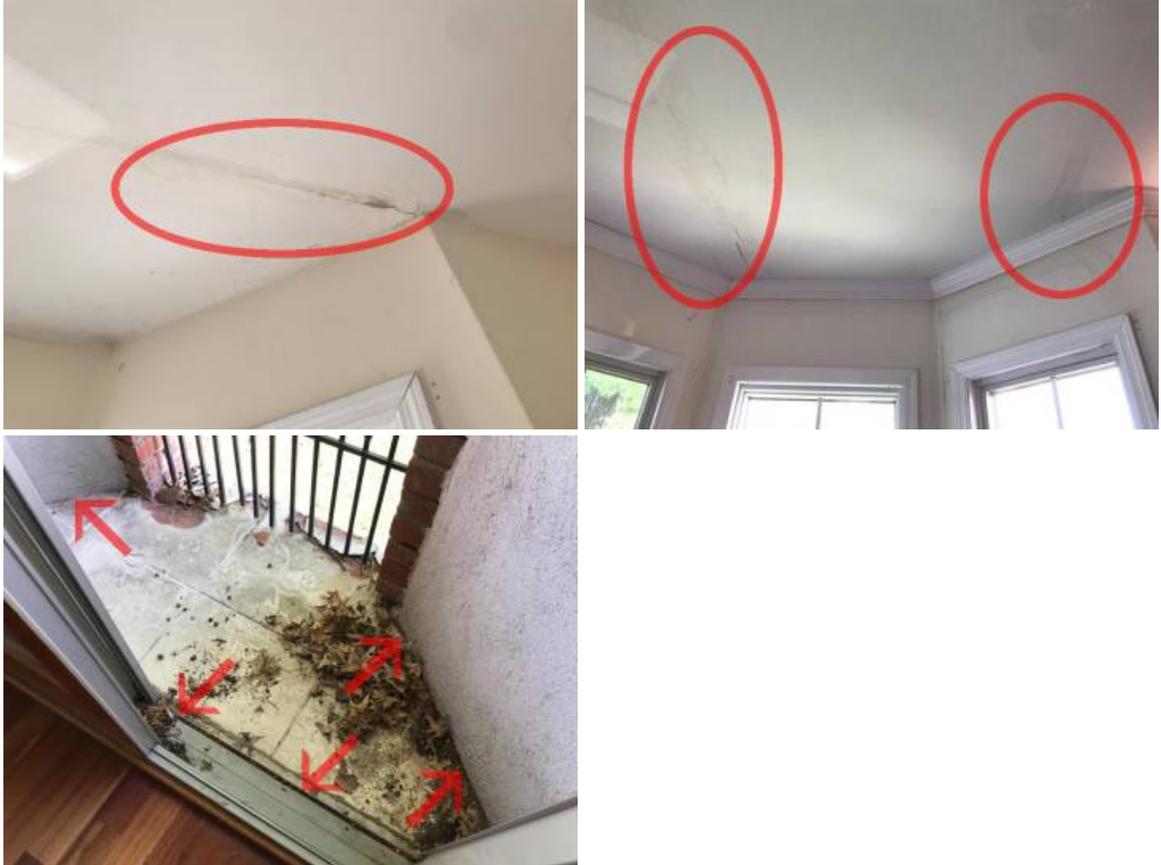
Water stains noted but does not appear current. It appears balcony water penetrated through cracked tiles, door sill or corner of the wall. It is very important that flashing and counter flashing at every corner should be properly installed at the balcony. Have a qualified balcony contractor evaluate further.

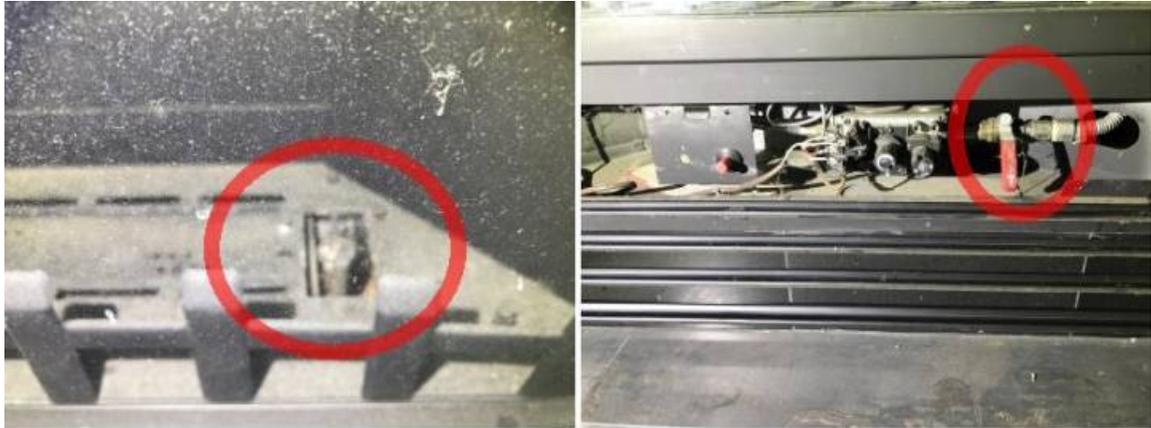
Location: Living Room, Gas fired burner and gas logs are not evaluated - They should be installed according to manufacturing specifications. Investigate further. Die to pilot light off. Test prior to closing.

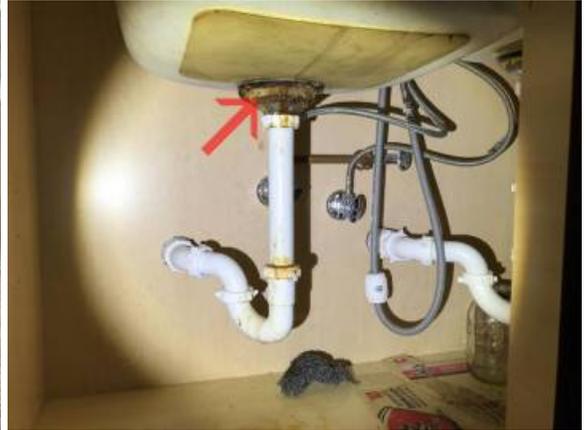
Leakage is noted at the drain line - Repairs are necessary.

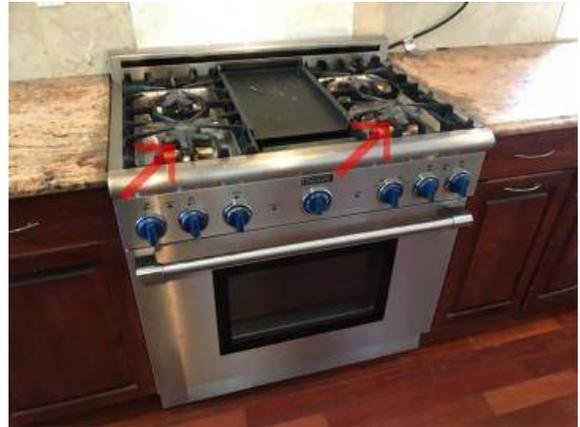
Gas. The stove burners are not all working properly - Clean or repair the defective burners.

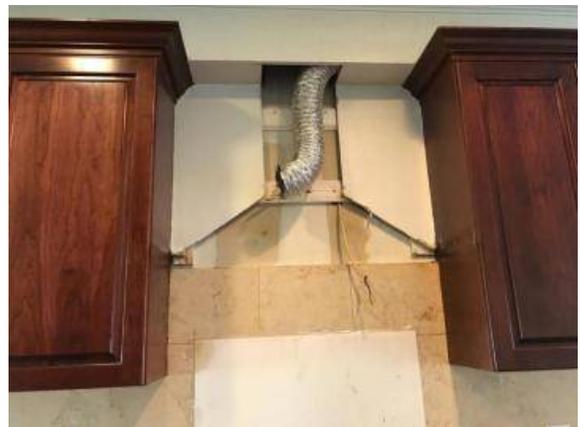
External ventilation is provided. No fan/hood presented - Installation of fan/hood is recommended.
