SUMMARY REPORT

Tuesday, June 16, 2020

RE: 123 Abc St, Abcd, NJ 07000

Confidential Property Condition Report

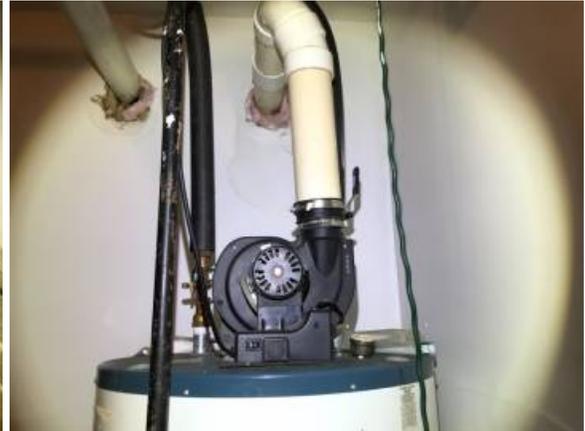
The unit is end of the life due to tank leaking - Replace.

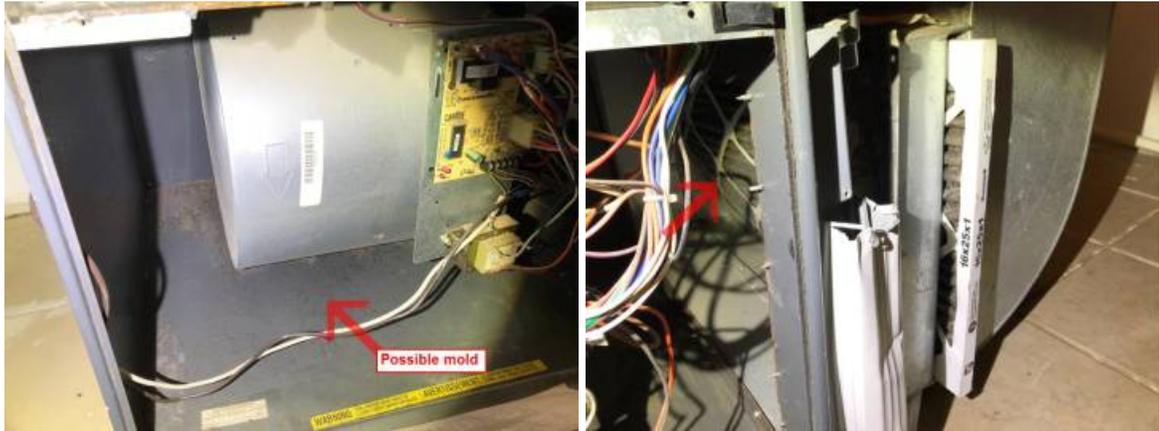
Filter installed is loose. Secure in place. **Mold suspicious observed** - Have a licensed mold examiner evaluate further recommended.

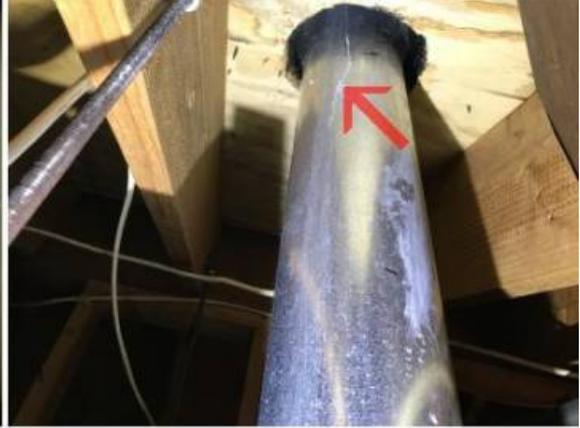
Rusted vent flue and sign of water leaking from the roof were observed. Have a qualified roof contractor inspect roof flashing (Refer to roof exposed flashing section)

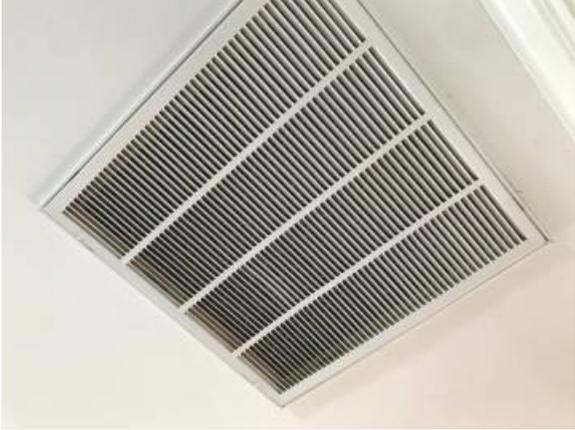
Dirty filters reduce airflow and increase cost of operation for heating. Replacement recommended at this time.

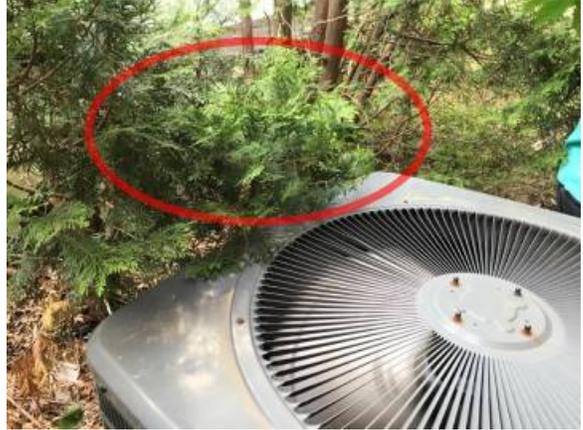
Recommend clearing foliage from unit; Not enough clearance.

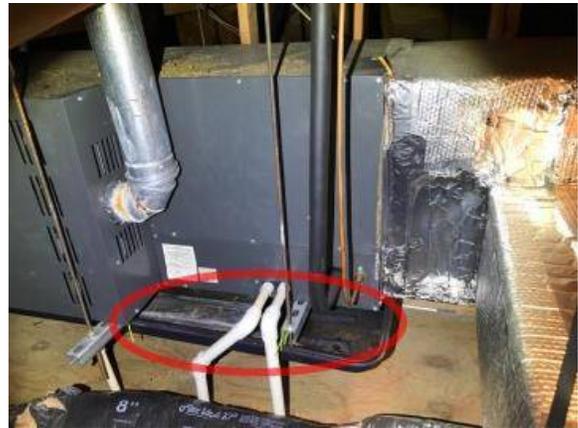
Evaporator unit has leaked in the past as evidenced by rust stains in its auxiliary drain pan. Recommend to have the system serviced by AC professional before cooling season.

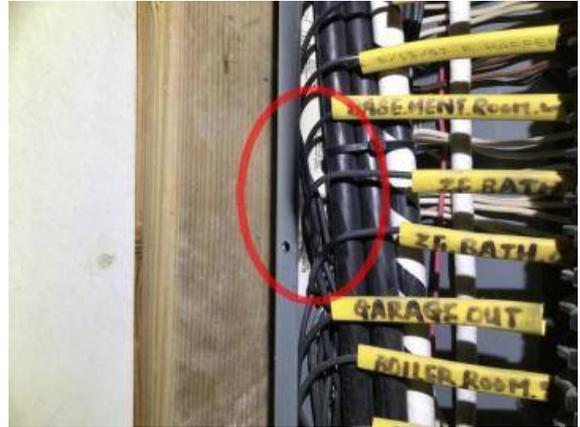
When close the dead front cover, the screw(left middle) damaged a wire insulation due to tight and less clearance. Sign of electric arc was remained on the panel. Also the breaker which the insulation damaged be tripped manually for safety. Have a licensed electrician repair **IMMEDIATELY FOR SAFETY**.

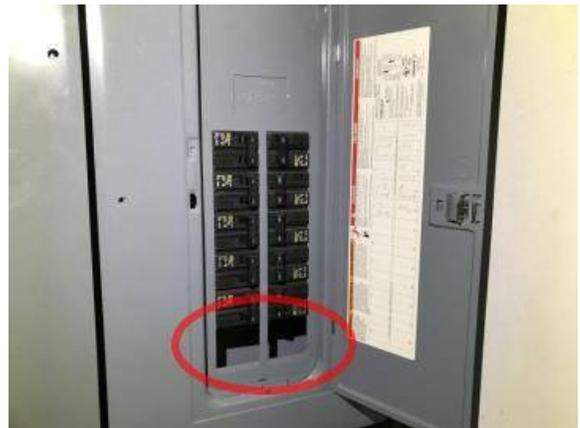
SUB PANEL NOTES:
Missing knock-out filler observed. SAFETY HAZARD - Install knock-out filler for safety.
