ASB-328-28-041

Title: Fuel – Inspection of Fuel Line Clamps

Dornier 328-100

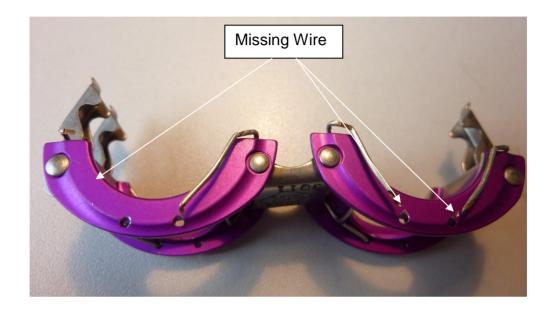
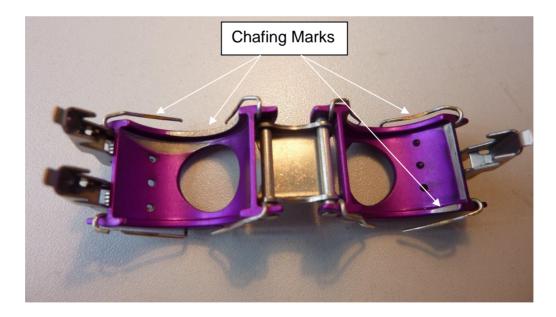
Figure 1: Examples of Reported Damage

Chafing of fuel line clamp bonding wires inside feeder tank.

328 SSG received reports of damaged bonding wires on fuel line clamps in post SB-328-28-490 installations. The basic clamp function is not impaired, but proper bonding and thus lightning protection might be affected. Refer to Figure 1.

In addition, chafing marks on jet pump inlet, connection part and fuel lines occurred.

Parts with chafing marks beyond defined limits have to be replaced.

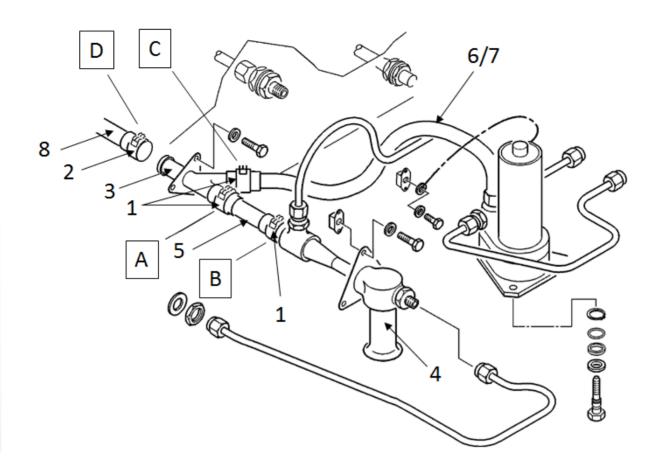
Figure 2: Clamp Identification and Findings for Reporting

NOTE: LH installation shown. RH installation mirrored.

- 1) Inspect all Hydraflow fuel line clamps at locations A D for damage of bonding wires in the area. Take pictures of each location for reporting purposes. Refer to Figure 2.
- 2) Open clamps and remove them from tank. Record installation locations.
- 3) Visually inspect clamps for worn or missing bonding wires. If you find worn or missing bonding wires, replace clamp and report the location.
- 4) Visually inspect the jet pump outlet, connection part and fuel lines for chafing marks. Remove parts from tank if chafing marks are found. Refer to the related AMM JIC's.
