Dornier 328

This sheet transmits Revision 2 to Alert Service Bulletin ASB-328-57-037 titled: Wings – Inspection of the Lower Inner Panel for Cracks.

No. ASB-328-57-037

Title: Wings - Inspection of the Lower Inner Panel for Cracks.

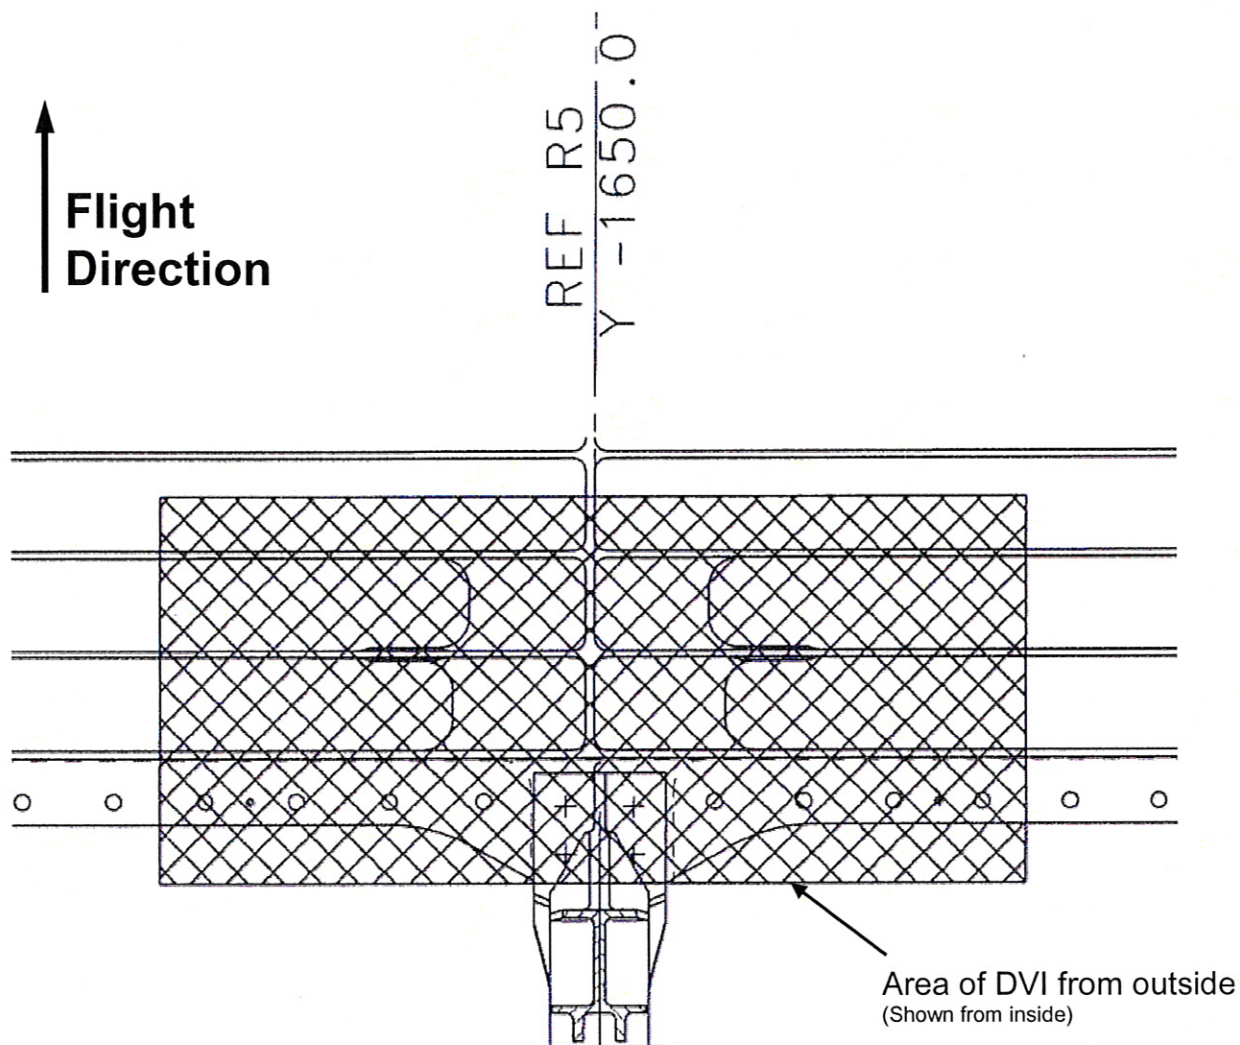
**Fig. 1**Model Dornier 328Rev. No. 2No. ASB-328-57-037Rev. Date. May 20, 2008Date of Issue May 05, 2008Page 7 of 12

Cracks have been found at lower wing panel rear trailing edge L/H and R/H of flap lever arm 1 (rib 5).

- (1) Detailed visual Inspection according NTM 51-25-90:
 - (a) Perform a detailed visual inspection of the lower wing panel (outside) around the flap lever arm 1 (rib 5) in the area as marked in Fig. 1.

NOTE: Cracks seem to start at the attachment holes of access panels.

CAUTION: IN CASE OF NO FINDINGS THIS DETAILED VISUAL INSPECTION HAS TO BE PERFORMED EVERY 50 FLIGHT HOURS UNTIL THE EDDY CURRENT ACCORDING (2) AND (3) HAS BEEN PERFORMED.

IF CRACKS ARE FOUND AN EDDY CURRENT INSPECTION ACCORDING (2) AND (3) HAS TO BE PERFORMED IMMEDIATELY.

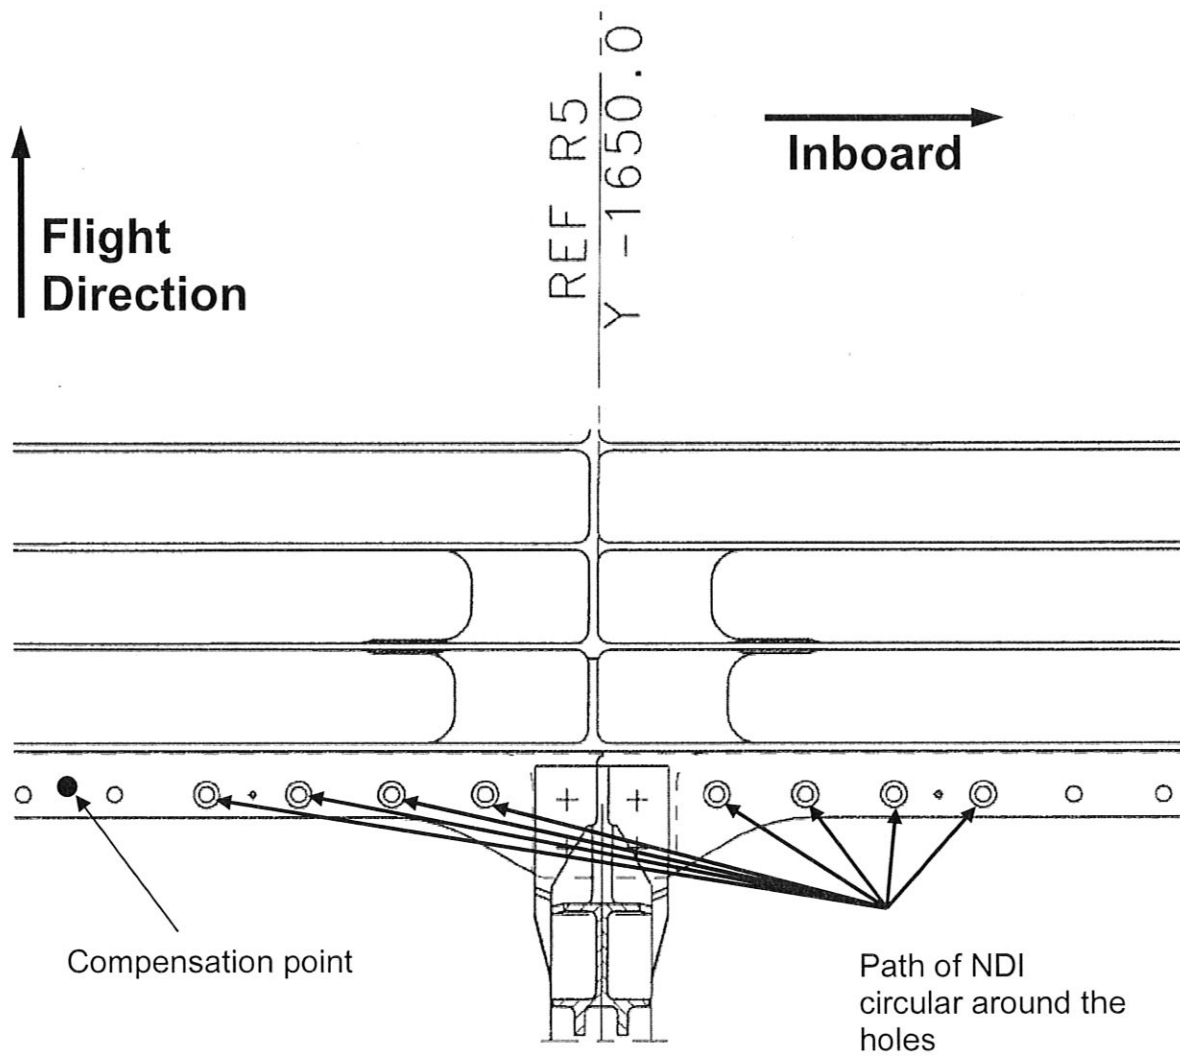
Fig. 2

- (d) Calibrate the instrument using the calibration standard as given in the manufacturer's instructions.
- (3) Perform an Eddy current NDI in the area marked in Fig. 2, Fig. 3 and Fig. 1 (for cracks detected in former inspections).
- (a) Set the necessary frequency to 200 KHz according to NTM 51-25-60, page 4, "Depth of Penetration versus Frequency" (refer to Diagram 1).

- (b) Calibrate your equipment using the calibration standard according NTM to achieve the crack signal for 1.0mm located at approximate 80% Screen Height (refer to Diagram 2). Put the probe on the compensation point near to the inspection area and set the lift-off as necessary, refer to Fig. 2.

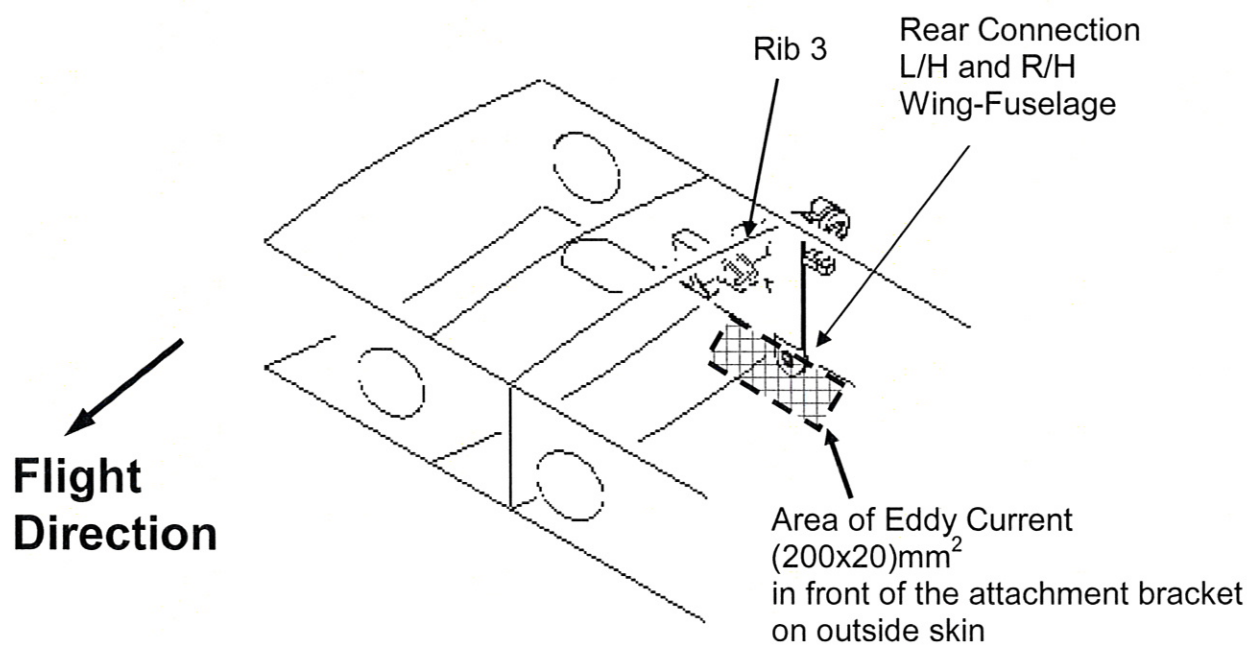
**Fig. 3**

- (c) Perform the inspection as given in Fig. 2, Fig. 3 and Fig. 4. Use the probe position and scan along path movements as illustrated (refer to Fig. 4).
- (d) Look at the CRT screen for signals that are different from that of the compensation point.

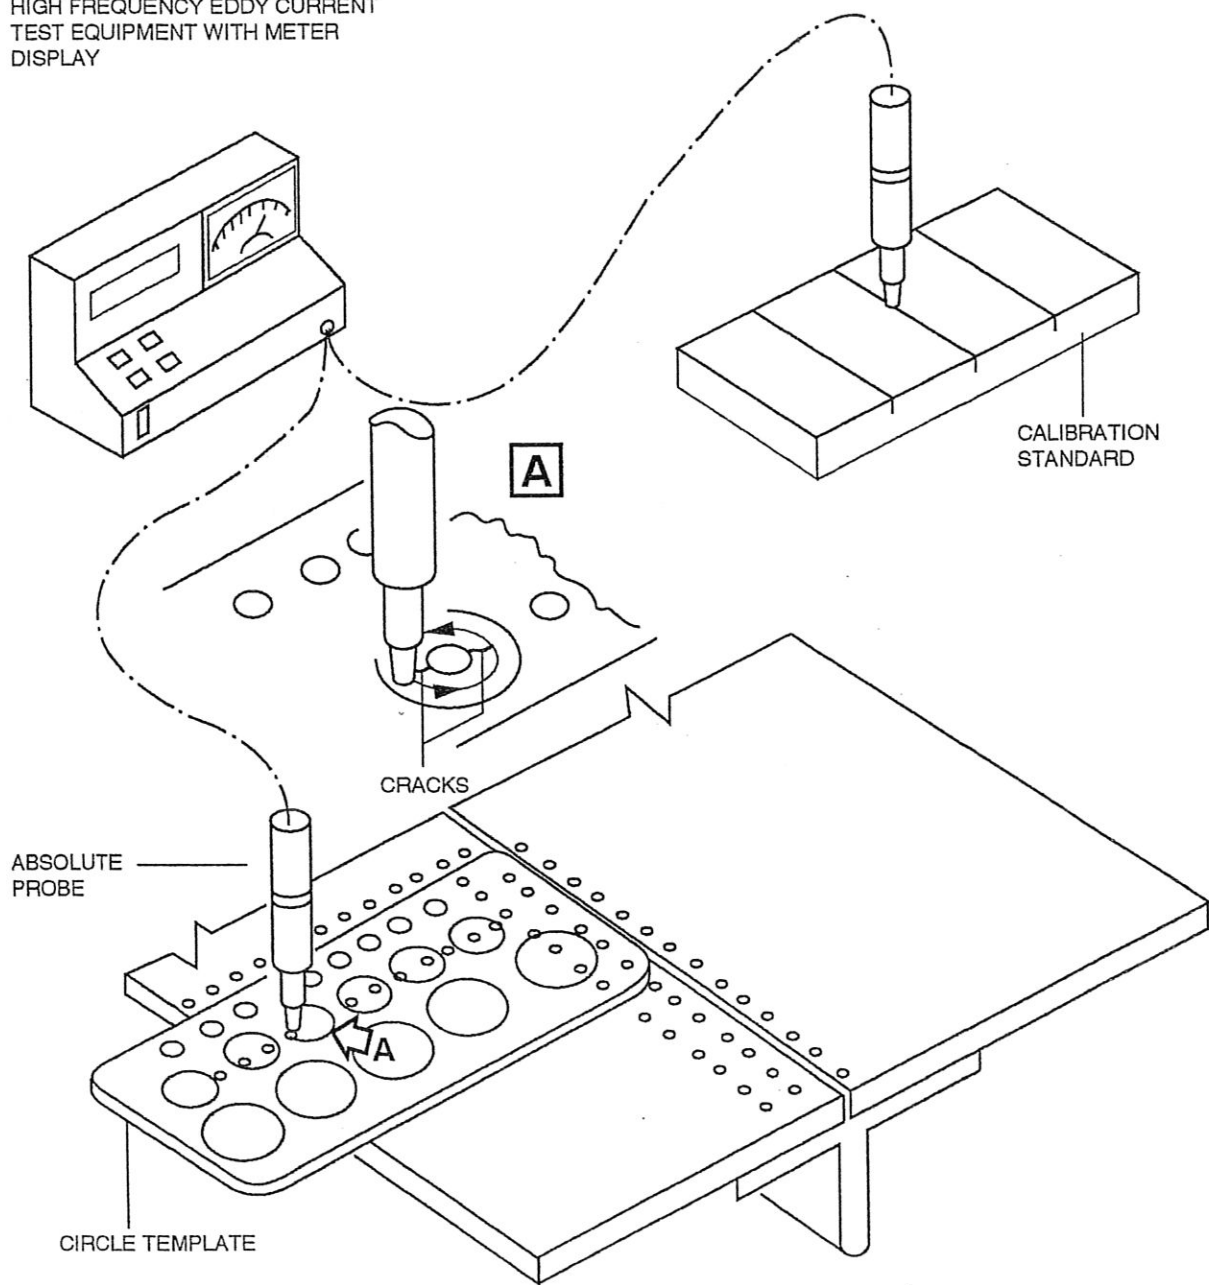
Fig. 4

Inspection for Surface Cracks

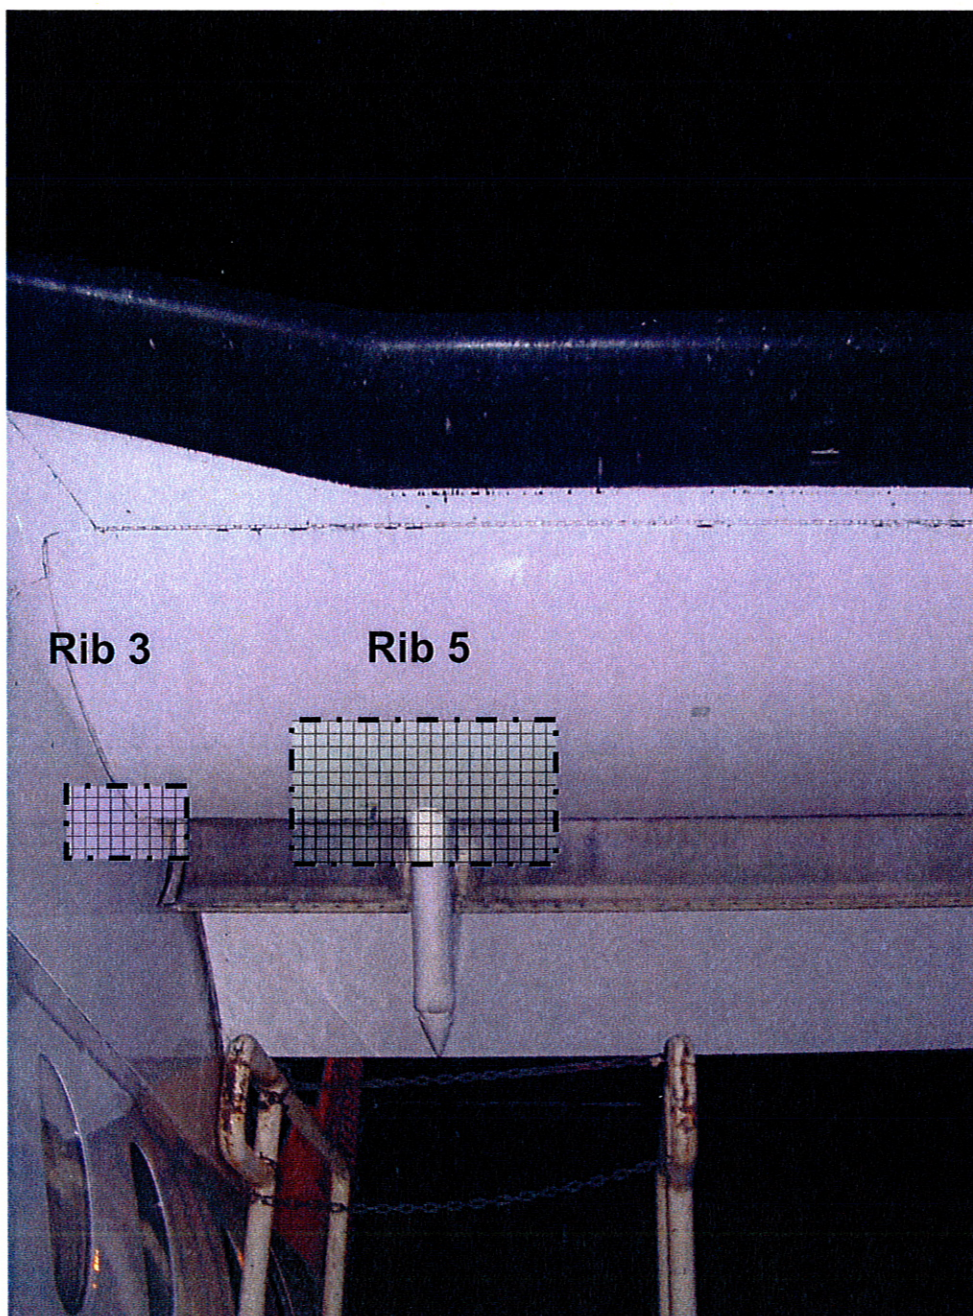
**Picture 1: Location of inspecting area**Model Dornier 328Rev. No. 2No. ASB-328-57-037Rev. Date. May 20, 2008Date of Issue May 05, 2008Page 11 of 12

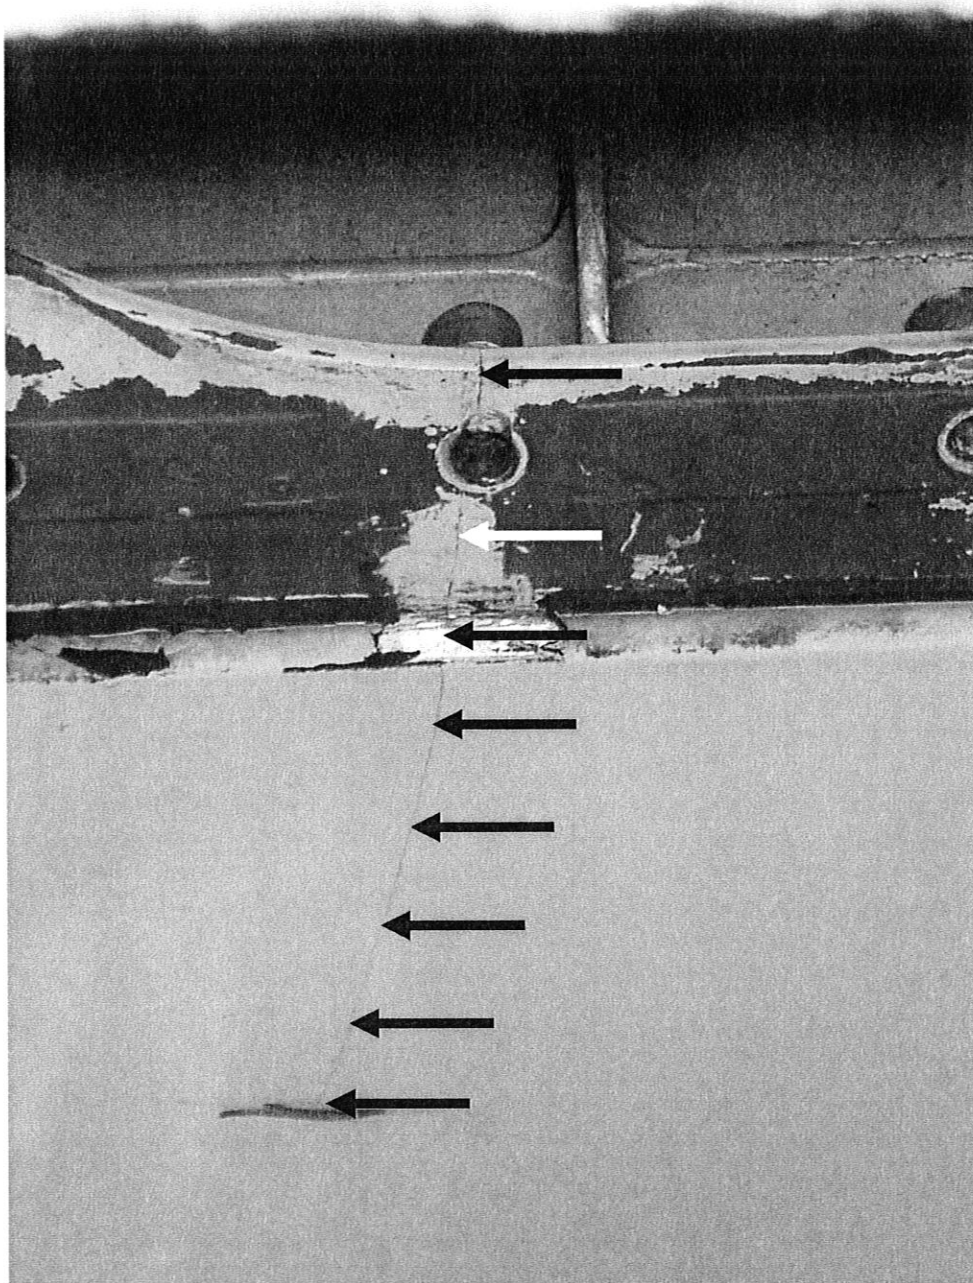
Picture 2: Example of a crack (lower outside view)

NON-REVENUE FERRY FLIGHTS (THREE FLIGHT CYCLES) ARE PERMITTED FOR DETECTED CRACKS WITH A LENGTH NOT EXCEEDING $L_{\max} = 12,5\text{mm}$ ($\sim 0.5''$).

IT IS NOT PERMITTED TO OPERATE THE AIRCRAFT WITH A CRACK LENGTH EXCEEDING L_{\max} WITHOUT AUTHORISATION ISSUED BY 328 SUPPORT SERVICES GMBH.

- (1) The repair design (RAS) will be defined based on the individual damage.
