Dornier 328J

This sheet transmits Revision 2 to Alert Service Bulletin ASB-328J-57-015 titled: Wings – Inspection of the Lower Inner Panel for Cracks.

No. ASB-328J-57-015

Title: Wings - Inspection of the Lower Inner Panel for Cracks.

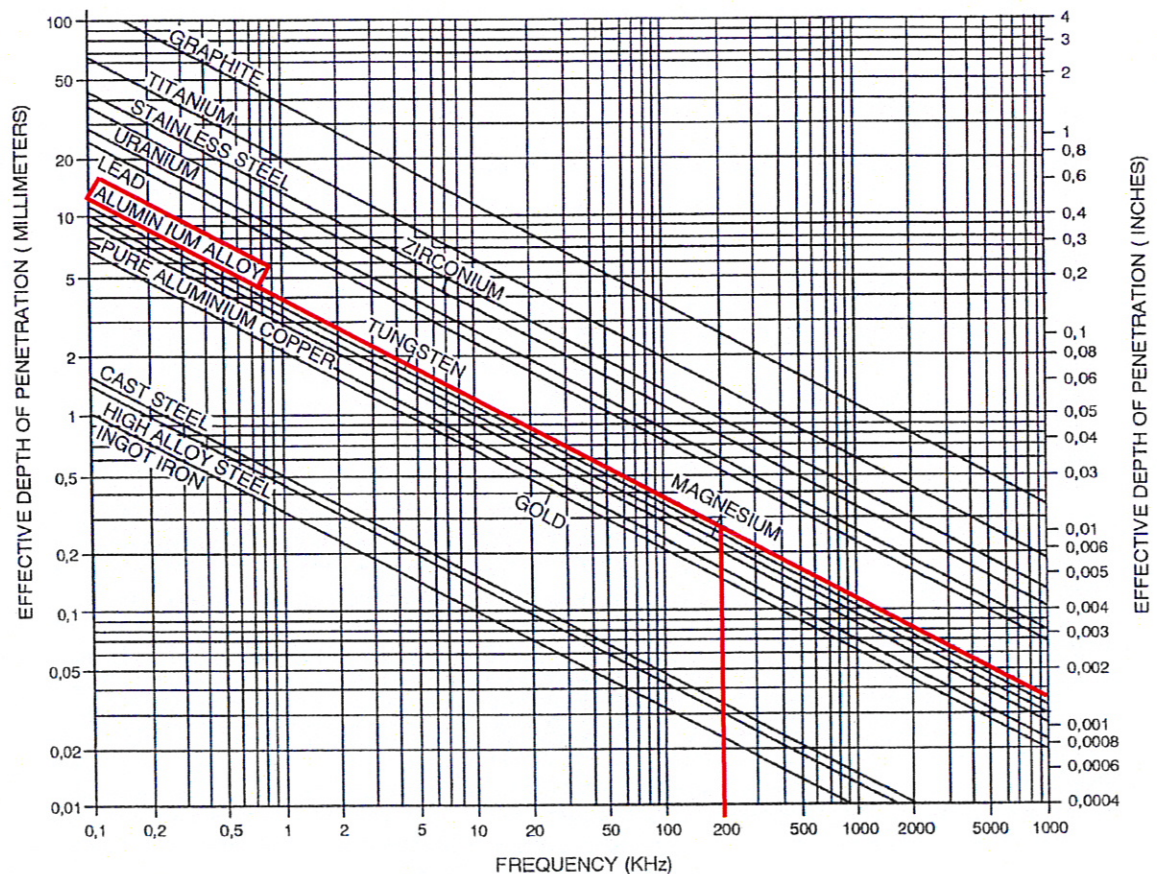
**Diagram 1: Depth of Penetration versus Frequency
(according NTM 51-25-60, Page 4, Fig.2)**

- (d) Calibrate the instrument using the calibration standard as given in the manufacturer's instructions.
- (3) Perform an Eddy current NDI in the area marked in Fig. 2, Fig. 3 and Fig. 1 (for cracks detected in former inspections).
- (a) Set the necessary frequency to 200 KHz according to NTM 51-25-60, page 4, "Depth of Penetration versus Frequency" (refer to Diagram 1).

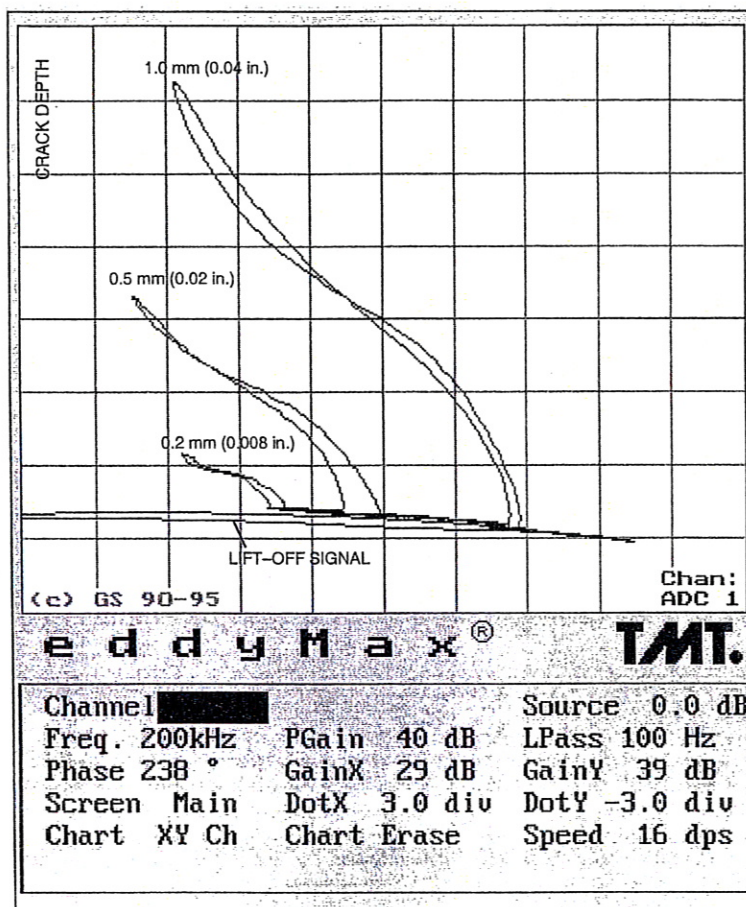
Diagram 2: Equipment calibration signal according NTM

- (b) Calibrate your equipment using the calibration standard according NTM to achieve the crack signal for 1.0mm located at approximate 80% Screen Height (refer to Diagram 2). Put the probe on the compensation point near to the inspection area and set the lift-off as necessary, refer to Fig. 2.

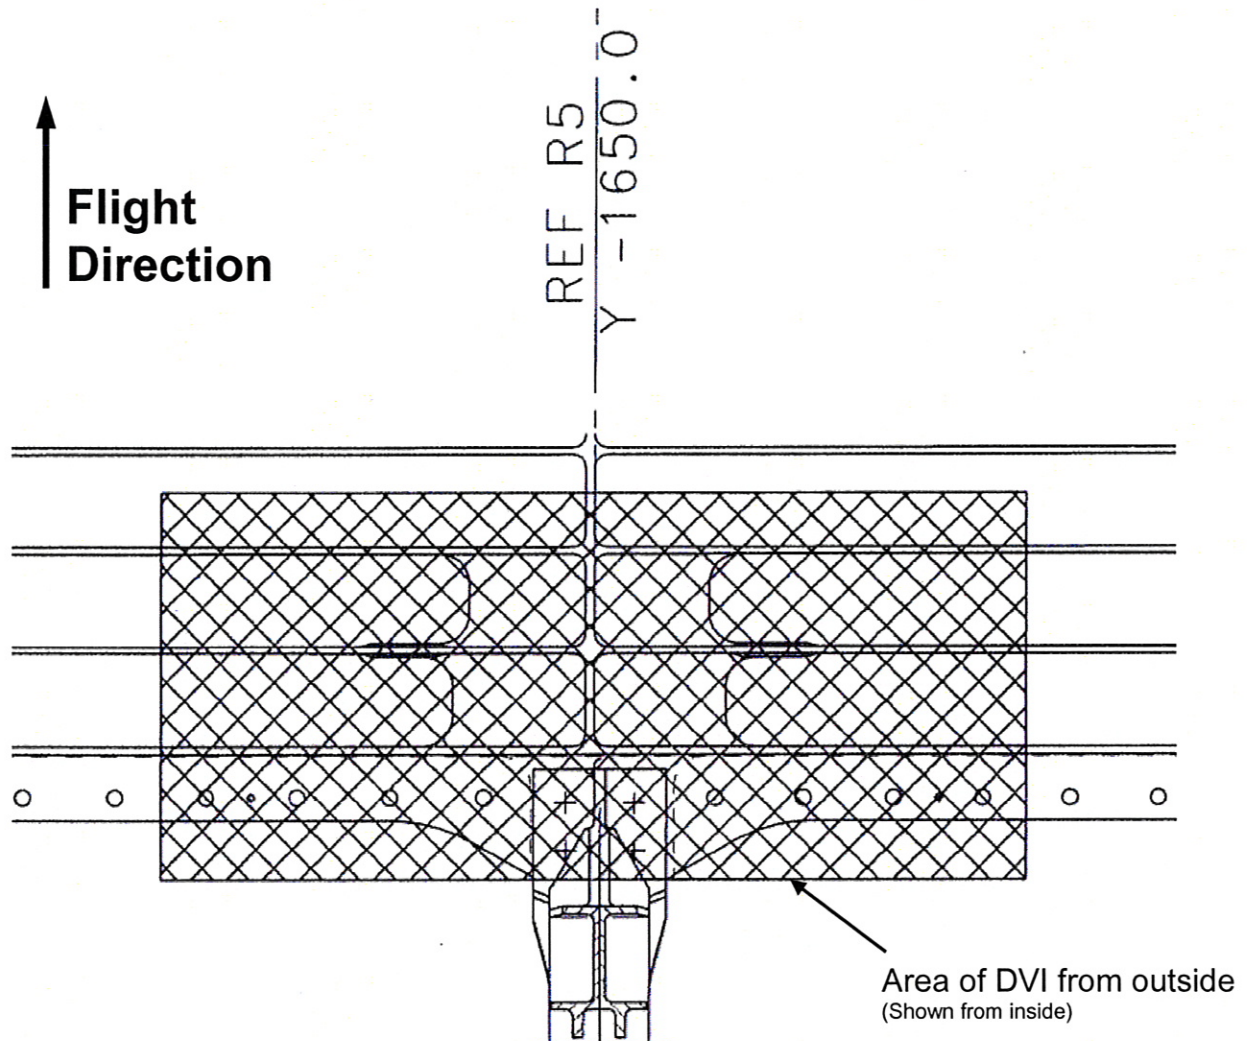
**Fig. 1**Model Dornier 328JRev. No. 2No. ASB-328J-57-015Rev. Date. May 20, 2008Date of Issue May 05, 2008Page 7 of 12

Cracks have been found at lower wing panel rear trailing edge L/H and R/H of flap lever arm 1 (rib 5).

- (1) Detailed visual Inspection according NTM 51-25-90:
 - (a) Perform a detailed visual inspection of the lower wing panel (outside) around the flap lever arm 1 (rib 5) in the area as marked in Fig. 1.

NOTE: Cracks seem to start at the attachment holes of access panels.

CAUTION: IN CASE OF NO FINDINGS THIS DETAILED VISUAL INSPECTION HAS TO BE PERFORMED EVERY 50 FLIGHT HOURS UNTIL THE EDDY CURRENT ACCORDING (2) AND (3) HAS BEEN PERFORMED.

IF CRACKS ARE FOUND AN EDDY CURRENT INSPECTION ACCORDING (2) AND (3) HAS TO BE PERFORMED IMMEDIATELY.

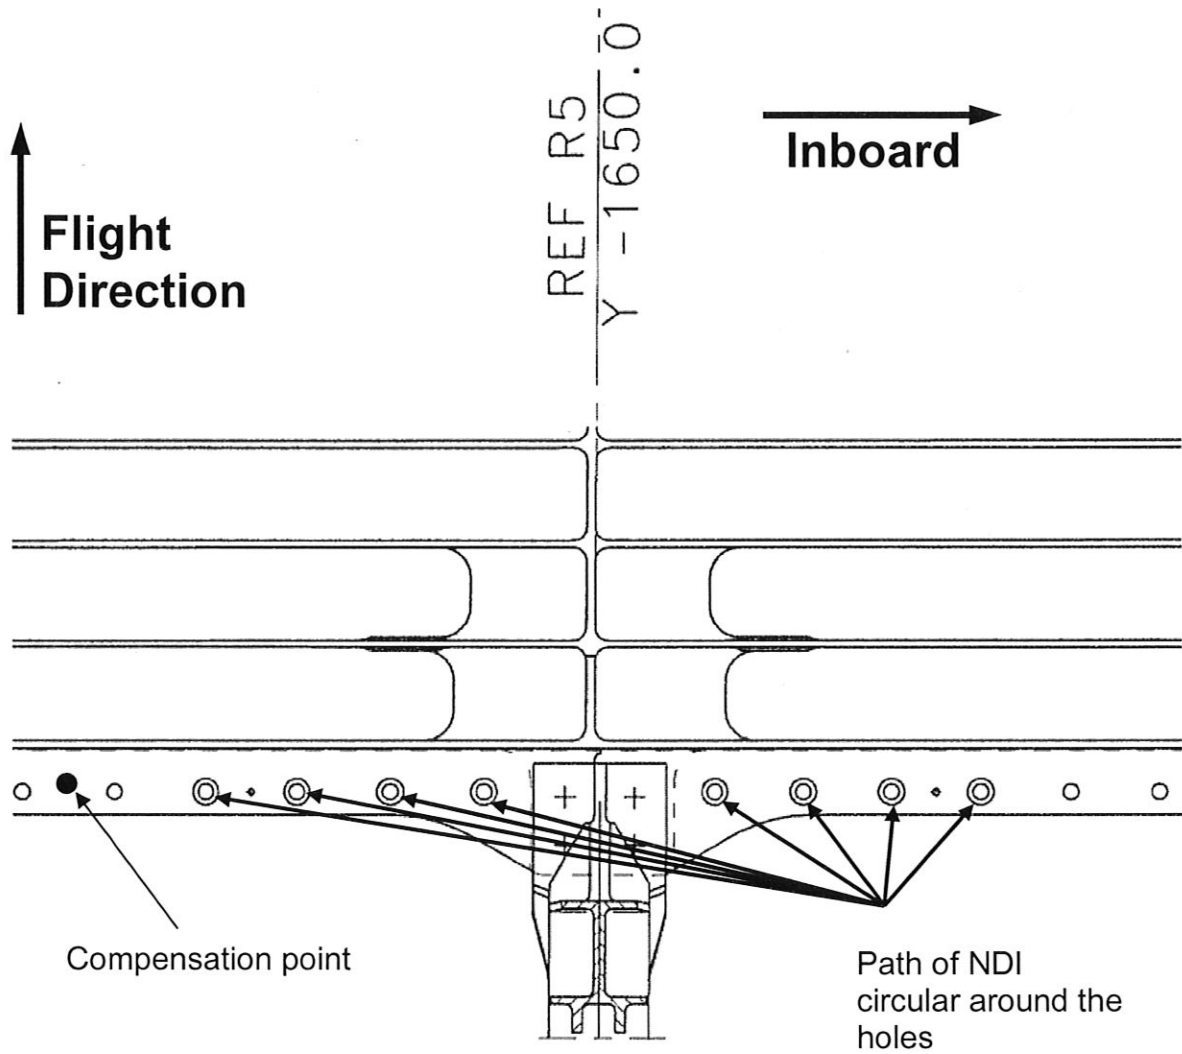
Fig. 2

- (c) Perform the inspection as given in Fig. 2, Fig. 3 and Fig. 4. Use the probe position and scan along path movements as illustrated (refer to Fig. 4).
- (d) Look at the CRT screen for signals that are different from that of the compensation point.

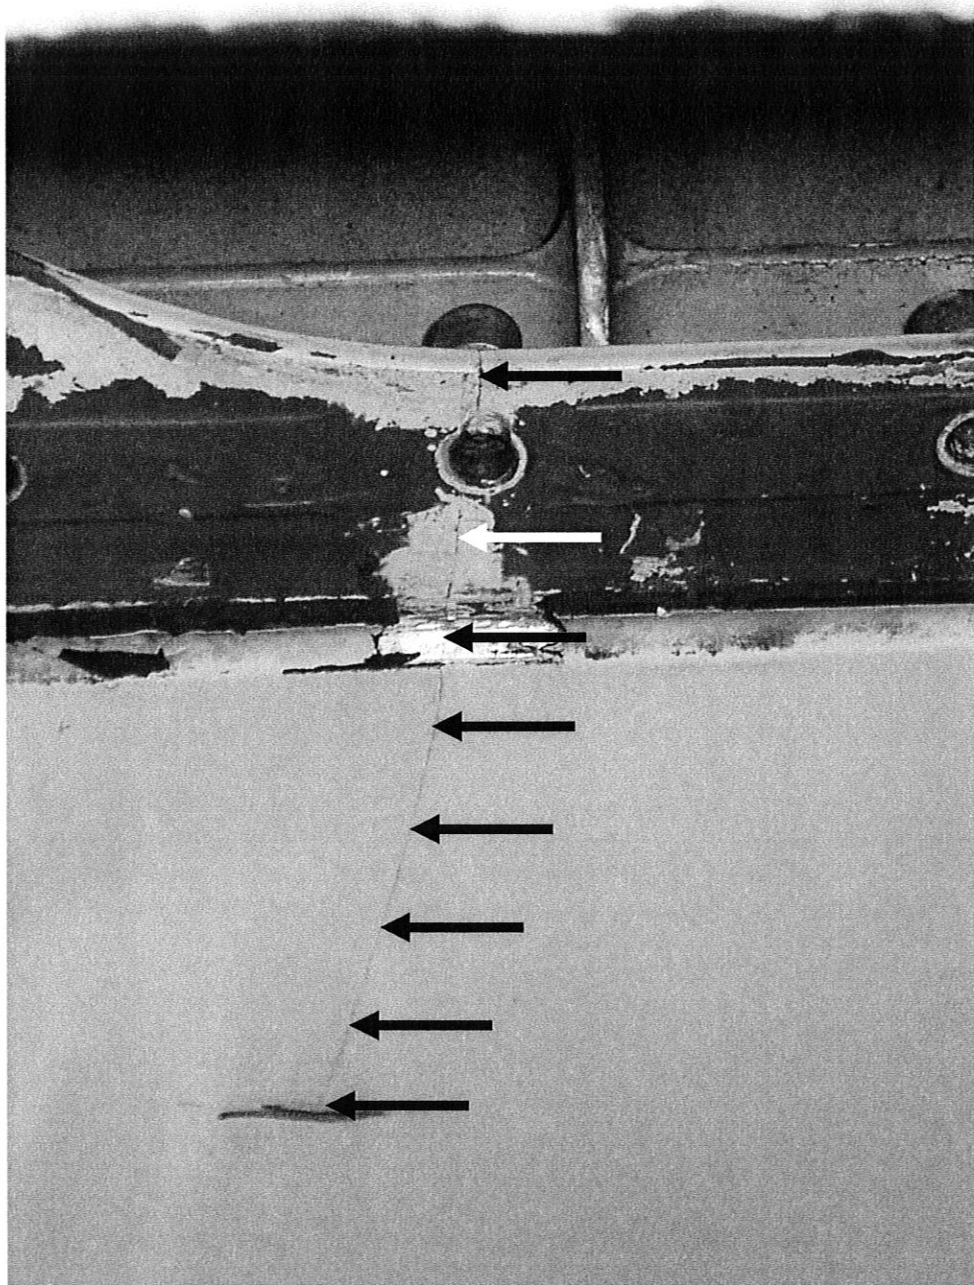
Picture 2: Example of a crack (lower outside view)

NON-REVENUE FERRY FLIGHTS (THREE FLIGHT CYCLES) ARE PERMITTED FOR DETECTED CRACKS WITH A LENGTH NOT EXCEEDING $L_{\max} = 12,5\text{mm}$ (~0.5").

IT IS NOT PERMITTED TO OPERATE THE AIRCRAFT WITH A CRACK LENGTH EXCEEDING L_{\max} WITHOUT AUTHORISATION ISSUED BY 328 SUPPORT SERVICES GMBH.

- (1) The repair design (RAS) will be defined based on the individual damage.
