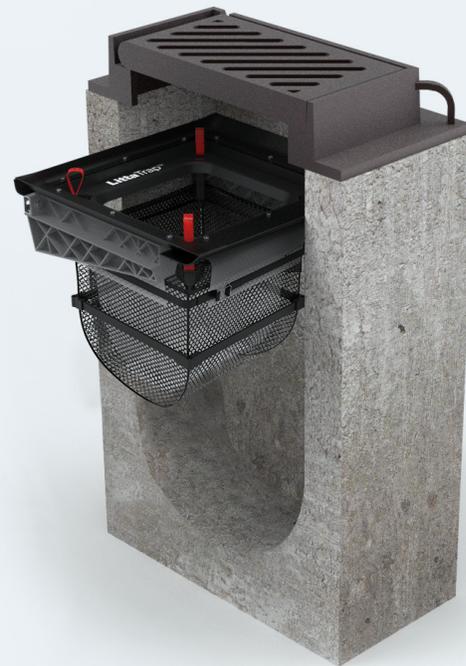
**The LittaTrap™** is an innovative catch basin insert that has been designed to capture trash and debris and enhance the performance of a catch basin in capturing and retaining sediment. The product has been laboratory tested and shown to capture 99% of trash debris (>5mm) and improve the capture of TSS by the catch basin by 40%. The performance of trash capture can be enhanced with the use of liners with smaller apertures to target specific contaminants. This performance of this LittaTrap was enhanced with a 1000-micron performance liner to capture gross pollutants and other pollutants greater than 1 mm in diameter.

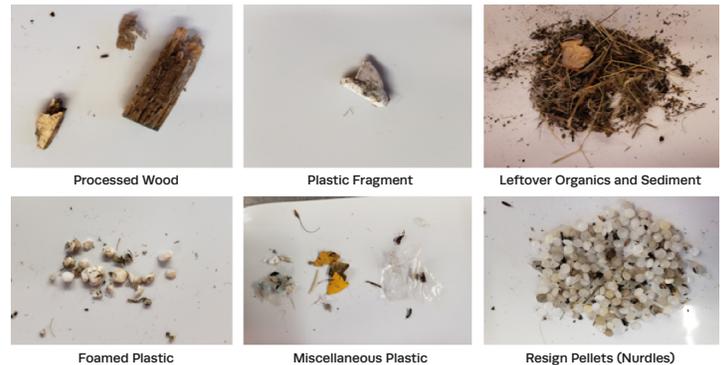
Figure 4 shows the litter from one of the collections sorted into individual categories (not to scale)

The LittaTrap™ inspections were carried out monthly for three months, following appropriate health and safety protocols. During dry weather, the litter and debris captured in the LittaTrap™ were removed and then sorted, as shown in Figure 4 below. The sorted litter was counted and weighed. The catch basin was also inspected for evidence of bypass as well as general hydraulic performance to ensure the units capture effectiveness. During the first collection, the insert was not sitting level in the frame, and some resin pellets bypassed the LittaTrap™. Once the seal was corrected, there was no further indication of bypass during the subsequent inspections. Following the pilot, it is recommended that visual inspections are carried out monthly for the following year to determine maintenance requirements and the unit is then maintained before it reaches 80 percent capacity.
