Saving Prospect Lake

| PVC geomembrane helps restore a Colorado Springs landmark

By Stanford W. Slifer, Greg J. Monley,
Kyle Hier, and Timothy D. Stark

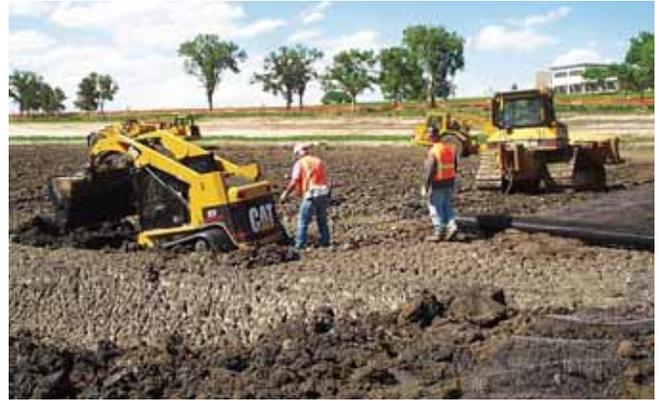
Photos 2 & 3 | Subsurface conditions included soft, high-plasticity clay. Sealed panels were shipped to the project site.

Subsurface conditions encountered within the lake consisted of very soft, high plasticity clay with organics (**Photo 2**) overlying interbedded sands and clays, with shallow groundwater and flowing sands prevalent in the deepest part of the lake. The lake was also rich in fishhooks, glass and other debris from 100 years of recreational activity. Initial alternatives for lining the lake included a compacted clay liner (CCL) or soil admixtures to reduce the permeability of the lakebed soils.

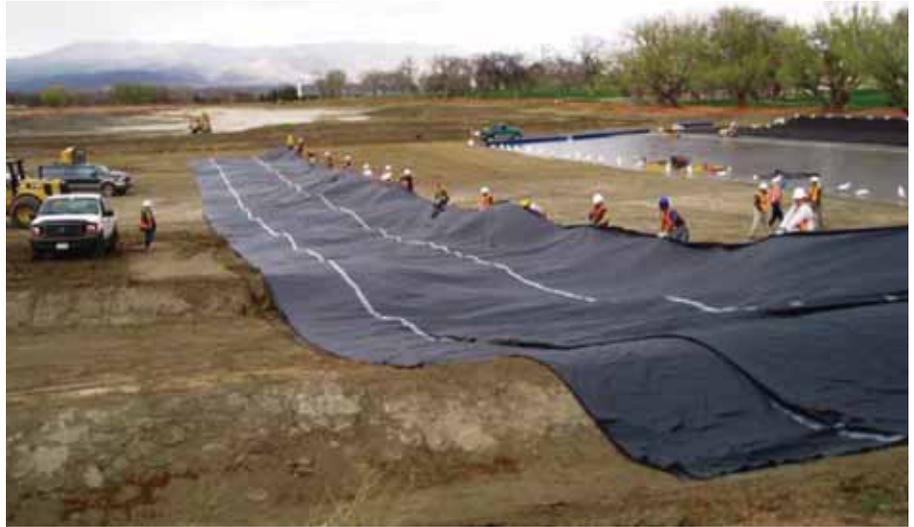
Photo 4 | The large PVC panels were unfolded and deployed.

The large PVC panels were quickly unfolded and deployed (**Photo 4**). The use of large panels greatly reduced the required number of field seams. During the construction phase, weather conditions and the earth-moving contractor's ability to prepare the subgrade, dictated the pace of geomembrane installation and seam testing. SSCI personnel successfully placed, dual-track hot-air welded, and air-channel tested nearly all of the longitudinal and butt seams.

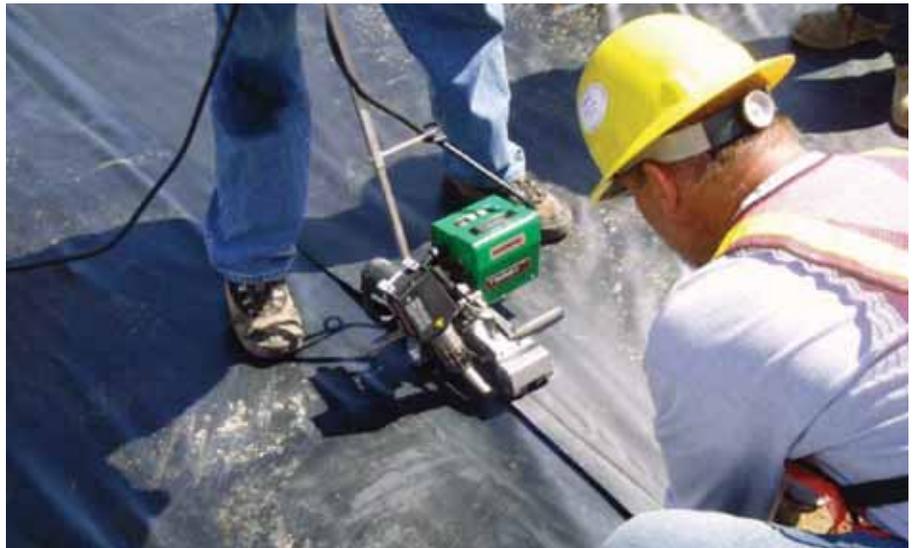
Photo 5 | Air-channel testing has been gaining popularity and has advantages over destructive testing.

The air-channel testing of PVC field seams is gaining popularity and provides a number of advantages over destructive testing of PVC seams (**Photo 5**). One of the advantages is that the air-channel pressure can be used to verify the PGI specified seam peel strength (PGI 2004) of 2.6 N/mm (15 psi) using the sheet temperature and a relationship presented by Stark et al. (2004). Thus, demonstrating that the air channel holds the required air pressure can be used instead of destructive seam sampling and testing.

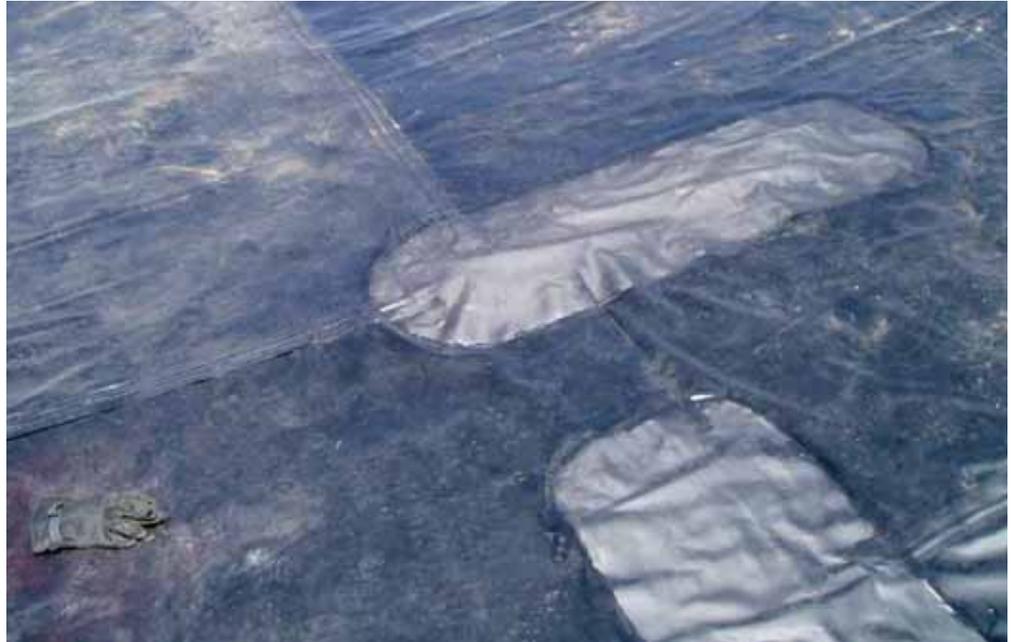
Photo 6 | Two examples of patches for destructive samples.

Photo 6 shows two patches for destructive samples of T or butt seams to ensure an adequate field seaming in the presence of a butt seam. A butt seam occurs when two fabricated panels butt against each other, which usually involves seaming over a pre-existing weld. No problem was encountered wedge welding the T or butt seams on this project.

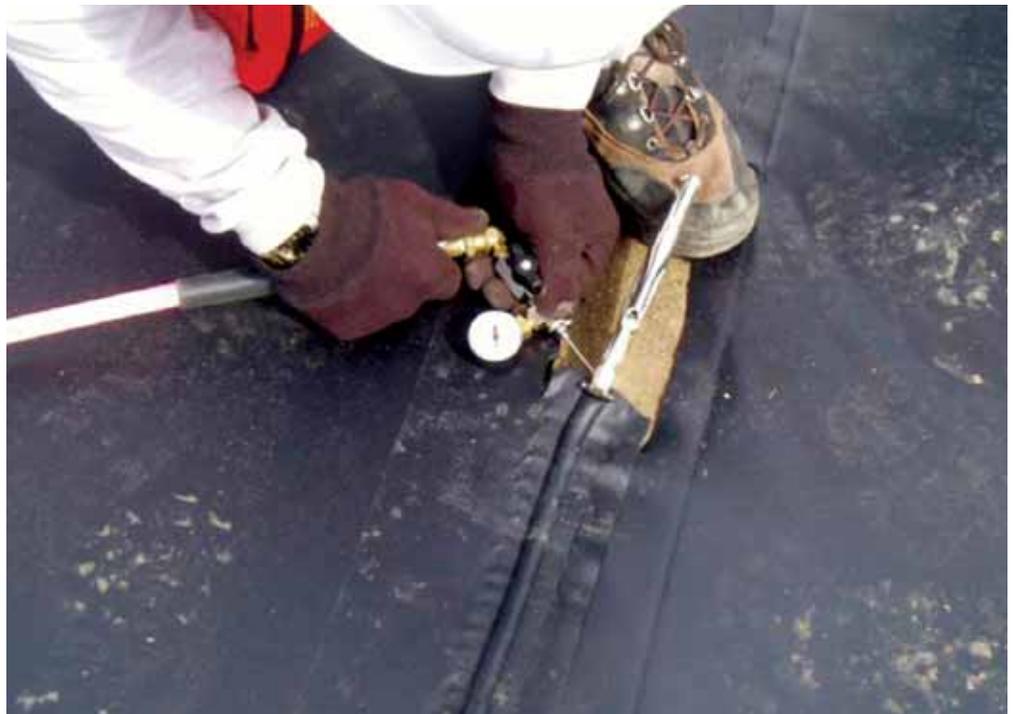
Photo 7 | An inflated field seam with no defects in the welds.

Photo 7 shows an inflated field seam and there are no defects in the welds because the inflated air-channel exhibits a uniform shape, i.e., no aneurysms. In addition, the entire length of field seam was tested using the air-channel test procedure to evaluate the integrity of the dual seams, and air-lance testing was used to identify possible defects along the exposed outside edge of the dual seams.

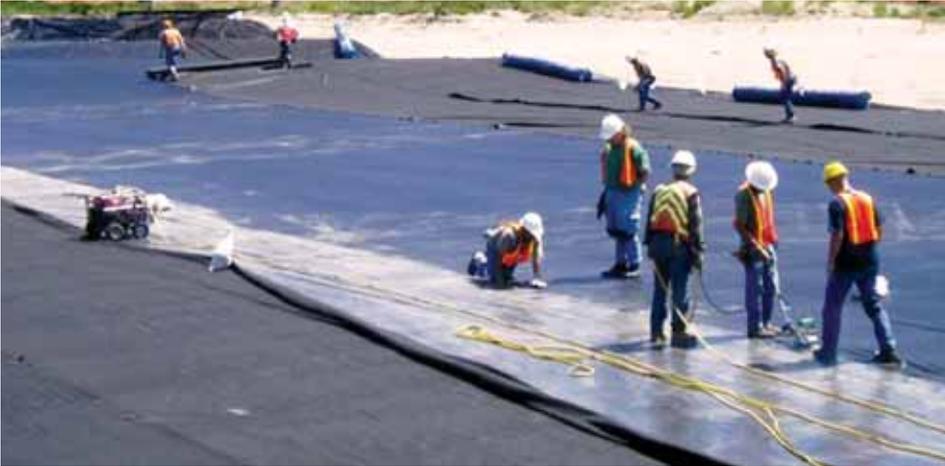
Photo 8 | Geotextile was deployed over a PVC panel while the panel is welded.

Photo 8 shows the geotextile being deployed over a PVC panel while the panel is still being welded.
