Slope and Settlement Movements of an MSW Landfill during Elevated Temperatures

Abstract: Elevated temperature events are problematic for Subtitle D landfills because they: (1) are challenging to identify and delineate; (2) can remain undetected for a relatively long period of time; (3) are difficult to extinguish; (4) may damage engineered components, (5) direction and rate of movement are not uniform, and (6) produce side effects that may damage a facility enough to warrant permanent closure. In addition, slope instability and movement have occurred at these landfills with elevated temperature, leachate, and/or gas pressures. This paper discusses the mechanisms for slope instability, including elevated gas pressures, perched leachate surfaces, and reduced MSW shear strength. Based on a case study, slopes are found to move outwards of up to 15 m. In addition, the slope can reverse backwards into the settlement bowl if settlement is excessive.

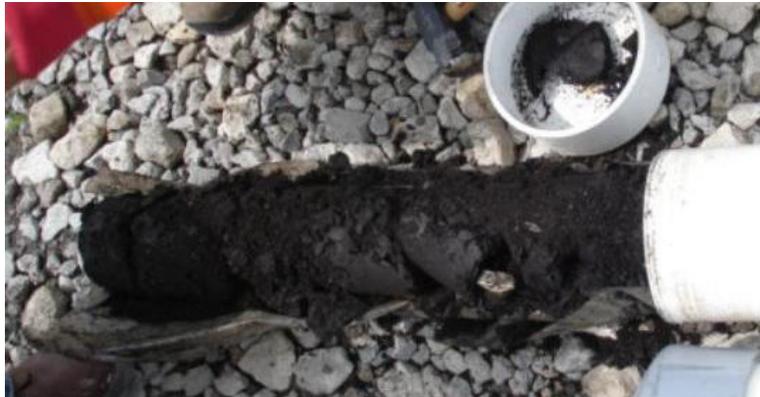
The interconnecting plastics and other reinforcing materials that contribute to the high shear strength of MSW are most likely consumed, degraded, burnt, and/or decomposed by elevated temperatures (see Fig. 1). This results in a reduction of shear strength parameters of MSW which has been observed in samples obtained during gas well drilling and excavations in MSW landfills experiencing elevated temperatures. Fig. 1 shows thermally degraded waste obtained in a 100 mm diameter sample from an MSW landfill that experienced elevated temperatures. When the ash was handled it fell apart and thus did not exhibit any cohesion. In addition, the ash compressed significantly when a normal stress was applied to it by hand or in a laboratory direct shear device. The thermally degraded MSW compressed so much that there was insufficient material in the upper and lower shear boxes to conduct a shear test with

FIG 1. Thermally degraded (combusted) waste from 100 mm diameter sample

the sample at hand. Based on these observations, it appears that an effective stress shear strength envelope with an effective stress cohesion of zero and a maximum friction angle of 20° are assumed to represent the shear strength parameters of the thermally degraded MSW at this site (Stark et al. 2010). These shear strength parameters are probably not applicable to other MSW landfills because of differences in waste constituents, the use of leachate recirculation, the presence of an aluminum waste reaction, and thermal degradation caused by combustion or pyrolysis at this site.

The strength parameters assumed for thermally degraded MSW (c' and ϕ' of 0 kPa and 20° , respectively) are considerably lower, which can lead to a reduced factor of safety. This friction angle is also substantially less than degraded friction angles suggested by others, e.g., 30° (Kavazanjian et al. 1995) for decomposed waste, because most of the components of the MSW are reduced to ash including the reinforcing materials. Therefore, facilities that have experienced an aluminum reaction, combustion, or pyrolysis could be less stable simply because of a large reduction in MSW strength even if elevated gas and liquid pressures are not present.

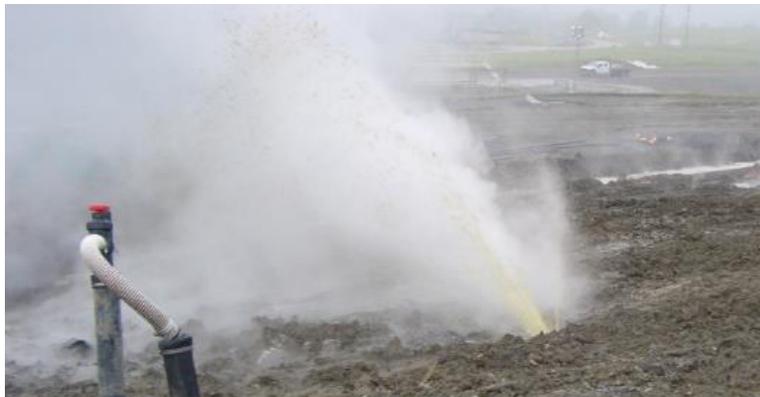
When gas and leachate migrate to landfill side slope and are impeded by the cover system (soil or geomembrane), gas pressures and leachate can accumulate and cause leachate outbreaks. The elevated leachate and gas pressures occasionally manifest as “leachate geysers” (Fig. 2) and can eject 9 to 11 m into the air (Stark et al. 2012). These leachate geysers also can be encountered when borings are drilled in the waste for gas wells or exploratory purposes. In some instances, the soil cover system is replaced with a geomembrane to control odors. Although the liner encapsulates the surface, outbreaks can still occur at seams and gas wellhead connections.

FIG. 2 Leachate outbreak of 2 to 4 m at MSW landfill side slope (photo courtesy of Ohio EPA)
