A STUDY OF THE EFFECTS OF SURFACE MODIFICATIONS AND PROCESSING ON THE FATIGUE PROPERTIES OF NITI WIRE

Mark A. Polinsky, Dennis W. Norwich, Ming H. Wu
Memry Corporation, Bethel, CT 06801 USA

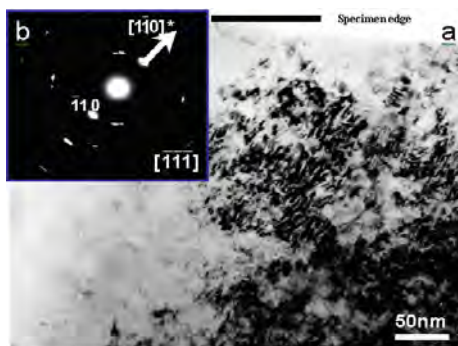
The subsurface microstructure shows that in addition to removal of the oxide and the subsurface compressive stresses the B2 structure has been deformed by the Mechanical Polishing process. The deformation can be seen at varying depths near the surface of the test parts with higher dislocation density near the surface, Figure 14 and Figure 15.

Fig. 14 The bright field image and the associated SAEDP at about 125 μm under the surface. The SAEDP shows the $[-1-1-1]$ zone axis diffraction of the B2.

Figure 14 – Electron Diffraction and Transmission Electron Image of Mechanically Polished Microstructure 125 μm below the Surface

Fig. 15 The bright field image and the associated SAEDP at 200 nm under the surface. The SAEDP shows the $[-1-1-1]$ zone axis diffraction of the B2.

Figure 15 – Electron Diffraction and Transmission Electron Image of Mechanically Polished Microstructure 200 μm below the Surface

The combination of deformation and the subsurface compressive stress is responsible for the increased fatigue life compared to the Electro Polished and Chemical Etch processes.

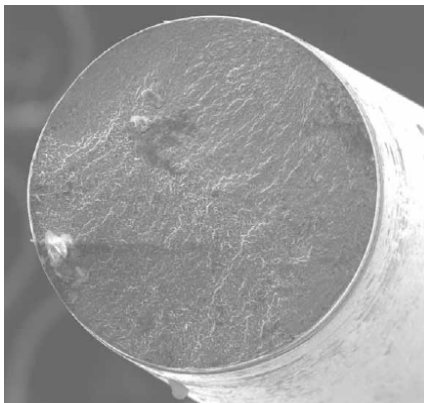
The initiation point of the fracture is increasingly difficult to identify with the typical pattern that radiates from the fracture wide and spread out. Figure 22 and Figure 23.

Figure 22 - SEM Image of High Cycle Fatigue Fracture

Figure 23 – SEM Image of High Cycle Fatigue Fracture

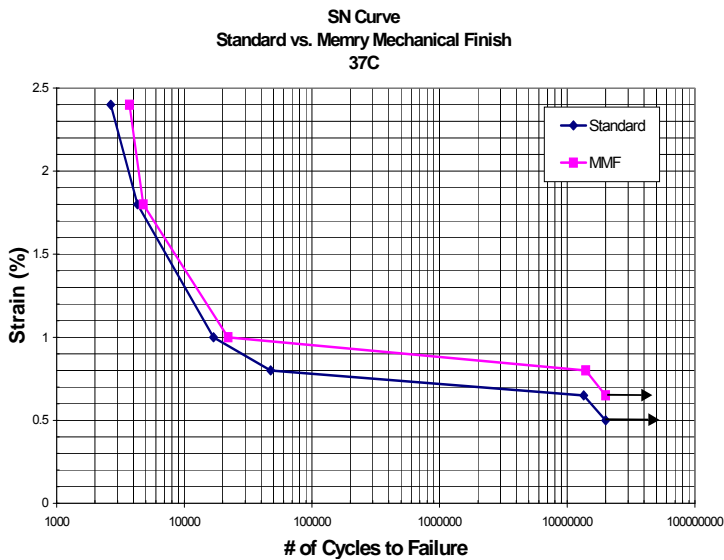
The following two S-N curves, Figure 24 and Figure 25 were generated to document the effect of surface finish on fatigue life. The first curve, Figure 24, compares parts produced with no post processing surface finish to parts mechanically finished and passivated.

Figure 24 – S-N Curve for Standard & Mechanically Polished Wire

The Mechanical Polishing process shifts the S-N curve up and to the right increasing the fatigue lives of parts produced with this process. Both sets of parts were produced from the same material and heat-treated with the same process.

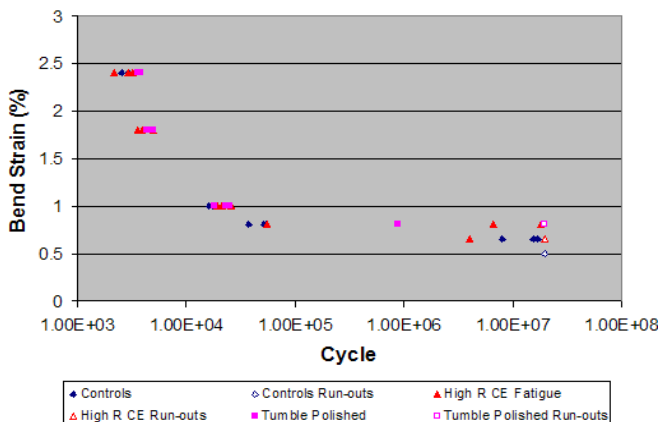
Figure 25 is an additional S-N curve that also includes an additional data set for parts processed using Chemical Etching. The data for this process falls in between the points for no post processing and for the mechanical polish post processing. The control group is the Standard parts, the CE group is Chemically Etched, and the Tumble Polish is the Mechanically Polished.

Figure 25 – S-N Curve for Standard, Chemically Etched and Mechanically Polished Parts
