Lewis Bandt Bridge, Geelong

Swart & Sons were contracted by the South West Alliance (VicRoads) in 2018 to remediate approximately 480 metres of the metalwork railing on the outbound lane of the Lewis Bandt Bridge, located over the Moorabool River, approximately 11 kilometres from Geelong.

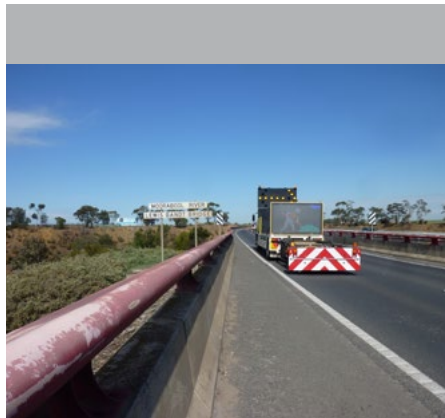
After only six years, the top coat on the bridge's metalwork had started to detach and fail.

Metalwork on the outbound lane of the bridge showing signs of deterioration

Where areas of corrosion were found, treatment was carried out to repair the corrosion. These areas were subject to spot removal of the corrosion using mechanical abrasion and the application of a zinc-filled primer.

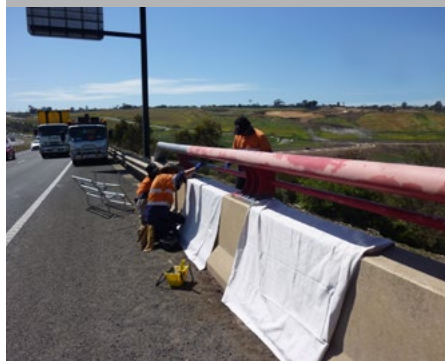
Metalwork cleaned and, where required, spot treated and primed, in preparation for the protective coating

The entirety of the bridge metalwork was cleaned - by hand - using nothing more than water and scouring pads to ensure there was no adverse environmental impact.

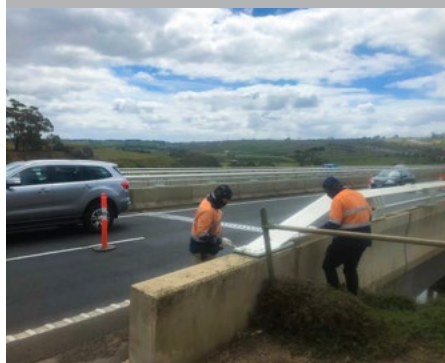
Workers applying the final coat to the bridge metalwork

Once the primer had been applied and cured, two further coats (intermediate and final) were applied, via brush or roller, to the entirety of the metalwork we were contracted to remediate.
