## Pedestrian Bridge Painting, Mount Waverley

Swart & Sons were contracted by VicRoads in March 2019 to remove corrosion and apply protective coatings on a pedestrian bridge over Blackburn Road at Mount Waverley. Many challenges were faced during this project due to both the complexity of the project and the ownership of land abutting the bridge, however all works were completed within the specified timeframe and to the satisfaction of VicRoads and other stakeholders.

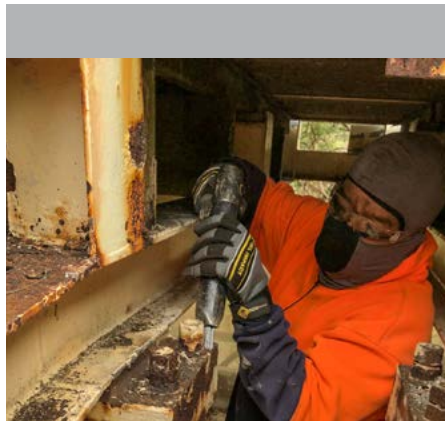
**Removing corrosion from underside of bridge prior to application of protective coatings**

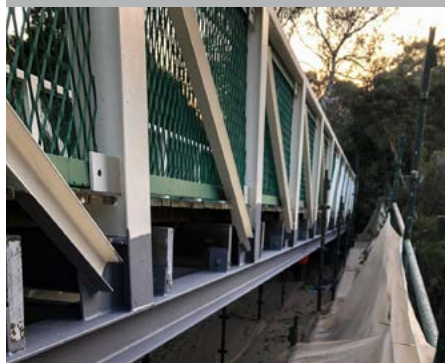
**Final coat to handrails and intermediate coat to underside with containment erected to capture any falling debris**

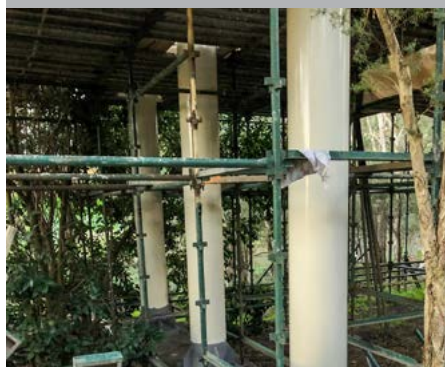
**Bridge piers were cleaned and coated with a three-part protective coating system**
