Managing Transient voltage surges

The objective of this paper is to provide a basic understanding of transient voltage surges and their impact on the design and installation of distribution/power class transformers.

Pacific Crest Transformers

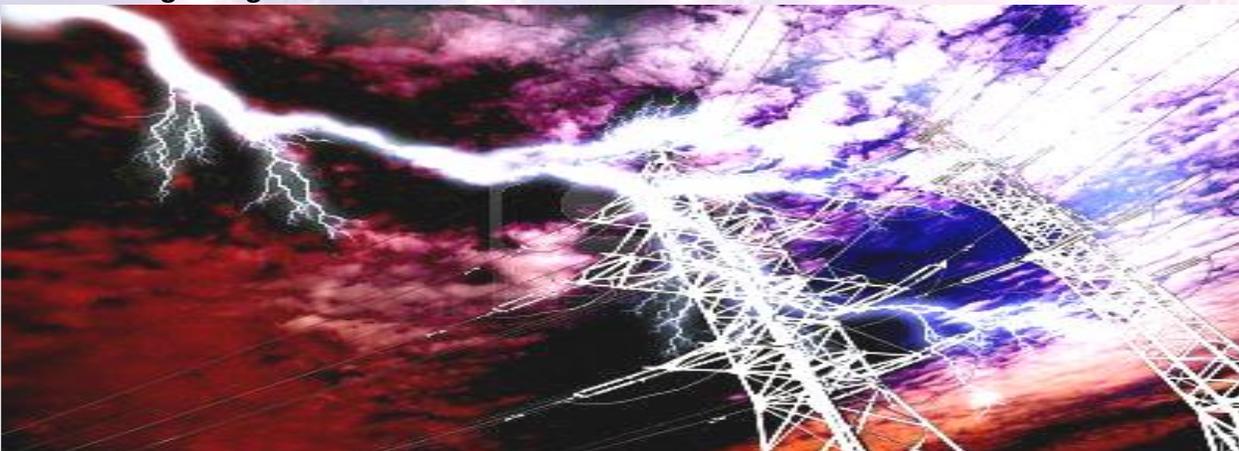
Impulse – from lightning

The typical signature of a lightning voltage surge reveals a single short term high frequency spike which decays to zero in as little as one nanosecond (1 billionth of a second!).

A full wave (lightning impulse) represents a disturbance that occurs some distance from the transformer and travels along the transmission line to the transformer. Note the similarity to the impulse lightning wave earlier in this paper.

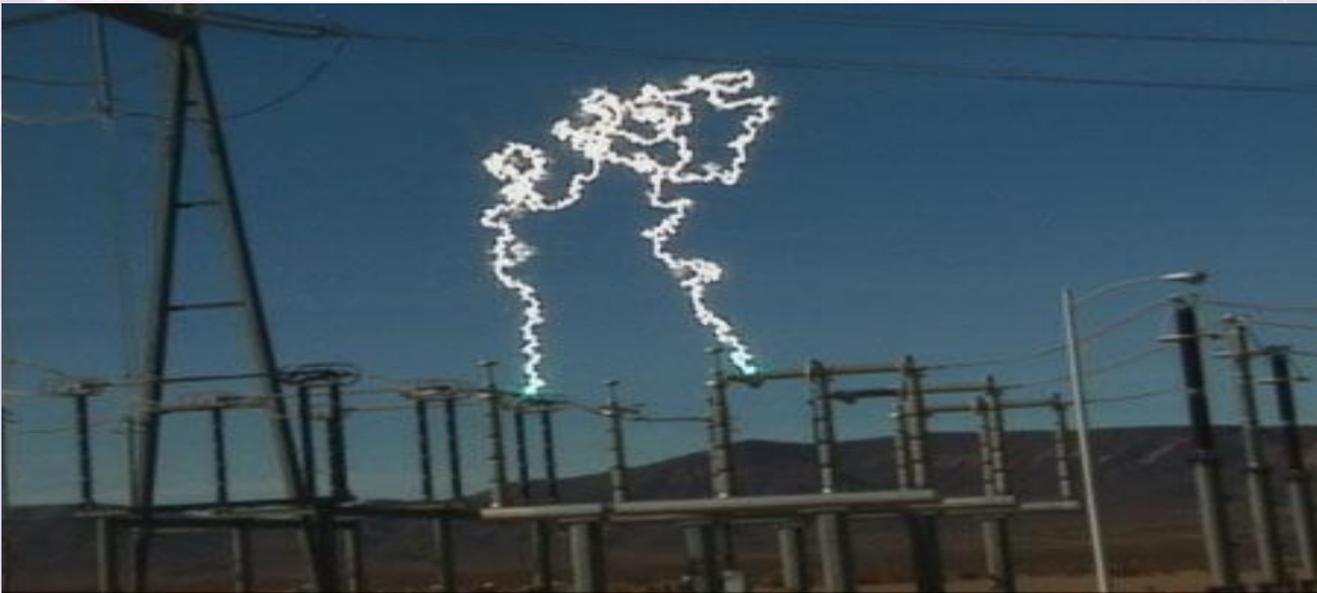
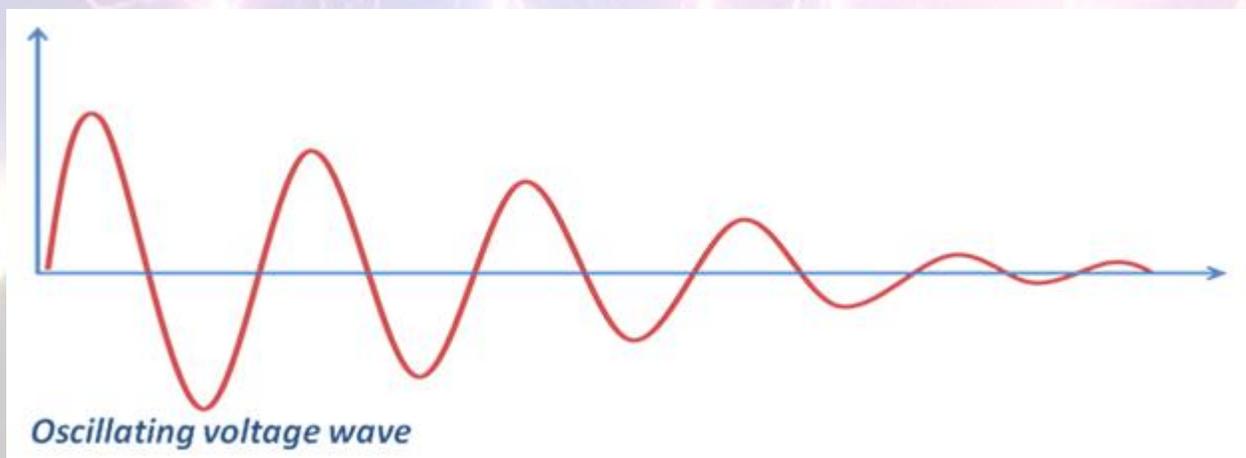
Oscillating – switching

Although lightning strikes may be the most obvious, the majority originate as a result of system switching or disconnection of electrical equipment. Switching transients occur when circuit breakers open/close transformer primaries, such as automatic switching between utility services or on-site power generation. For example when a breaker interrupts current flow, an arc develops across the breaker contacts. Since the current interruption usually occurs somewhere other than the current zero crossing point, the arc will remain until the current crosses zero. The result is a voltage developing across the contacts, known as the transient recovery voltage (TRV). The level of such a surge has the potential to exceed the insulation system of the associated transformer(s).

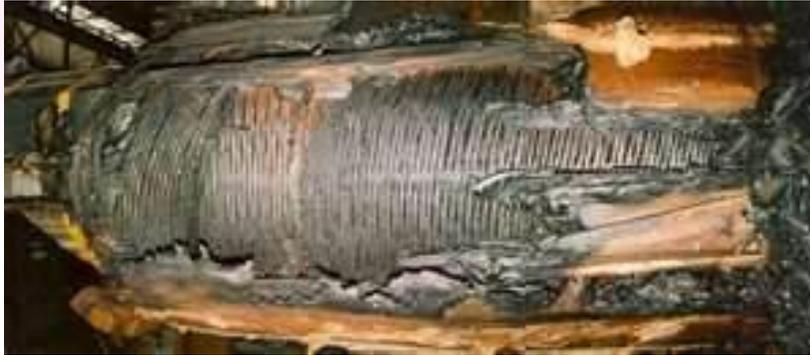
Overstressing transformer insulation systems may lead to coil failures

Above is a photo of an actual coil failure caused by a transient voltage surge.

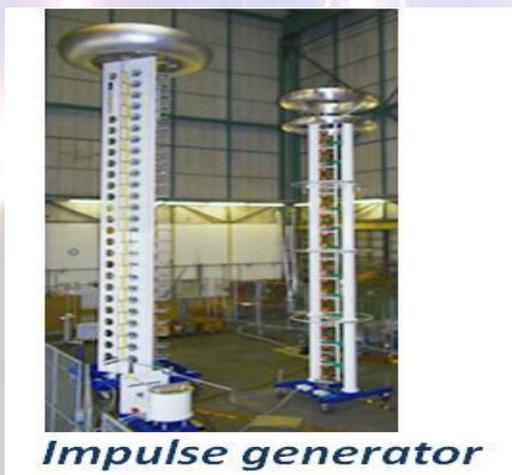
An impulse generator is an electrical apparatus which produces very short high-voltage surges. High impulse voltages are used to test the dielectric strength of electric power equipment against lightning and switching surges.

The generator is made up of a multiple of capacitors arranged such that they can be charged in parallel to a specific voltage level, then discharged in series so as to produce an additive voltage equal to the required test voltage.

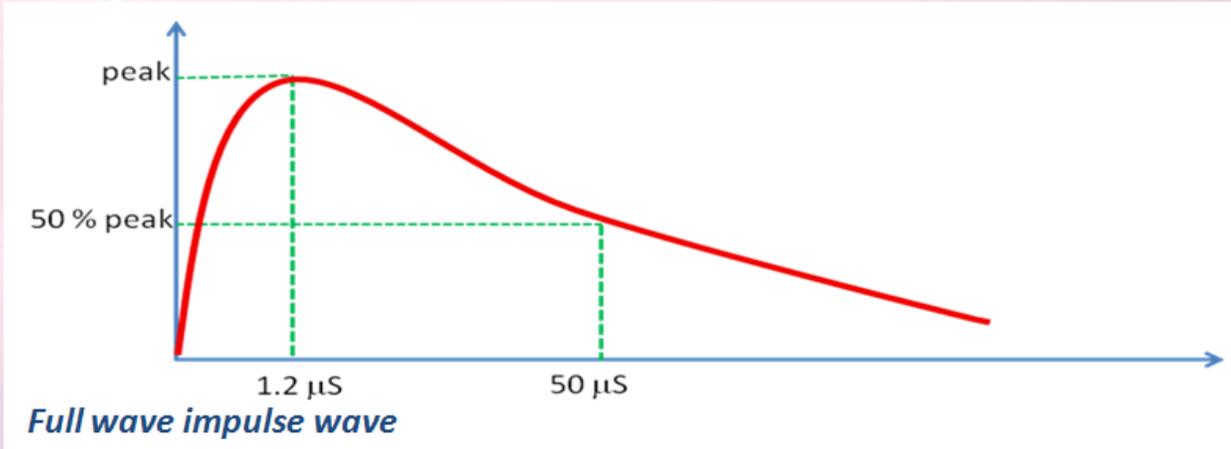
By standards, the full wave impulse test wave must be “1.2 x 50 μs” meaning that the voltage must rise to the BIL rating (for example 95kV for 15 kV class) within 1.2 microseconds and must not decay by more than 50% within 50 microseconds (see above table 6).

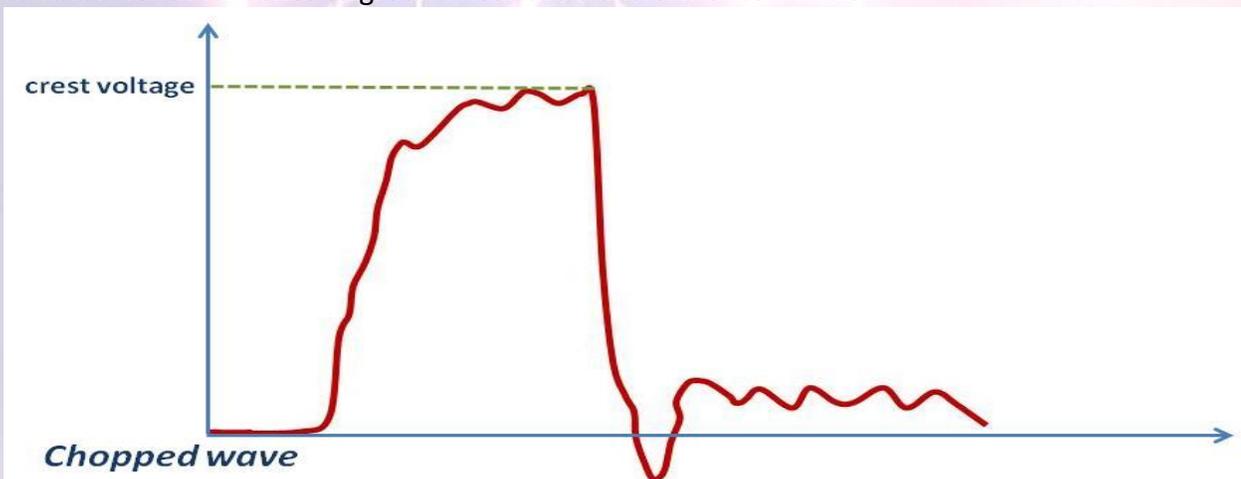
The chopped wave represents a traveling wave created by a disturbance that occurs some distance from the transformer that flashes to ground near the transformer terminals.

This is determined by using impulse waves that are of the same shape as that of the BIL waveform, with the exception that the wave is chopped after 3 microseconds. Generally, it is assumed that the chopped Wave Level is 1.15 times the BIL level.

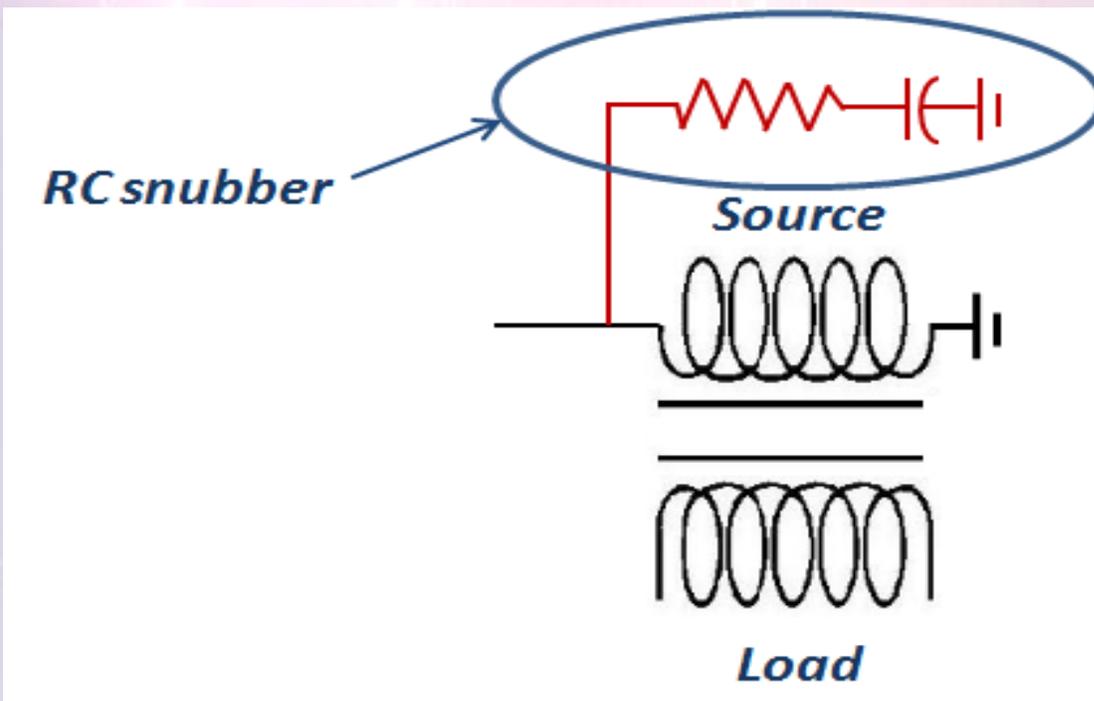
The RC-snubber network lowers the frequency of the transient voltage applied to the transformer primary below the resonance frequency of the circuit. It reduces the development of the oscillatory voltages and provides a low impedance path to ground for the transients.

The above schematic depicts the addition of a snubber in its' basic form. It is routinely added to the primary circuit, but in some installations a snubber may also prove to be beneficial on the low voltage side of the transformer.

Snubber circuits are not "shelf items". **They are designed for specific installations and require field electrical measurements by a qualified field engineer.** Ping tests are routinely made which allow for field simulation of transient faults on installed electrical equipment. Such testing reveals the required value levels for the resistors and capacitors to be used in the snubber.

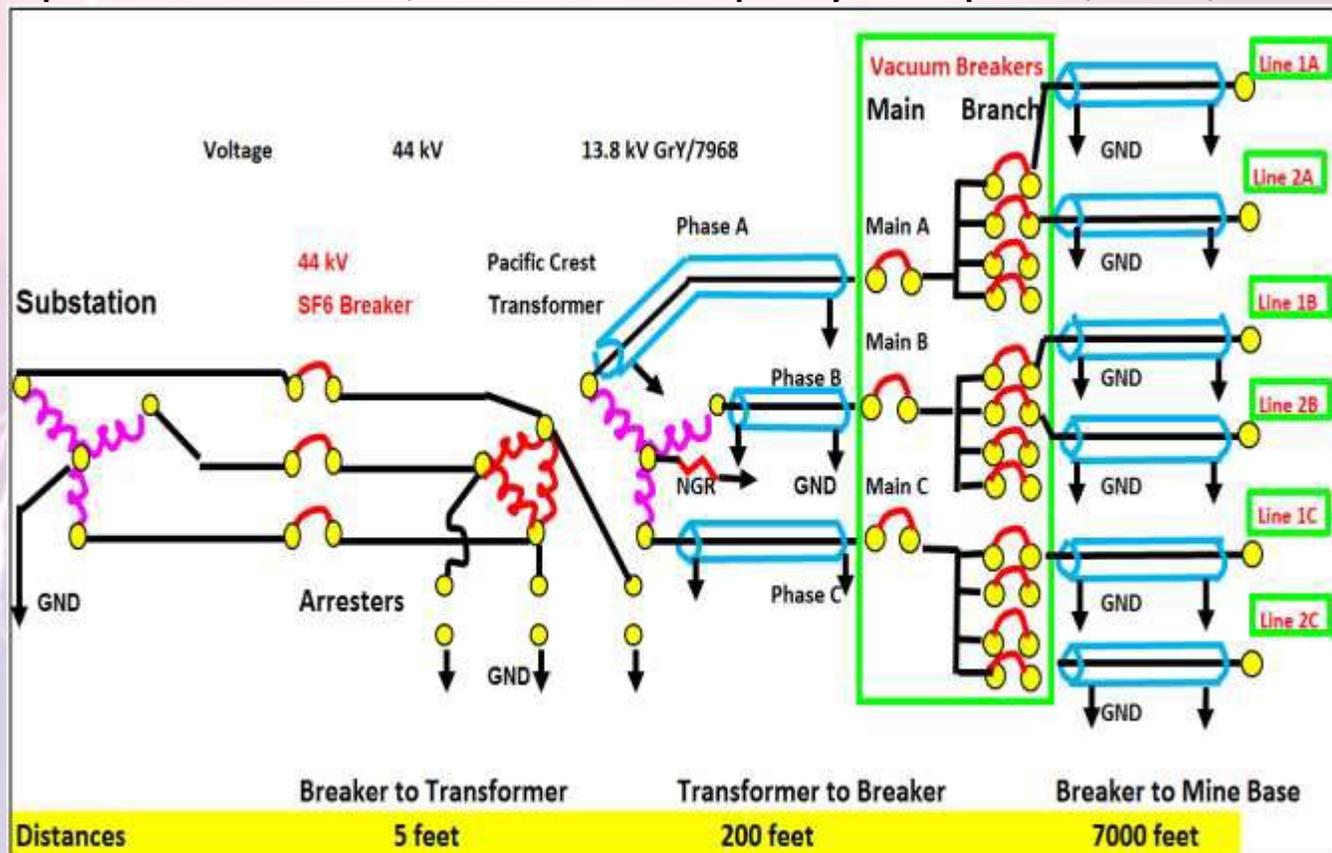
The major components in the field service transformer system

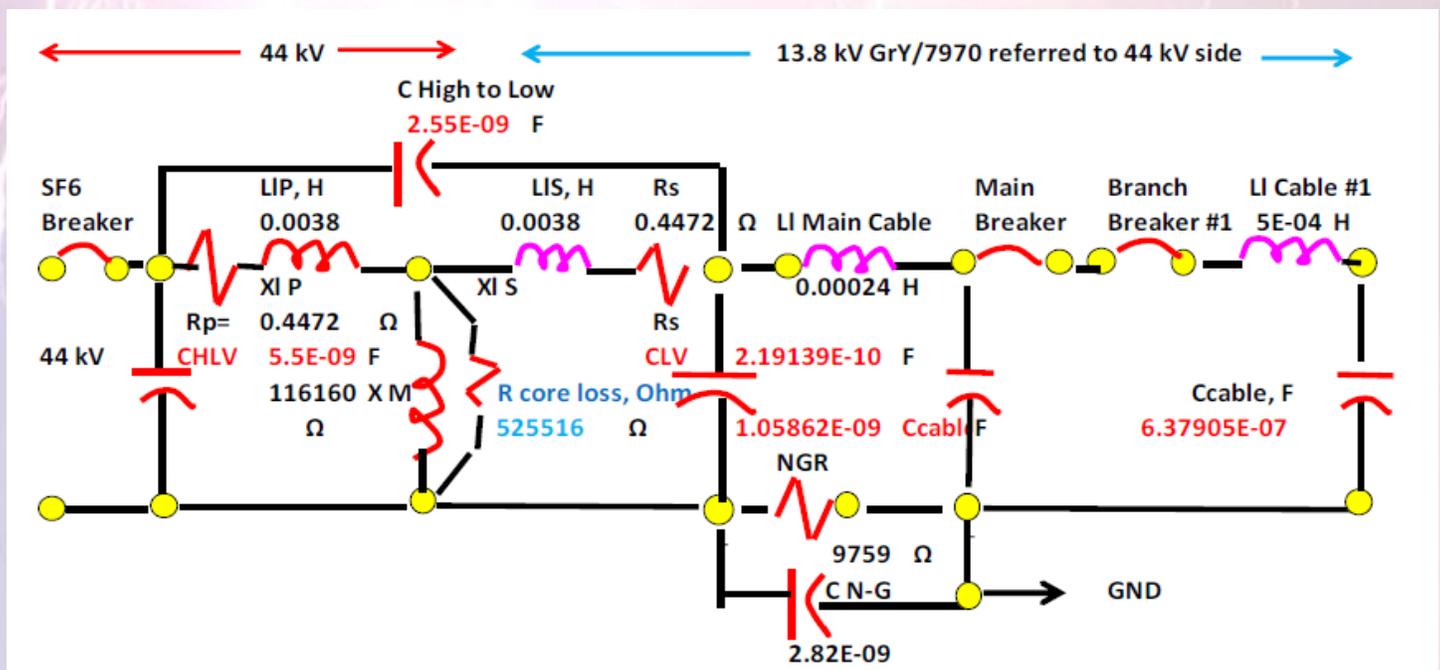
Figure 2: The single phase equivalent circuit of the transformer circuit

Note that there are multiple inductances and capacitances in the circuit. However, an extremely important series circuit exists between the leakage inductances of the transformer, additive to the leakage inductance in the 13,800 volt cable between the transformer and the Main Breaker to the shunt capacitances in the low voltage winding of the transformer in parallel with the shunt capacitance of the same transformer to main breaker cable. Table 2 below summarizes the parameters:

Figure 2 and table 2 are significant in pointing out the importance of shielded cables in influencing system resonances and reflections. The short 200 feet of cable between the transformer and the control room has both reduced the main resonant frequency as well as introduced a very high frequency in the mega Hz range. This combination is potentially extremely damaging if the circuit is able to be excited with any of the resonant components.
