Transformer Rebuild Option

Pacific Crest Transformers

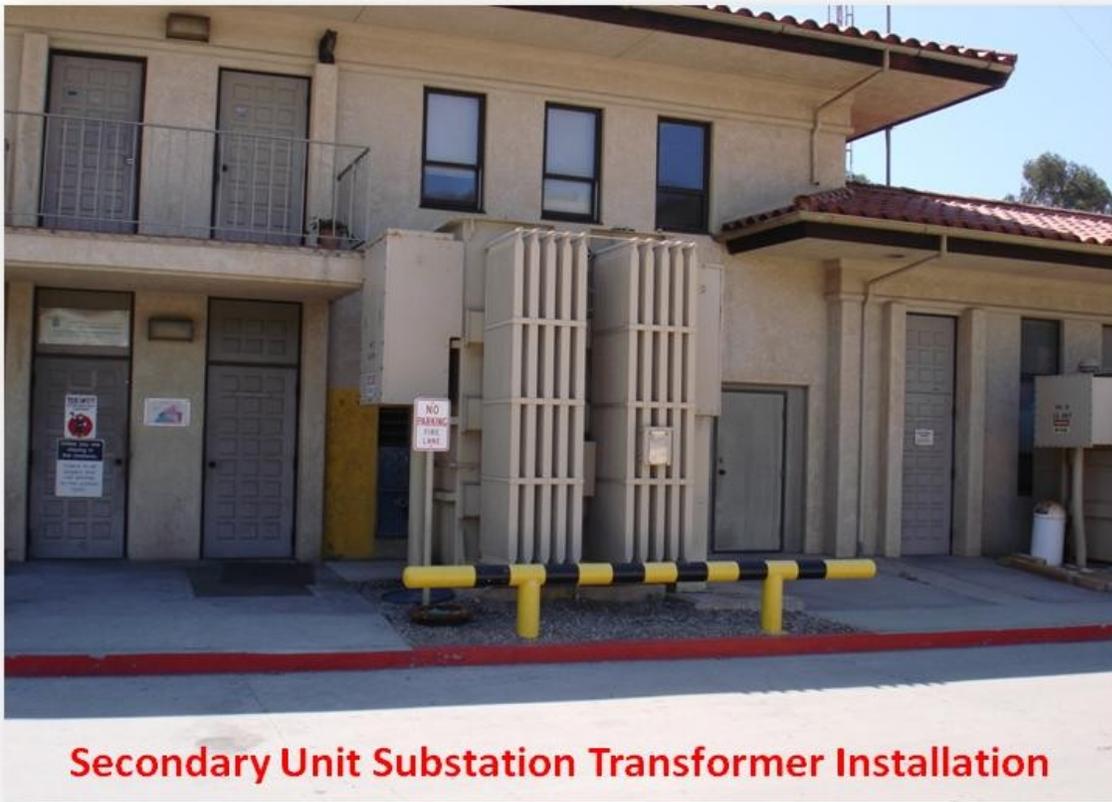
As an example, consider the transformer pictured above. It has a base rating of 10 MVA with a high voltage at 16500 delta and low voltage at 12470Y/7200, and was installed in 1978. The owner had determined that the insulation system had deteriorated to the point that they had to take action to alleviate the financial impact of an eventual failure. To address the situation at this time, would also provide the opportunity to have the transformer redesigned with a high voltage at 16500Y/9526 and low voltage at 12470 delta. This had to be done however while maintaining overall dimensions and phase bushing locations.

To maintain the HV and LV phase voltages while changing from a Δ -Y to a Y- Δ configuration required designing and manufacturing new windings. In addition, the original windings were constructed with aluminum conductor while the rebuilt were to be wound with copper.

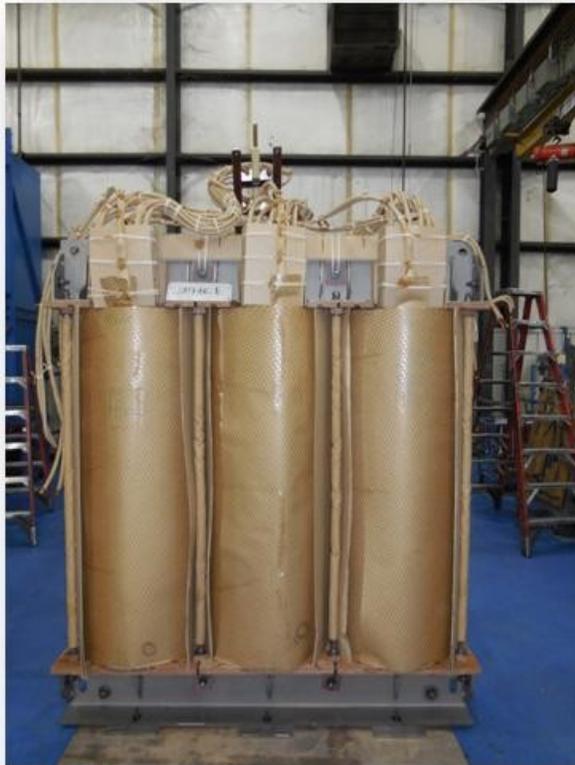
Rebuilt Core/Coil Assembly

The rebuilt core/coil assembly was designed, built, and configured to accommodate the existing tank dimensions. Since the original tap changer was 36 years old, it was replaced with a new, heavy duty switch.

The redesigned windings incorporate the latest technology so as to allow for 360 degree cooling. The top and bottom of each winding is secured via pressure plates with routed ducts which provide an unimpeded path for the cooling fluid as it flows from the bottom to top of each coil. The top and bottom plates are locked in place via through bolts in order to secure against axial movement.

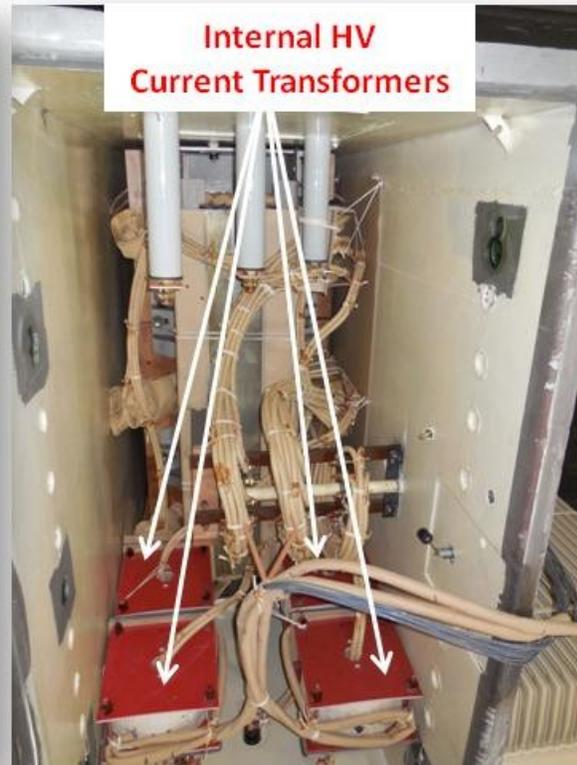
Rebuilt Core/Coil in Original Tank

To allow for constant monitoring of the transformer load, the owner had requested that under oil phase and neutral high side current transformers be added as can be seen in the above photo.

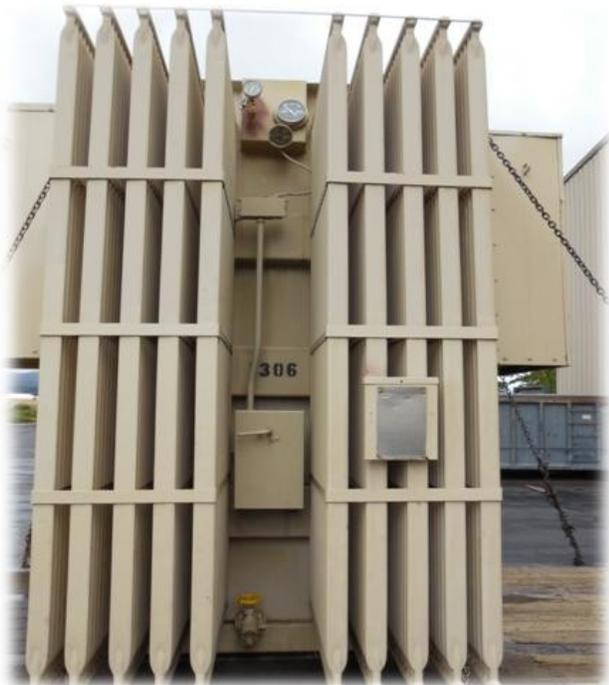
As Received at Factory

Pictured above is the subject transformer as received at Pacific Crest followed by that of the completed rebuild. The original tube type radiators have been replaced with panel type, which for their physical size, offer improved performance.
