Water Tank Cleaning Service Report

Water Tank Cleaning & Disinfection Report

**Client : M/s GLOBAL INDIAN
INTERNATIONAL SCHOOL**

Date : 27th August 2022

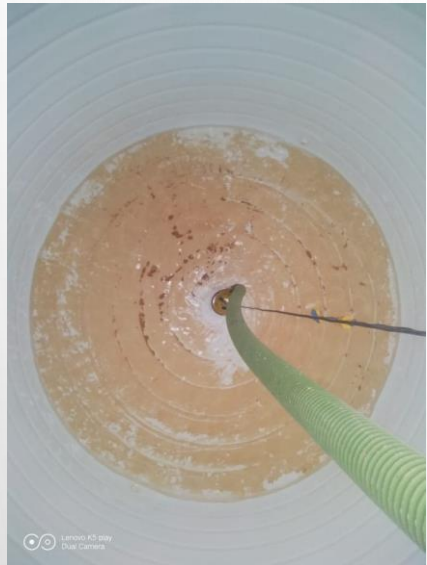
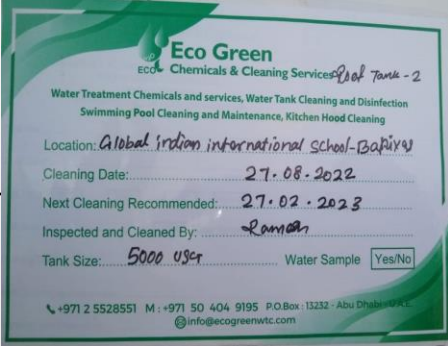
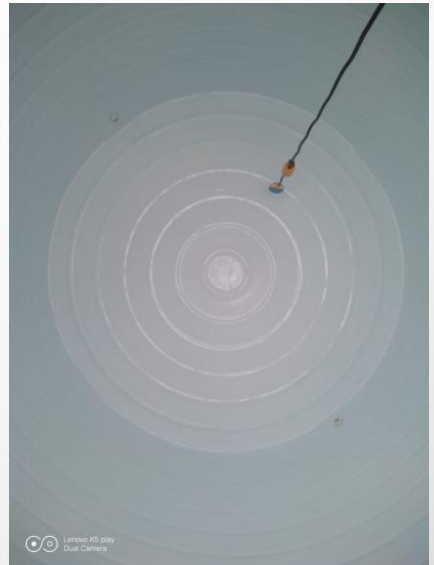
Global Indian International School –Roof Tank No.1 5,000 USG 27.08.2022

Before Cleaning	Sticker	After Cleaning

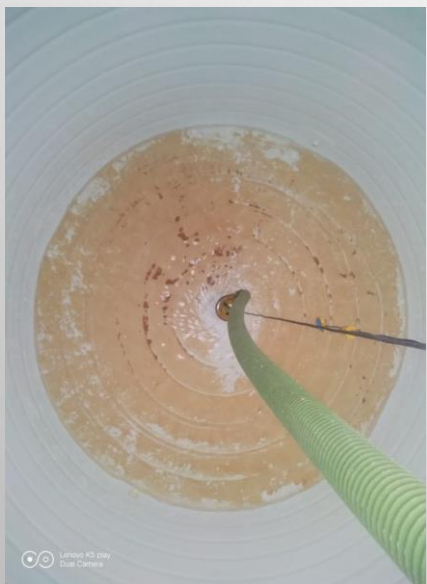
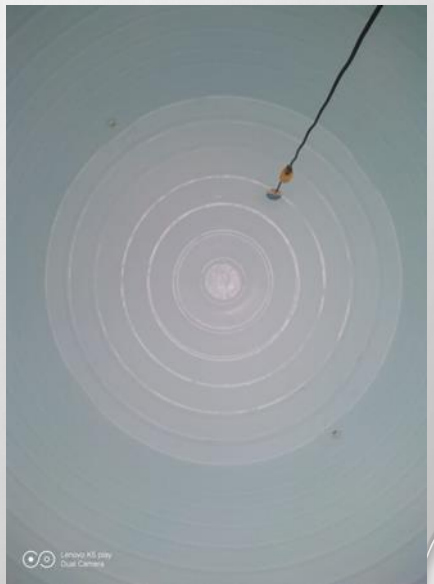
Global Indian International School –Roof Tank No.2 5,000 USG 27.08.2022

Before Cleaning	Sticker	After Cleaning
