Improving slope stability at Kışladağ Gold Mine

S. Ergun, E. Gungor & B. Ozdemir

Eldorado Gold Corporation / Tuprag, Usak, Turkey

ABSTRACT: This paper presents part of the slope stability improvement program carried out at Kışladağ Gold Mine in Turkey. A slope stability project was initiated at the site recently to review the minor slope failures as well as the geotechnical and final wall design aspects in detail. Two minor slope failures occurred in December 2014 at the north-east section of the pit in spite of the high quality slope stability implementations at Kışladağ Mine. The work presented in this paper showed that changes to the blasting and geotechnical parameters are required at the north-east section of the pit. Geotechnical design changes were 10 m bench heights with 70 ° slope face angle at that specific area. Having implemented several geotechnical and blast design changes, the followings were observed in the pit: reduced crest loss, reduced number of minor slope failures and more visible half barrels in friable rock types.

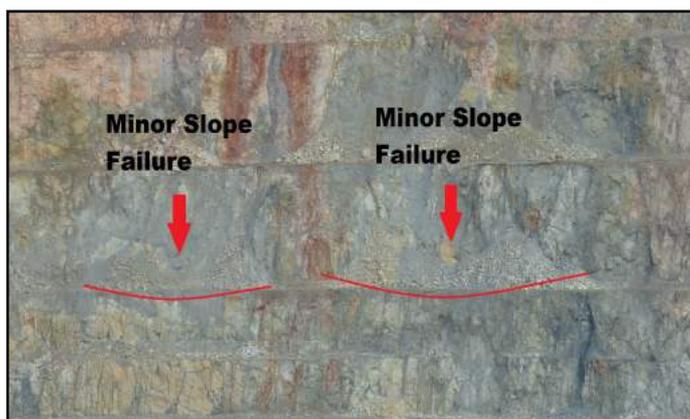
Two minor slope failures occurred at north-east section of the pit in December 2014 (Fig. 3). In-situ volumes were 96 and 130 m³.

Figure 3. Minor slope failures at north-east section of the pit.

Following these minor failures, a root-cause analysis was performed to identify the causes of these failures. Geotechnical and blast designs were also investigated as part of this work.

Causes for the minor slope failures were found to be two-fold:

- a) Geotechnical:
 - i. rain events which caused further reduction in the shear strength of the joints.
 - ii. structurally controlled weak rock mass.
- b) Blasting:
 - i. Subdrill: avoid subdrill into the catch bench as explained above.
 - ii. Change of primer location: They were located at the bottom of the holes. However, they should be located at the grade level to minimize the damage to the catch bench.
 - iii. Cumulative damage (repetitive blasting). Once the damage is caused by the blasts above the design crest, the blasts following this can drive the cracks further and reduce the shear strength of the joints further.
 - iv. Initiation timing: Use 67 ms along the control row to allow for the single hole firing and better relief to the rock mass.

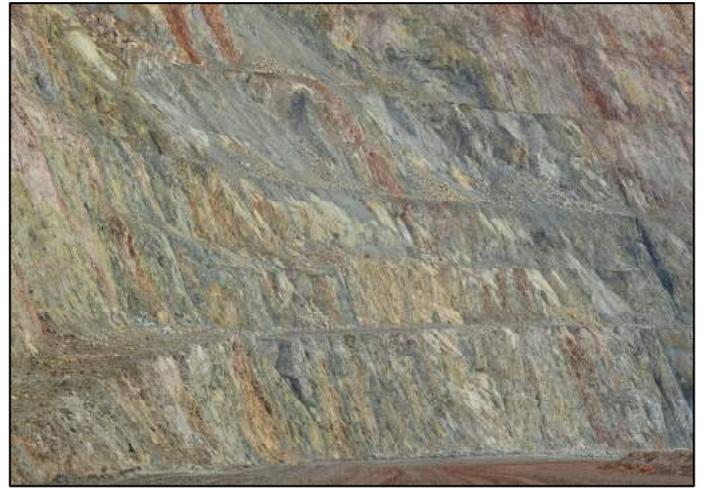
addition, above blasting recommendations were implemented. Having implemented above changes, the site did not experience the minor failures again and the crest loss was less indicating more stable slopes with these changes. Figure 7 is an example of the face condition after the changes have been applied.

Figure 7. A view from the north-east area of the pit after the design changes.

A significant reduction in the crest loss was achieved in this specific area by implementing the geotechnical and blasting recommendations as discussed above. Final crest line can be clearly seen after scaling is completed.

There were some areas where major and moderate levels of crest loss were minimized and/or eliminated. There were no cracks penetrating into the wall behind the final crest. Majority of the walls contained visible presplit holes (half-barrels) between 10 m and 20 m high, depending on the bench height used.

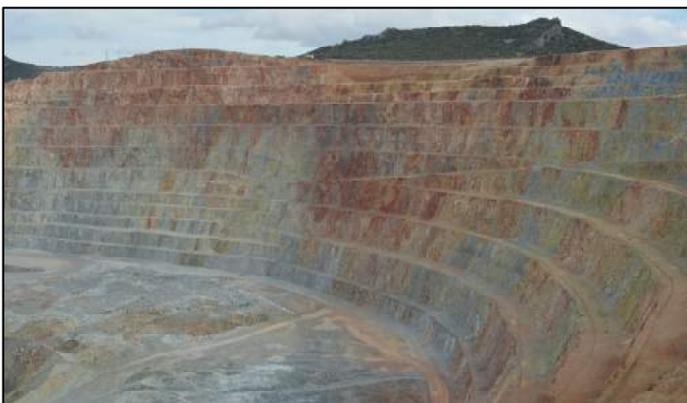
Inclined presplit holes using 95 mm hole diameter gave us good results at single and double bench profiles as shown in Figure 8. However, the number of collapsed holes has been reached up to %60 of the presplit holes in friable zones and %20 in blocky zones. Therefore, it was decided to try 140 mm presplit holes with different powder factors for different rock zones:

Figure 8. A view from very good single and double bench profiles with good floor conditions at Kışladağ Mine.

- Friable zone: 1.6 m spacing at 0.22 kg/m^2 powder factor;
- Blocky and semi massive zones: 1.3 m spacing at 0.28 kg/m^2 powder factor.

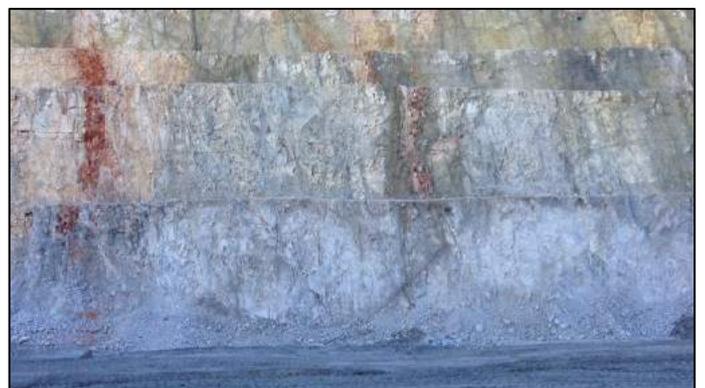
140 mm presplit holes trial was found to be successful with a reduction in the number of collapsed holes and similar or improved half barrels (Fig. 10). This should improve the vibration filtering into the wall and thus should improve wall stability.

Figure 10. A view from the trial 140 mm presplits at friable zones.
