# PRE-PURCHASE BUILDING INSPECTION REPORT

for John Smith

100B Sample Street  
Sample Town, Wellington  
6010, New Zealand

Inspection Date: 23 May 2018

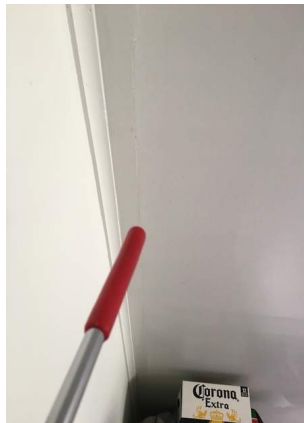
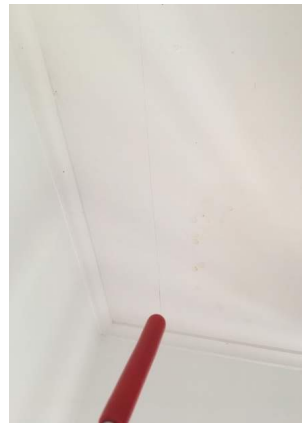
General plaster cracks were sighted to the kitchen ceilings due to age; areas can be rectified by a plasterer and a painter if desired.

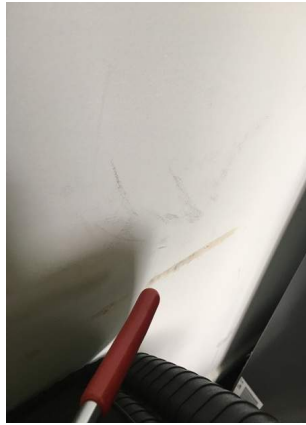
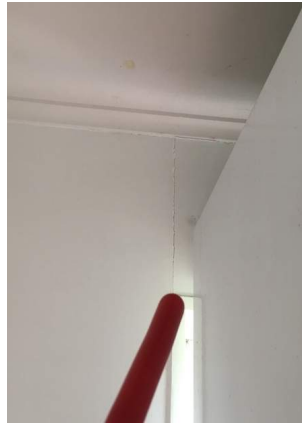
✗ No - General deterioration was sighted due to the age.

General deterioration was sighted due to the age, paint improvements can be made if desired. Some plaster cracks were sighted from movement and settlement over time, seek a plasterer and a painter to improve this area if desired.

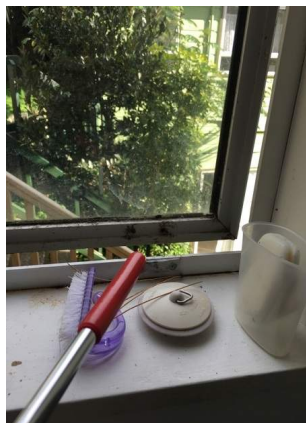
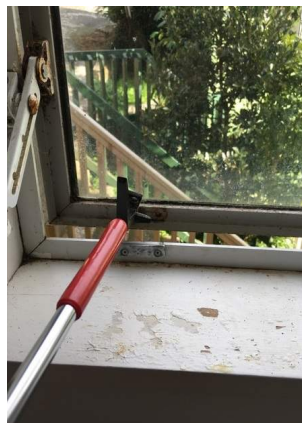
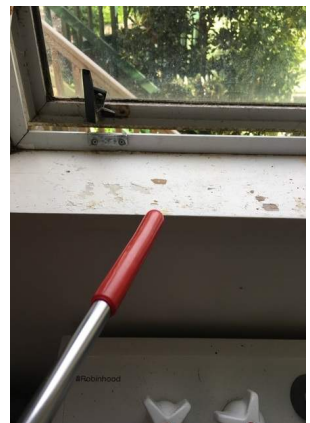
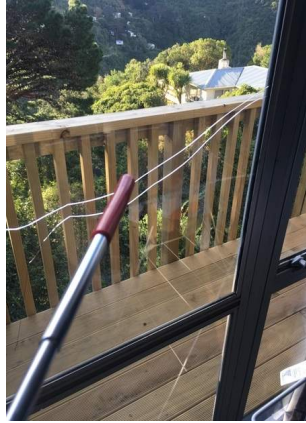
✗ No - General deterioration was detected.

A cracked pane of glass was sighted to one of the lounge windows, replacement of the affected pane is recommended by a glazing specialist.

Upgrades and improvements can be made to the hardware, rubber seals and window sills. Ensure the windows are kept sealed and watertight to prevent deterioration. Cleaning maintenance is always recommend to the sill drains.

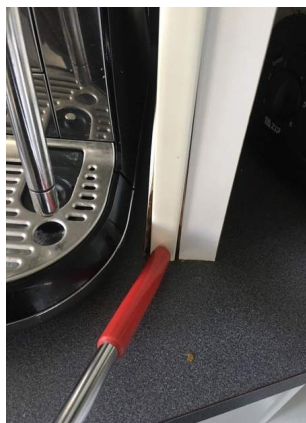
✗ No - General deterioration was sighted due to age.

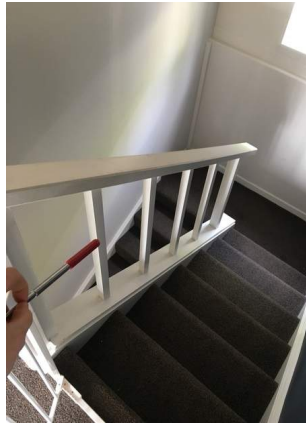
The handrail/barrier around the top and down the stairs may have complied when first built; however, this does not comply with the current building code and is a safety hazard. Upgrades are recommended by a tradesman builder.

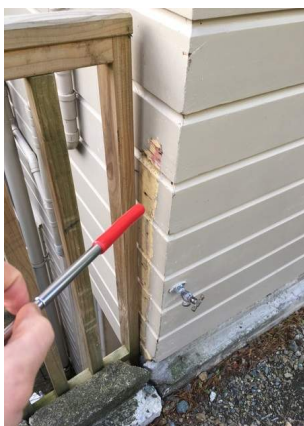
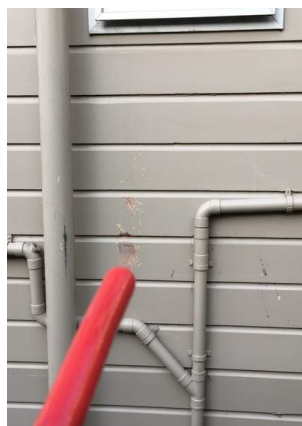
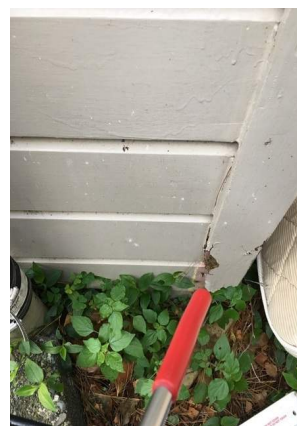
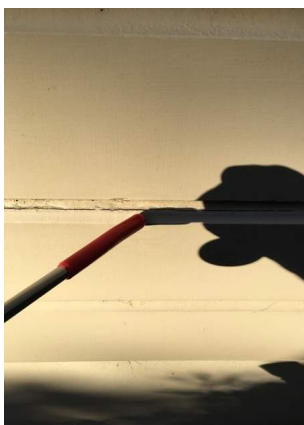
Paint deterioration was sighted due to age, repairs and maintenance is required now by a tradesman painter to protect the timber and prevent further deterioration. Timber repairs will also be required by a tradesman builder prior to painting as timber deterioration was sighted to the southeastern box corner.

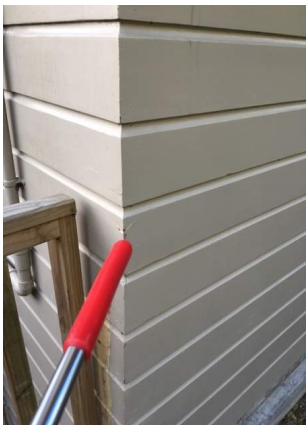
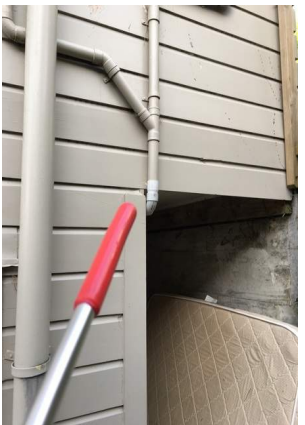
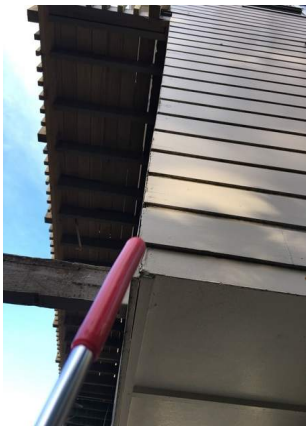
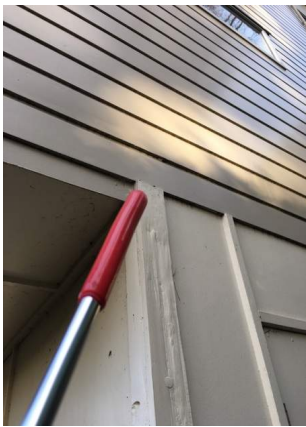
✗ No - Flashing work is required on the external corners.

SUPPLEMENTARY INFORMATION	I recommend installing corner soaker flashings or timber boxed corners on the open corners of the house to prevent moisture penetration and deterioration of the timber.
EXPLANATIONS	Location : Details : Rating: Minor Maintenance

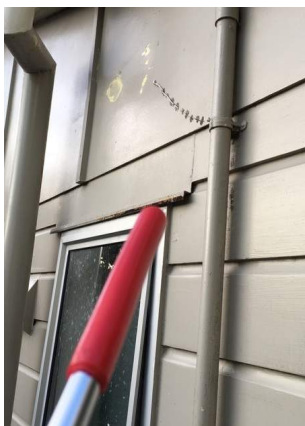
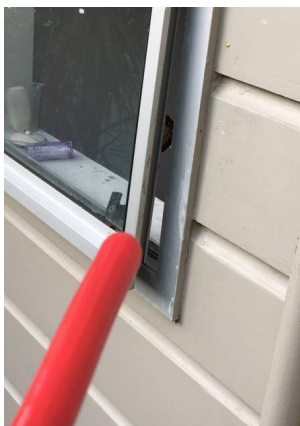
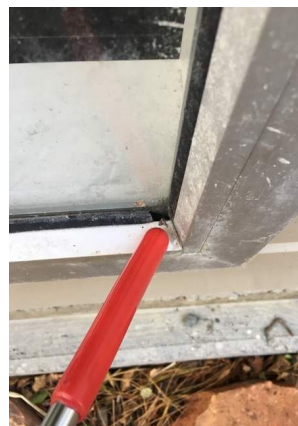
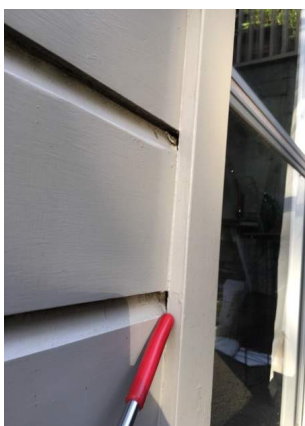
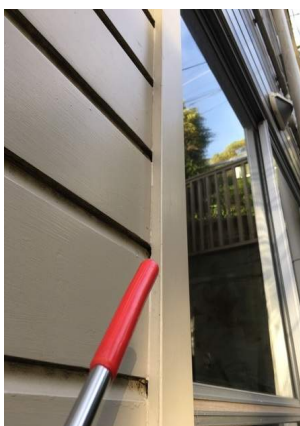
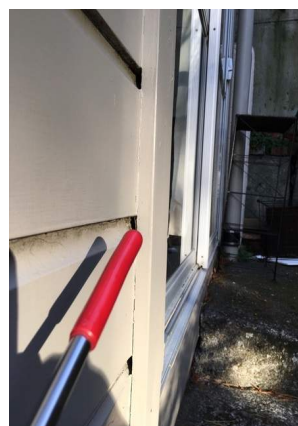
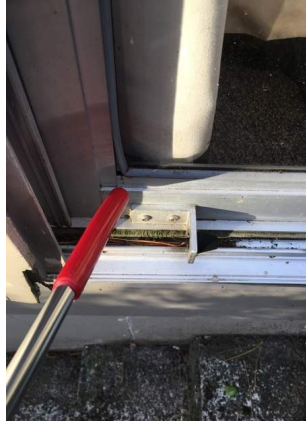
✗ No - Aluminium window maintenance required.

- The rusted head flashing over the laundry door requires rust treatment to help prevent further corrosion.
- Gaps were sighted between the windows and timber cladding, the installation of timber scallops or sealant is required to help prevent the chance of water ingress.

I recommend all the shrunken glazing rubbers are replaced to ensure the windows and doors are completely watertight & sealed. Some light corrosion is evident around the aluminium window frames, seek advice from an aluminium window glazier as to how this can be repaired. Adjustments can be made in areas to enable the windows to pull up tight when closed; an aluminium window glazier can be used to achieve this also.

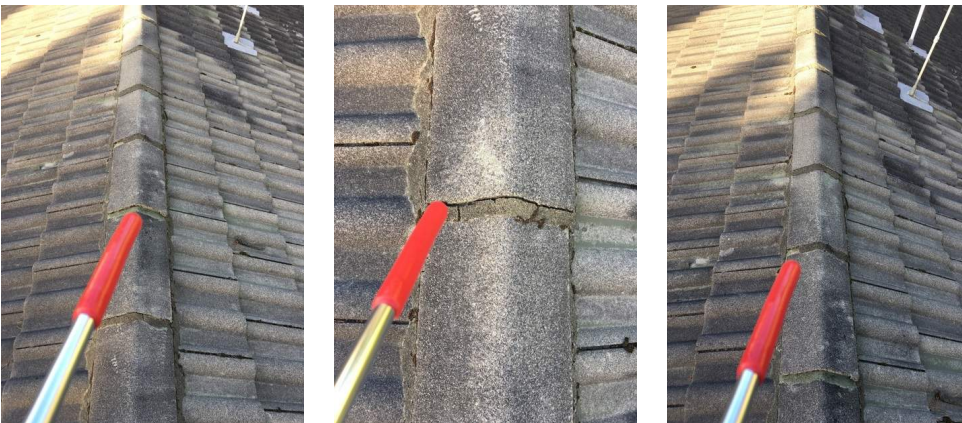
✗ No - Ridge capping mortar cracking.

Ridge capping mortar cracking and openings visible, this can allow water penetration during rainfall and requires rectification to prevent water ingress. See a licensed roofing specialist to have re-pointed.

**- Roof** - Hip capping mortar cracking and openings visible, this can allow water penetration during rainfall and requires rectification to prevent water ingress. See a licensed roofing specialist to have re-pointed.

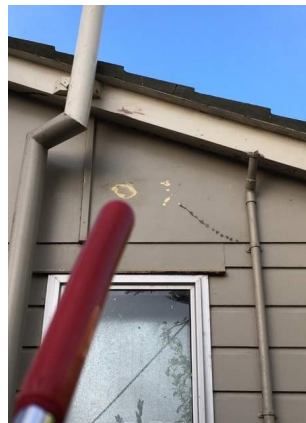
✗ No - Paint/coating in poor condition.

Paint deterioration was sighted, I recommend paintwork takes place now by an experienced painter to ensure areas are sealed and weathertight.

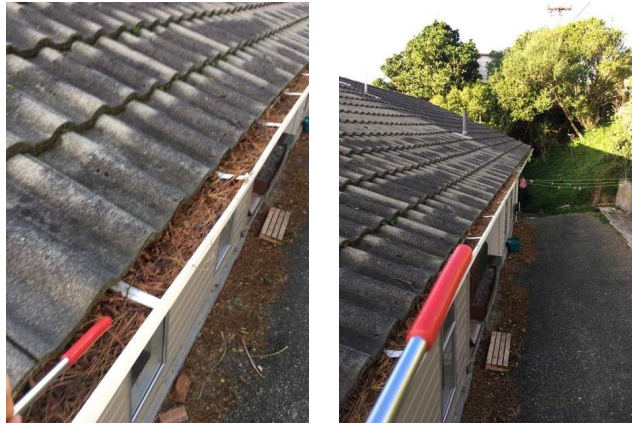
The guttering requires cleaning out to prevent blocking of downpipes and leaking into eaves and fascia.

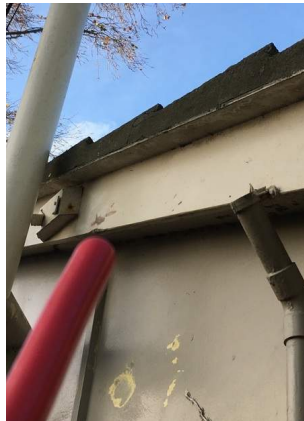
✗ No - Paint deterioration detected.

Paint deterioration was sighted, I recommend paintwork takes place now by a tradesman painter to ensure areas are sealed and weathertight.

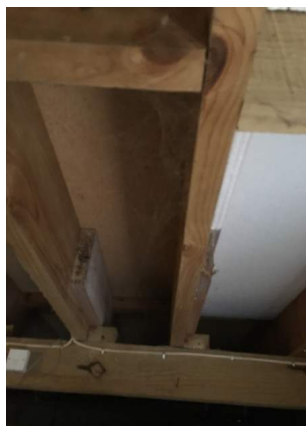
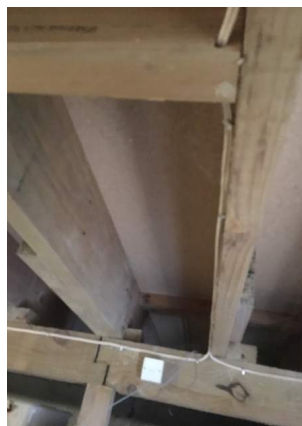
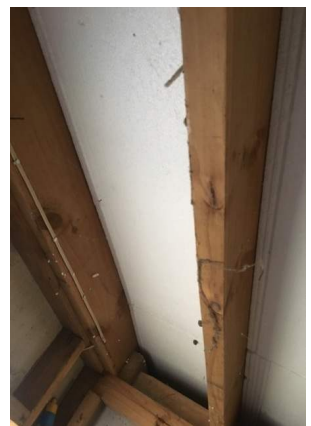
There has been a partial install of insulation in the subfloor. I recommend completion of this as this will help the household stay warm in the colder months and may reduce heating costs.

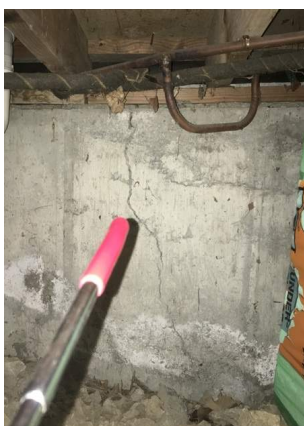
✗ No - Ring foundation crack detected.

A crack was sighted to the back of the ring foundation, repairs are required now by a concrete specialist or engineer on how to repair and the necessary steps that should be taken.

**- Subfloor** - A crack was sighted to the back of the ring foundation, repairs are required now by a concrete specialist or engineer on how to repair and the necessary steps that should be taken.

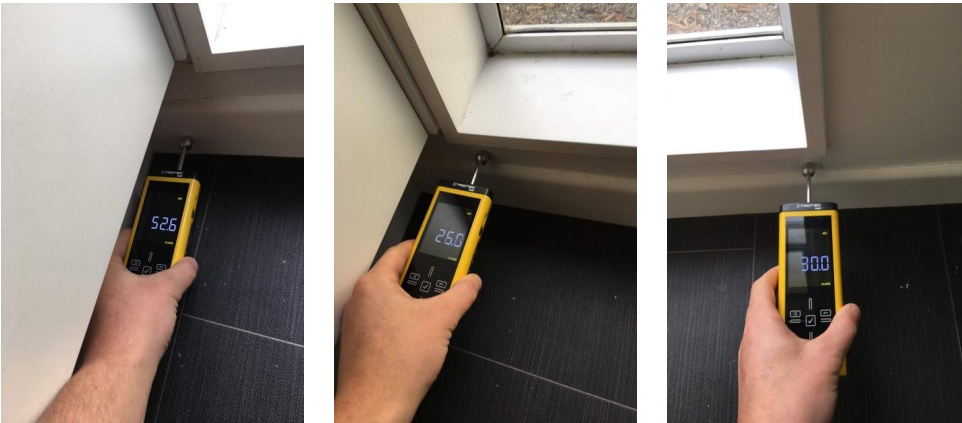
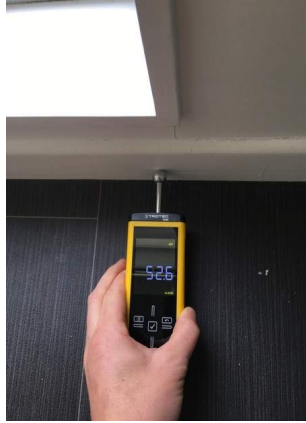
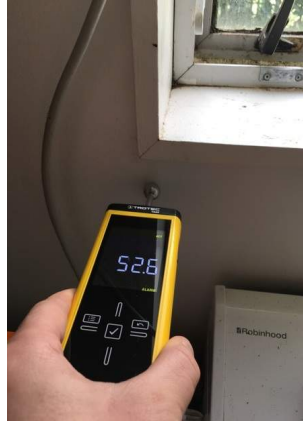
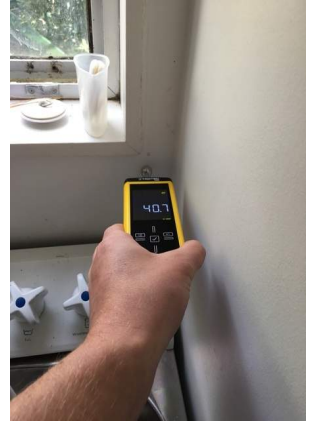
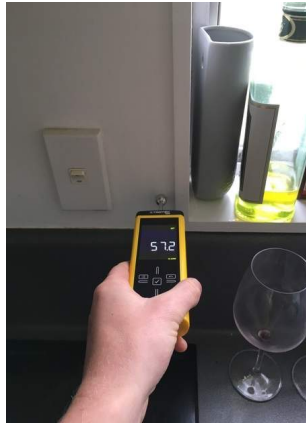
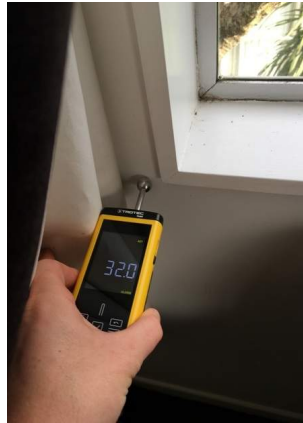
This was a non invasive moisture test to random areas of possible concern (like around the windows and doors on the exterior walls and wet areas; or areas with pipe work running through them). Accessible areas have been checked on the interior to check for moisture within the wall cavity. The moisture measurement is up to approximately 40mm deep. Levels will vary from house to house and any elevated reading will be recorded and further investigation will be required. The conditions and treatment type of internal framing is not known. An invasive instrument will never be used to prevent damage.

To avoid high moisture readings keep the exterior sealed and watertight, keep all vegetation clear from the perimeter of the dwelling and all surface water directed away from the house. Ensure the spouting is flowing and is watertight, sufficient ventilation is always recommended. Bathrooms and laundries should have vented fans in place, the windows of the dwelling should be vented often and use of a dehumidifier or moisture system is recommended.

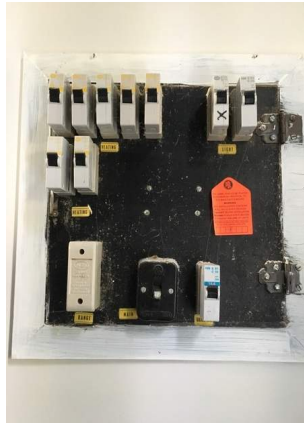
Some older porcelain fuses sighted and some newer sighted. I recommend having a licensed electrician inspect this fuse board to see what fuses are in use. I recommend all fuses are circuit breakers, upgrades are recommended on this style switchboard in the near future to keep up with current safety standards.

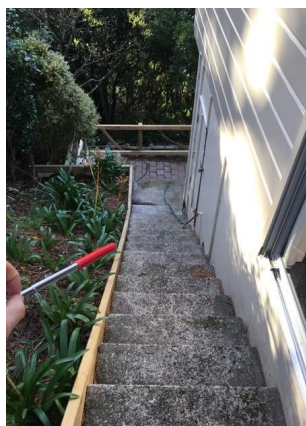
I recommend a compliant handrail is installed.

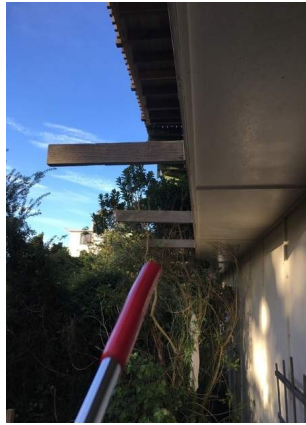
I recommend all vegetation is kept clear from the perimeter of the dwelling to prevent moisture ingress and deterioration.
