### Traditional Foundation

### ICF Foundation

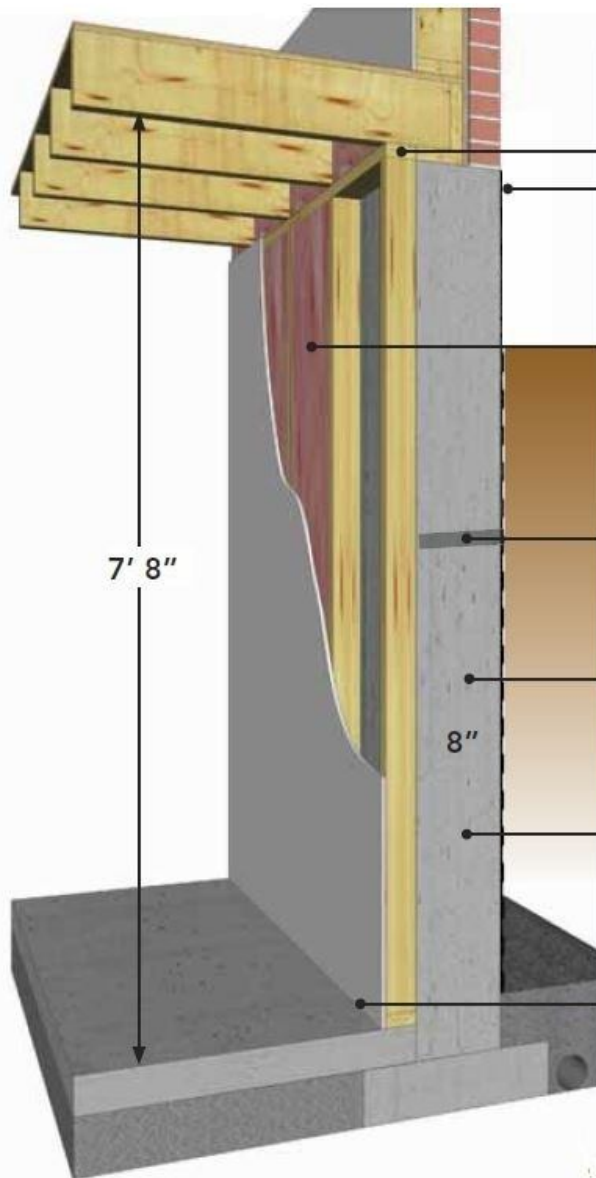
- Wood framed walls are inefficient, prone to rot, and allow thermal bridging.
- Lack of exterior EPS insulation provides easier pathway for water intrusion. Additional insulation is required on above grade walls.
- Wood and fiberglass insulation are susceptible to rot, mildew, and mold.
- Contact with moisture severely compromises R-value in fiberglass batt insulation.
- Penetrations from ties provide access point for water.
- Lack of horizontal rebar can result in cracks.
- Foundations are formed using heavy wood or steel forms that have to be removed. This requires more manpower, equipment, and time.
- Foundations are typically 8" - 10" wide to meet code, resulting in more concrete and increased costs.
- Multiple steps to finish basement.
- No insulation at floor slab results in a cold floor.

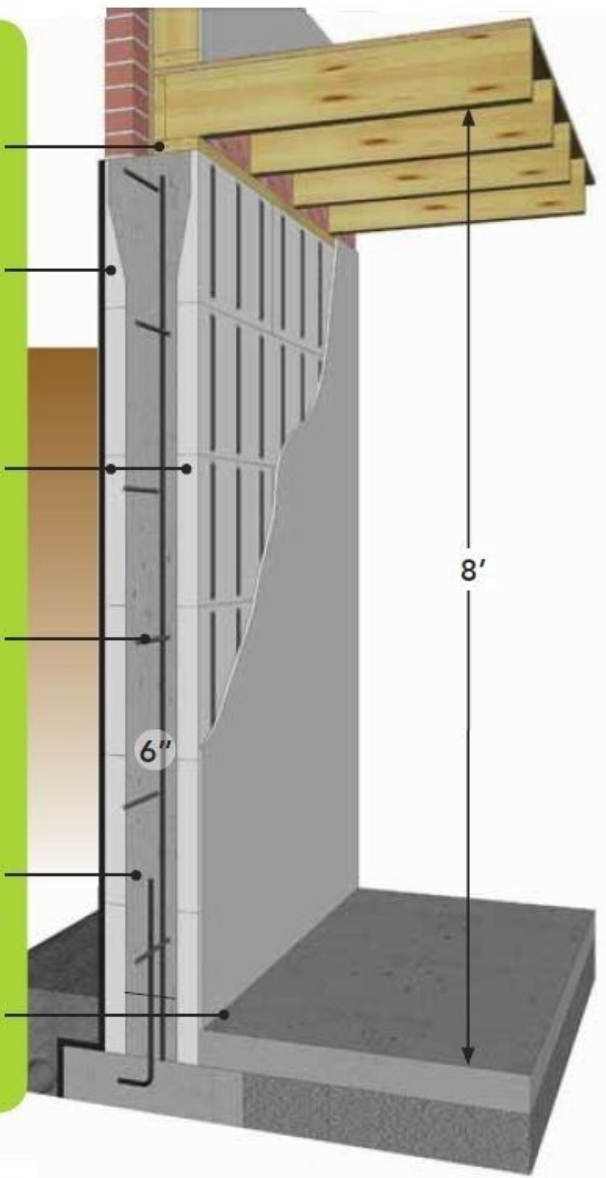
- Provide full height continuous EPS insulation eliminating cold spots and thermal bridging.
- Provides continuous insulation on both above and below grade walls.
- Encapsulates the wall in EPS insulation improving energy efficiency and preventing water intrusion.
- EPS material prohibits mold, mildew, or rot.
- EPS acts as a water barrier on both sides. Waterproofing on the exterior adds additional barrier.
- Walls include horizontal rebar preventing concrete cracking.
- EPS insulation is safe and does not absorb moisture so there is no compromise of R-value.
- Engineered design allows for thinner profile walls, reducing concrete costs.
- Lightweight, easy to work with, stack easily, are stay-in-place, and require a smaller crew.
- Is stronger allowing for a reduced concrete core size – typically only 6" thick.
- Insulated edge of floor slab.
