# **Marsh, Hemimarsh, and Open Water restoration potential of Square Marsh at the north end of Lake Calumet**

**Gary Sullivan, Ph.D.**

**The Wetlands Initiative  
53 W. Jackson Blvd.  
Suite 1015  
Chicago, IL 60604  
[www.wetlands-initiative.org](http://www.wetlands-initiative.org)**

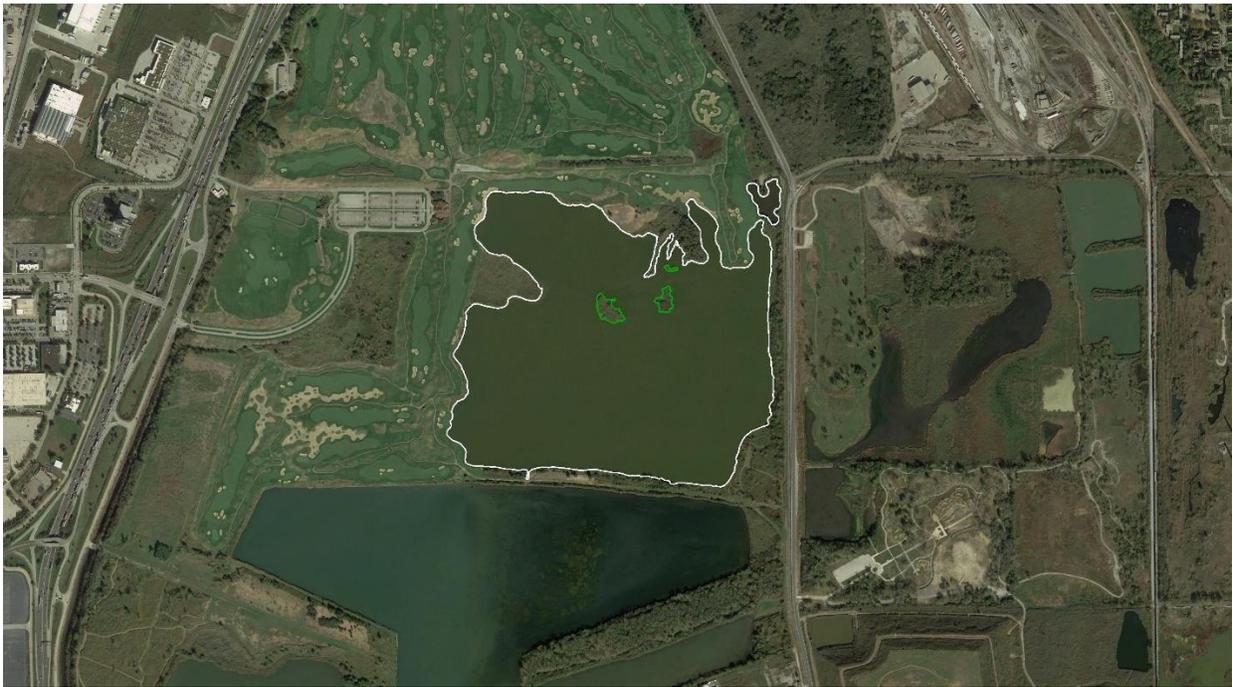
**Figure 1.** A 2018 satellite image of Square Marsh at the north end of Lake Calumet outlined in white, with islands outlined in green. The 140.6 acres of water are owned by the Port Authority. Imagery courtesy of Google Earth.

Square Marsh is a 138.4-acre open water area located at the north end of Lake Calumet (Figure 1). The Marsh is located just west of S. Stony Island Ave., east and south of the Harborside International Golf Center, and north of a berm and dirt track separating it from the open waters of Lake Calumet. The Marsh is owned by the Illinois International Port District at the Port of Chicago. The open water pool, once part of the open waters at the north end of Lake Calumet (Figure 2), became isolated from the rest of the lake by the ongoing deposition of various materials from 1900 through 1980 (Kay et al. 1997). The Marsh can now be characterized as an open water body up to approximately 6.5 feet deep with a few small islands totaling 1.5 acres in size. The shoreline along the golf course is highly managed, while other areas are dominated by common reed (*Phragmites australis*) and a mixture of weedy trees, shrubs, forbs, and grasses. The near-shore area is relatively steep as it was created as the lake was filled by dredge spoils, slag, municipal waste, construction debris, and other materials as it was pushed in from the edges. Consequently, only a small proportion of the pool is found in shallow depths (11.6% of the pool occurs at or below three feet in depth), while 88.4% of the pool is greater than 3.0 feet in depth. Currently, the Marsh can only be viewed from shore along the Harborside Golf Course as Port Authority property is not open to the public.

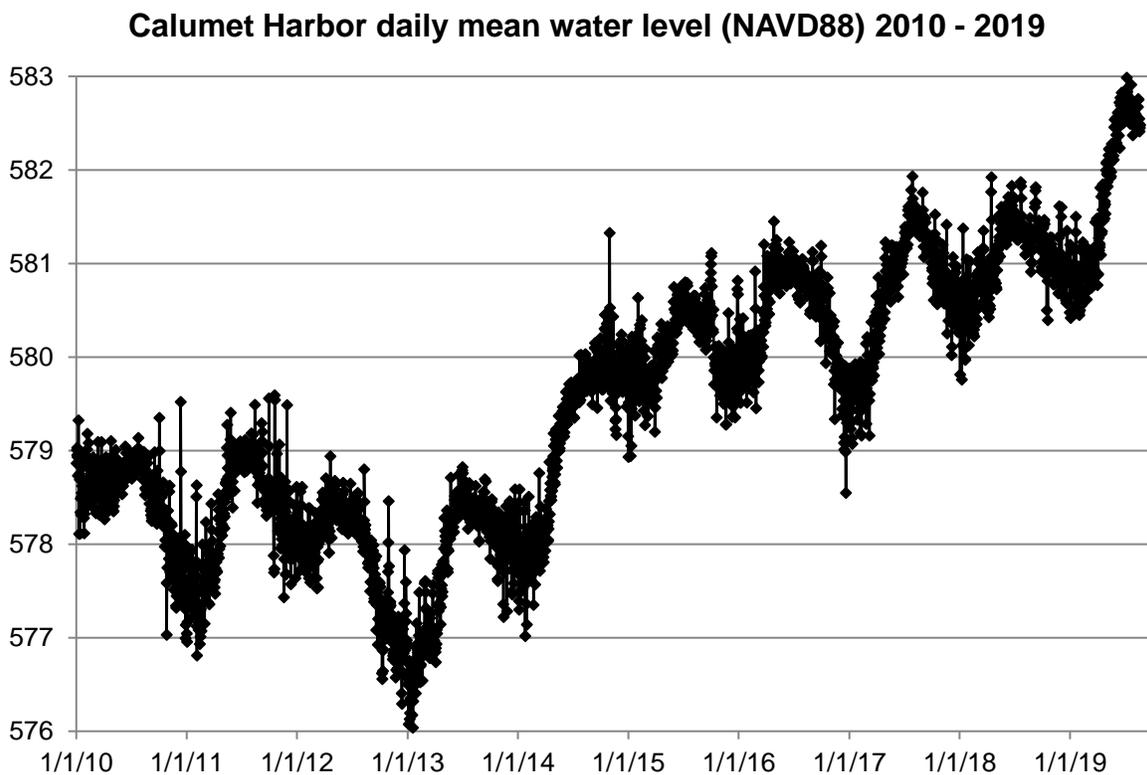
**Figure 3.** Mean daily surface water elevations of Lake Michigan measured at the Calumet Harbor gauge (station 9087044) from January 2010 through August 2019 in feet above mean sea level relative to the North American Vertical Datum of 1988 (NOAA 2019a).

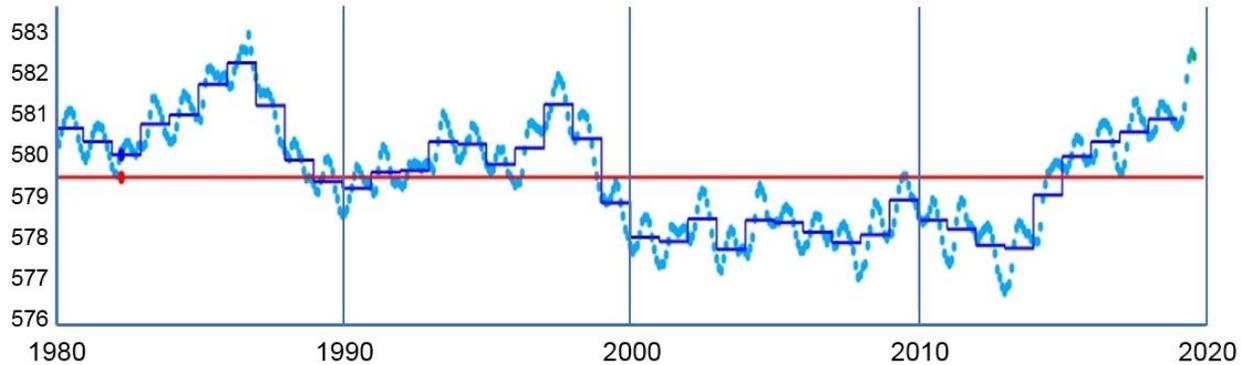
**Figure 4.** Mean monthly (dots), annual (blue line), and 100-year average (red line) surface water elevations of Lake Michigan in feet above mean sea level relative to the North American Vertical Datum of 1988 from 1980 to the present (NOAA 2019b). The period includes the highest water surface elevations ever recorded on Lake Michigan (October 1986) and the lowest (January 2013). July 2019 has the second highest monthly mean water surface elevation recorded.

due to the near-record high water levels in Lake Michigan, these levels are likely to fall in the next year or so based on historical Great Lakes records over the past 100 years (Figure 4). A new, lower water control structure would allow water to be maintained at a lower level, varied to mimic natural dynamics, manage invasive species, consolidate flocculant sediments, and/or stimulate the germination of marsh plant species.

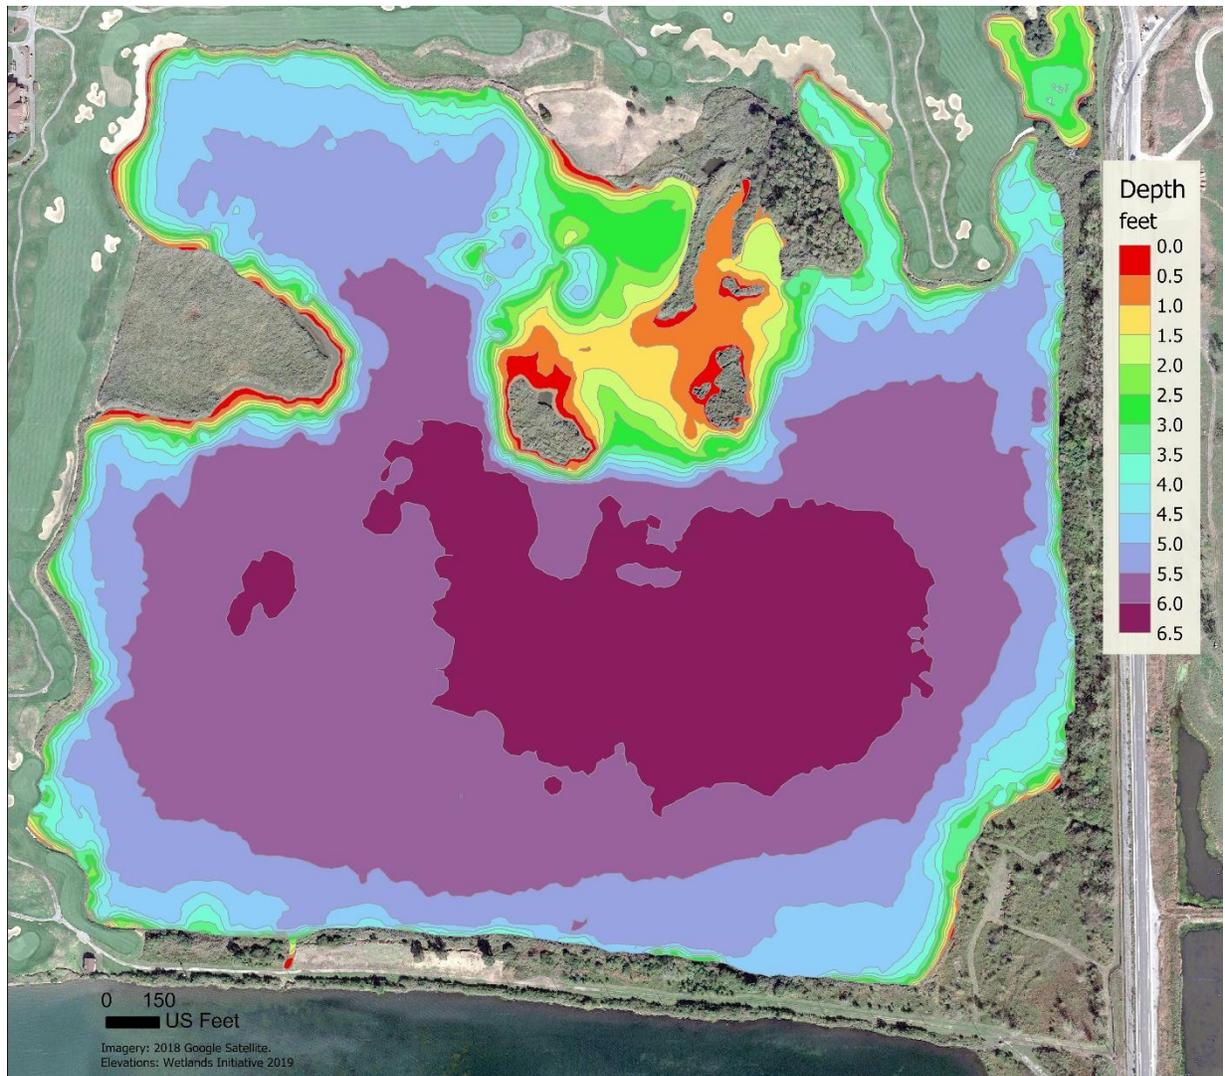
**Appendix 1.** Square Marsh bathymetry showing depth contours at 6-inch intervals on a 2018 satellite image courtesy of Google Earth. Depth is based on a water surface elevation of 582.5 feet MSL NGVD88 (The Wetlands Initiative).

The bathymetry of the Marsh can be characterized as a relatively steep sided body of water, most of which is found from 4.5 to 6.5 feet in depth, with an area of shallower water surrounding artificial islands in the north central portion of the pool (Appendix 1). The steep edges resulted from the way in which the Marsh shore was created, i.e. the north end of Lake Calumet was filled to the north, east, and west over a period of years with dredge spoil, slag, construction debris, and various other materials being pushed into the basin (see Figure 2). Additional construction debris and other material was added later to create islands and peninsulas in the northern portion of the basin. Due to the distribution of large chunks of concrete, bricks, steel, and other materials in this area, depth was measured relative to the base layer on which they protrude.

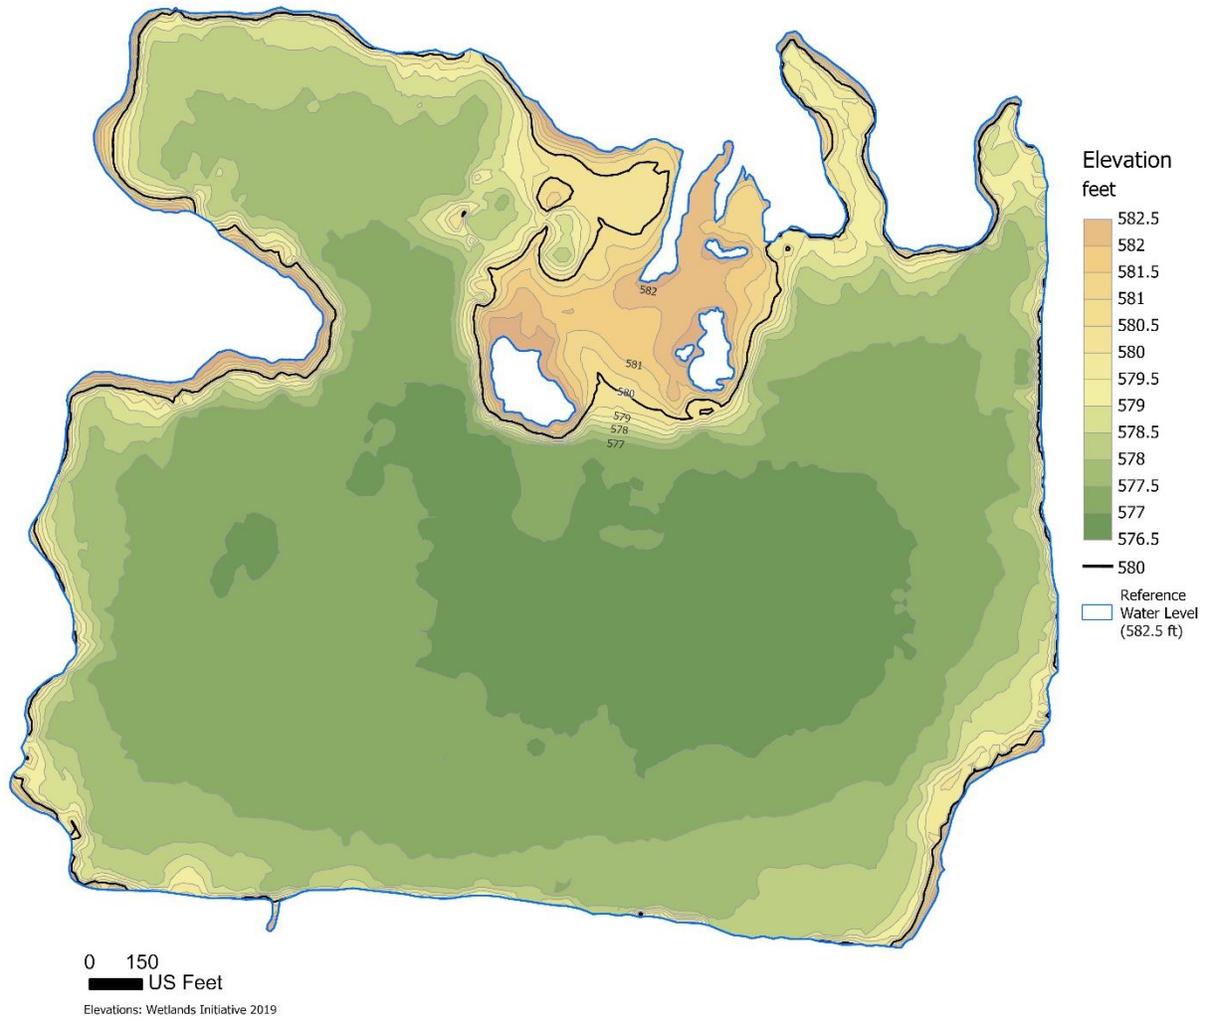
**Appendix 2.** The potential 12.6-acre marsh restoration footprint at Square Marsh delineated between the reference water level (582.5 feet MSL) and the black 30-inch depth contour (580.0 feet MSL; The Wetlands Initiative).

The last major challenge is simply the bathymetry. Due to the relatively steep shoreline, at the current water level there are only 12.6 acres, or 9.1% of the total pool area between shore and a depth of 30 inches (Appendix 2), the depth range of most emergent marsh species. Some species may grow deeper under dynamic water levels and otherwise good conditions to a depth of three feet or more, but 30 inches is a reasonable estimate of maximum hemimarsch depth. Maintaining

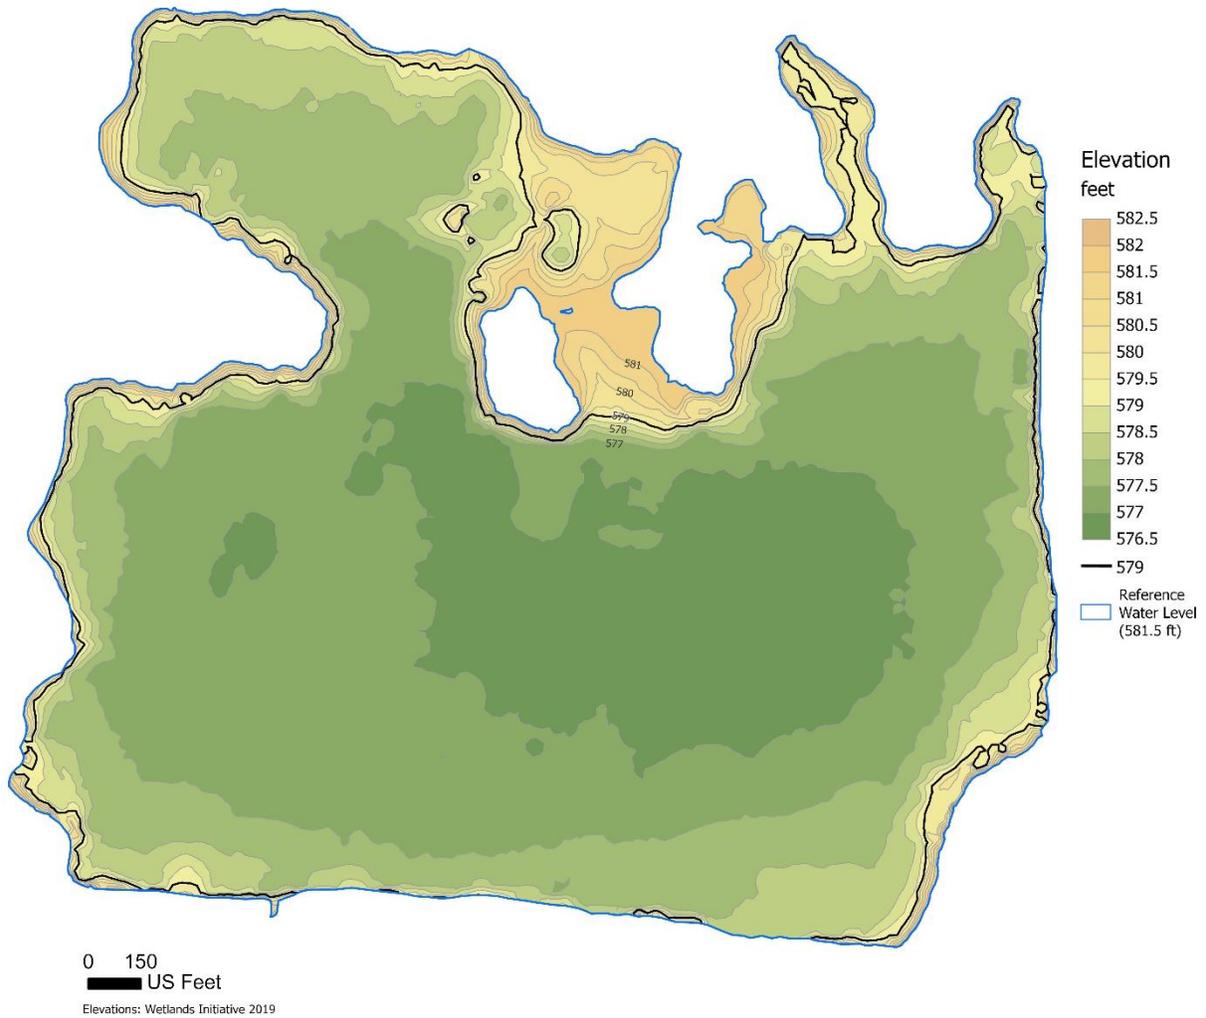
**Appendix 3.** The potential 15.9-acre marsh restoration footprint at Square Marsh delineated between the reference water level (581.5 feet MSL) and the black 30-inch depth contour (579.0 feet MSL; The Wetlands Initiative).

a target water level one foot lower (581.5 feet MSL) would shift these numbers to 15.9 acres of marsh out to 30 inches deep (11.8% of the lower pool area; Appendix 3). Maintaining a target water level an additional foot lower (580.5 feet MSL) would shift these numbers to 21.5 acres of marsh (16.7% of the lower pool area; Appendix 4). Regardless of the depth around which to maintain water levels, the Marsh is always going to be dominated by deeper water with a narrow fringe of emergent vegetation around the shoreline and a somewhat wider apron around the islands.

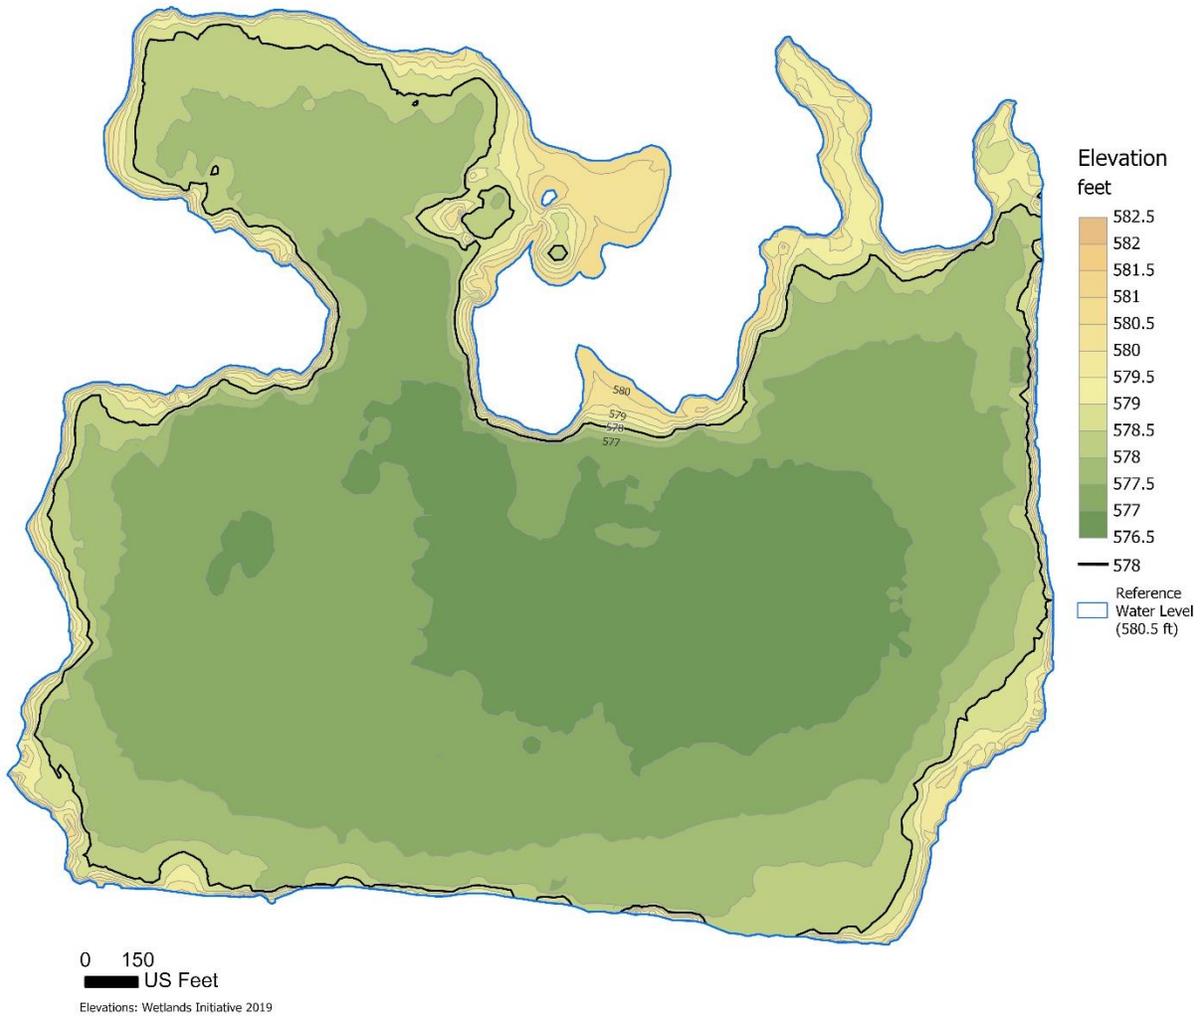
**Appendix 4.** The potential 21.5-acre marsh restoration footprint at Square Marsh delineated between the reference water level (580.5 feet MSL) and the black 30-inch depth contour (578.0 feet MSL; The Wetlands Initiative).

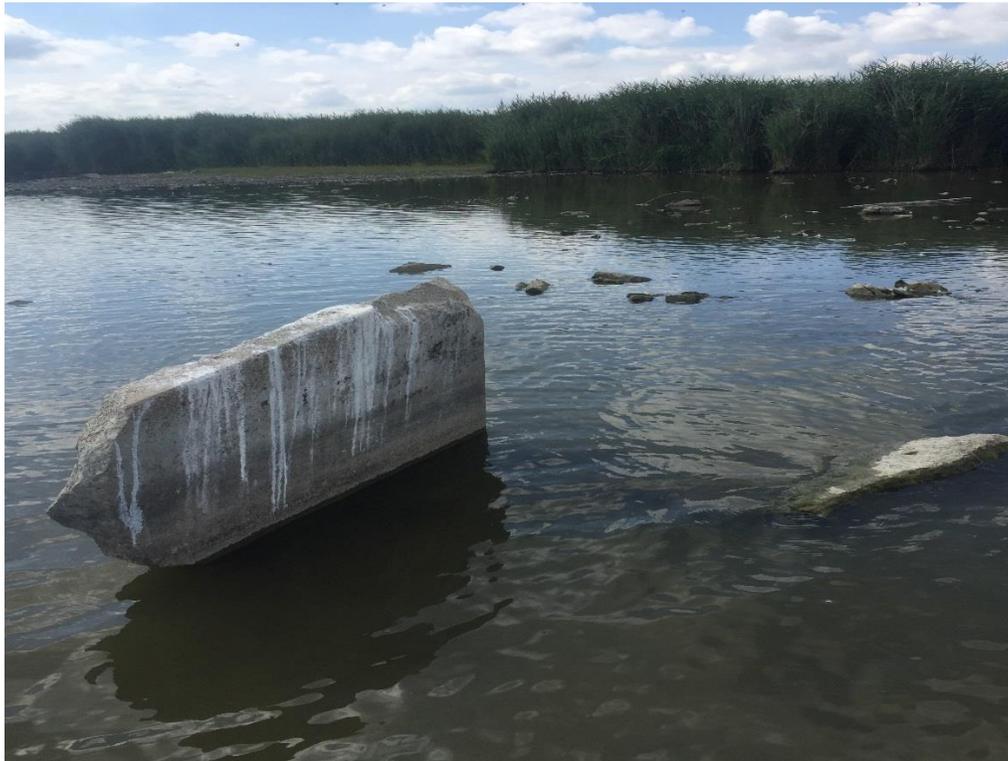
**Appendix 5.** Photos of survey area illustrating debris field projecting above surface, with eroded and slag shorelines.

1. Concrete above and below the surface

The next challenge is the extensive debris field covering native sediments in the shallower water zones in the northern portion of the Marsh. Although there are some areas in the shallow zone with fine sediments conducive to supporting native marsh vegetation, much of the shallow can be characterized by the deposition of rocks, concrete, bricks, slag, steel, and other materials. Much of this material projects up off the bottom and occasionally above the surface (see photos in Appendices). The extent of the debris zone has not been mapped quantitatively, in large part due to the extremely poor water transparency in addition to the difficulty of navigating the area on foot or by boat. Although the subsurface debris will likely make restoration work and later management difficult and potentially dangerous in some areas, some plants will still be able to grow up and around the materials where they are less dense. However, it would be extremely beneficial to remove the most egregious of these materials (if not all) once water levels can be reduced sufficiently to provide access and if the financial resources are available. One last factor to consider in this regard is simply aesthetics in that the restored wetland will likely become an important public resource where people are drawn to the rich diversity of wildlife. Support for this and similar future projects would be enhanced if the wetland both functions and looks like a natural part of the landscape.

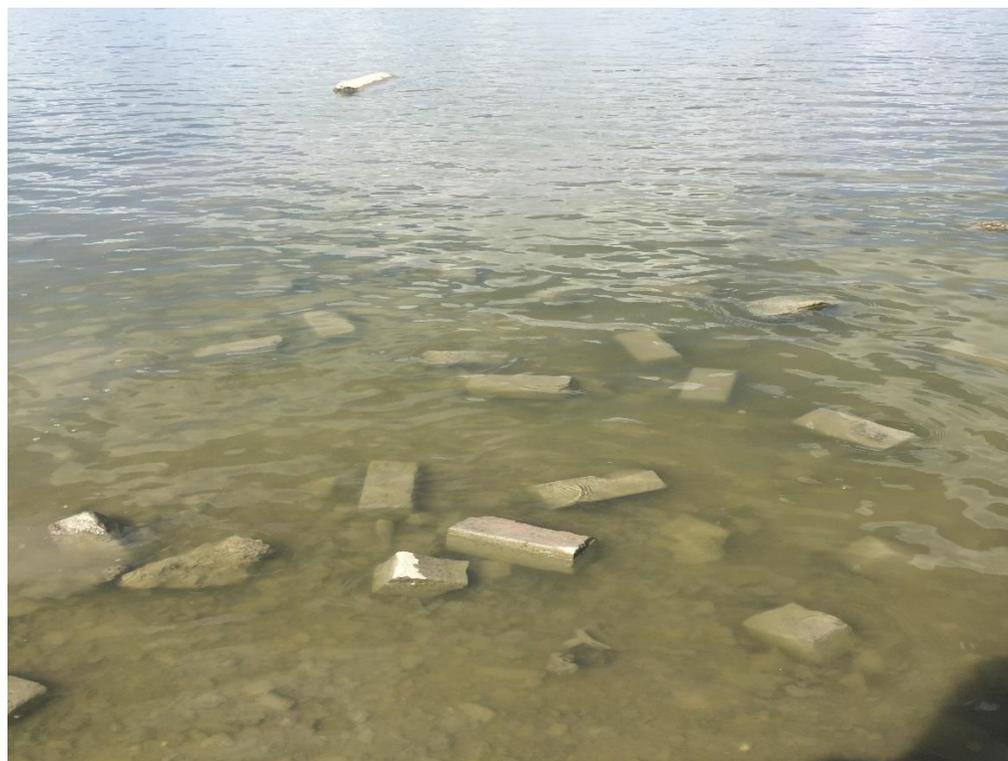
2. Bricks and stone covering portions of the bottom

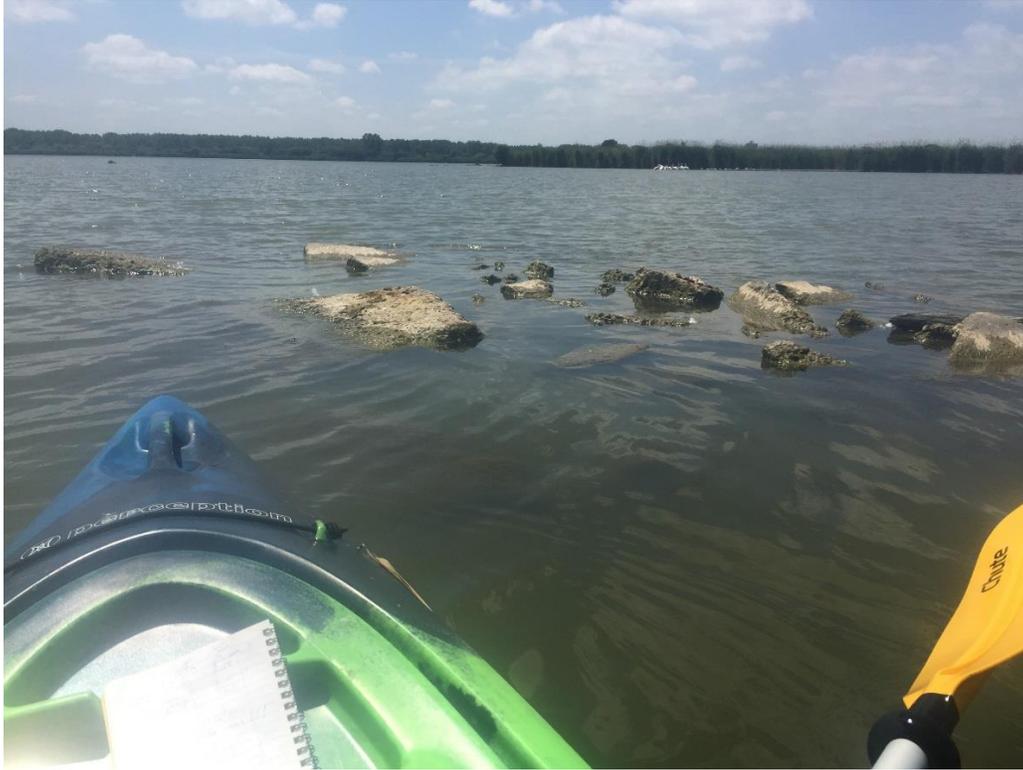
3. Concrete projecting above the surface

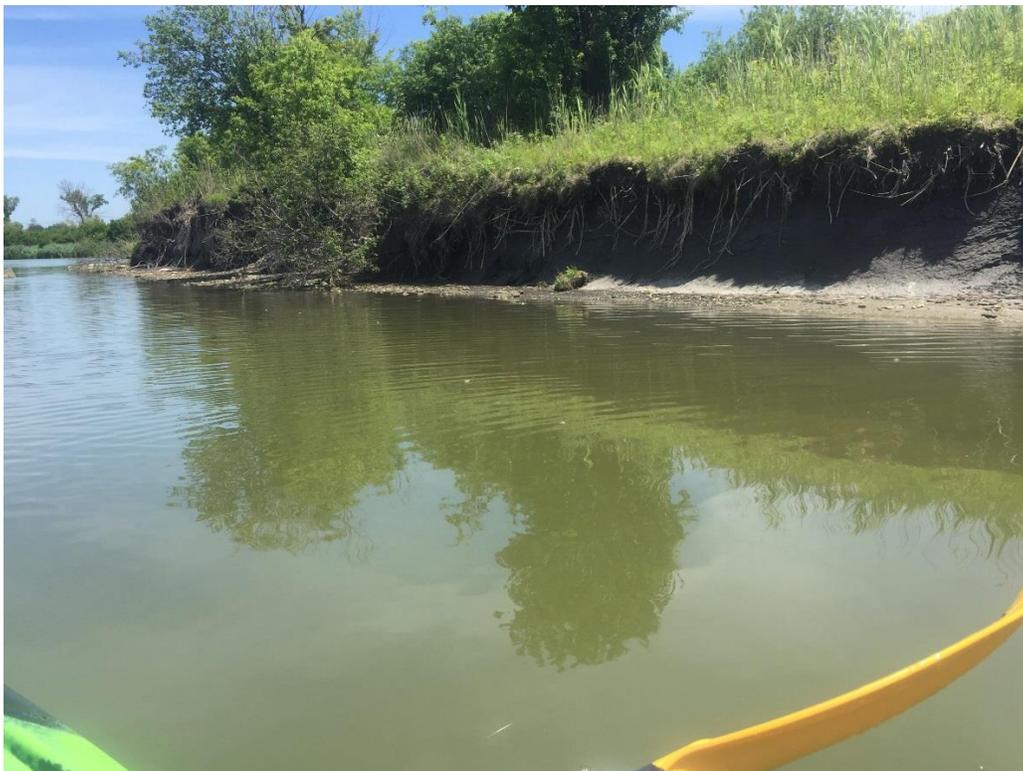
4. Eroded banks along the eastern shoreline

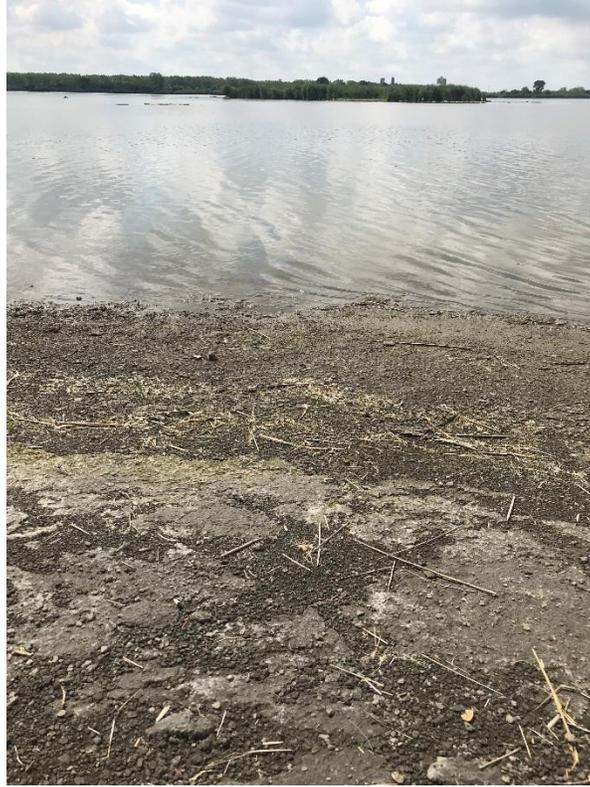
5. Solid slag deposited along north shore.

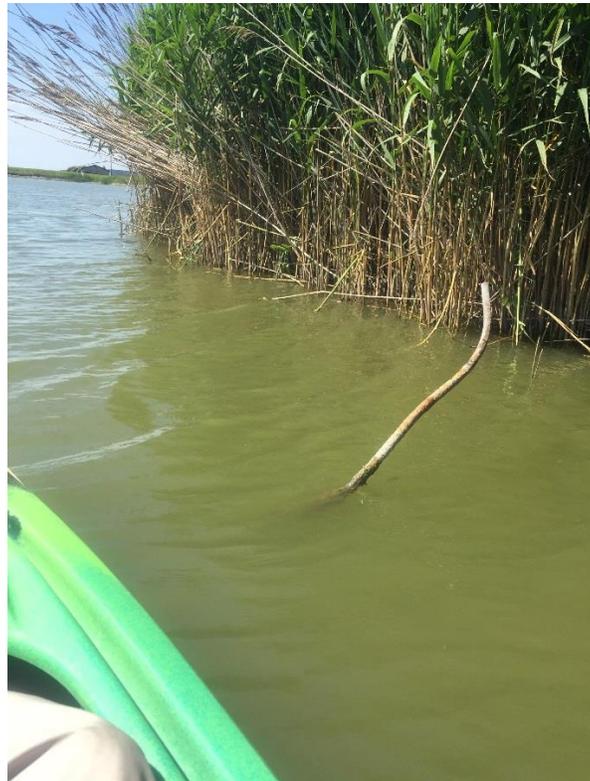
6. Steel projecting above surface along common reed shoreline.
