Rapid Site Report:

Odesa Art Museum, Ukraine

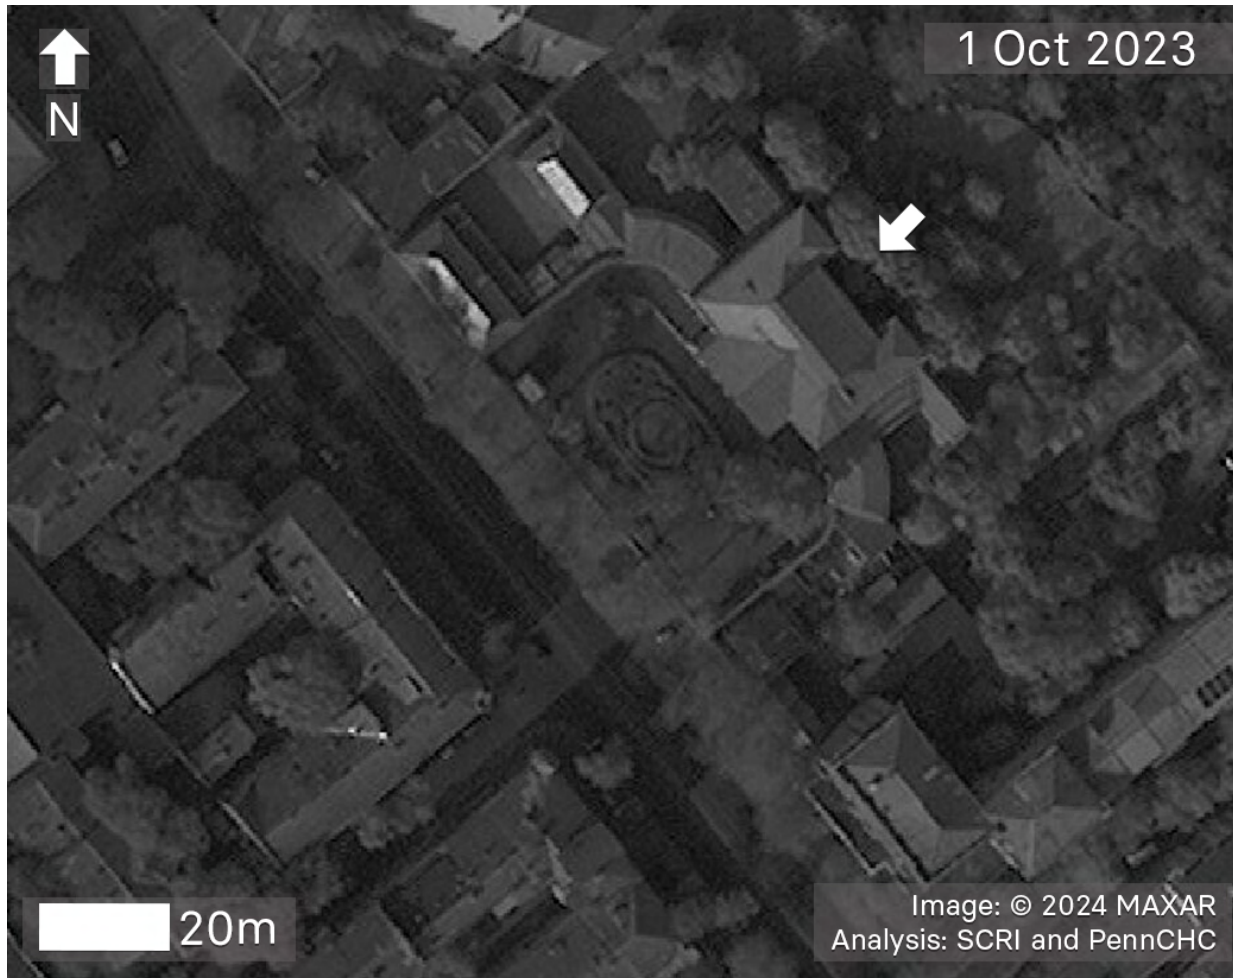
Image 1.

Satellite image of the Odesa Art Museum (dated 1 October 2023) shows no visible damage. Scale: 20m. Arrow points to the museum building. Source: © 2024 MAXAR.

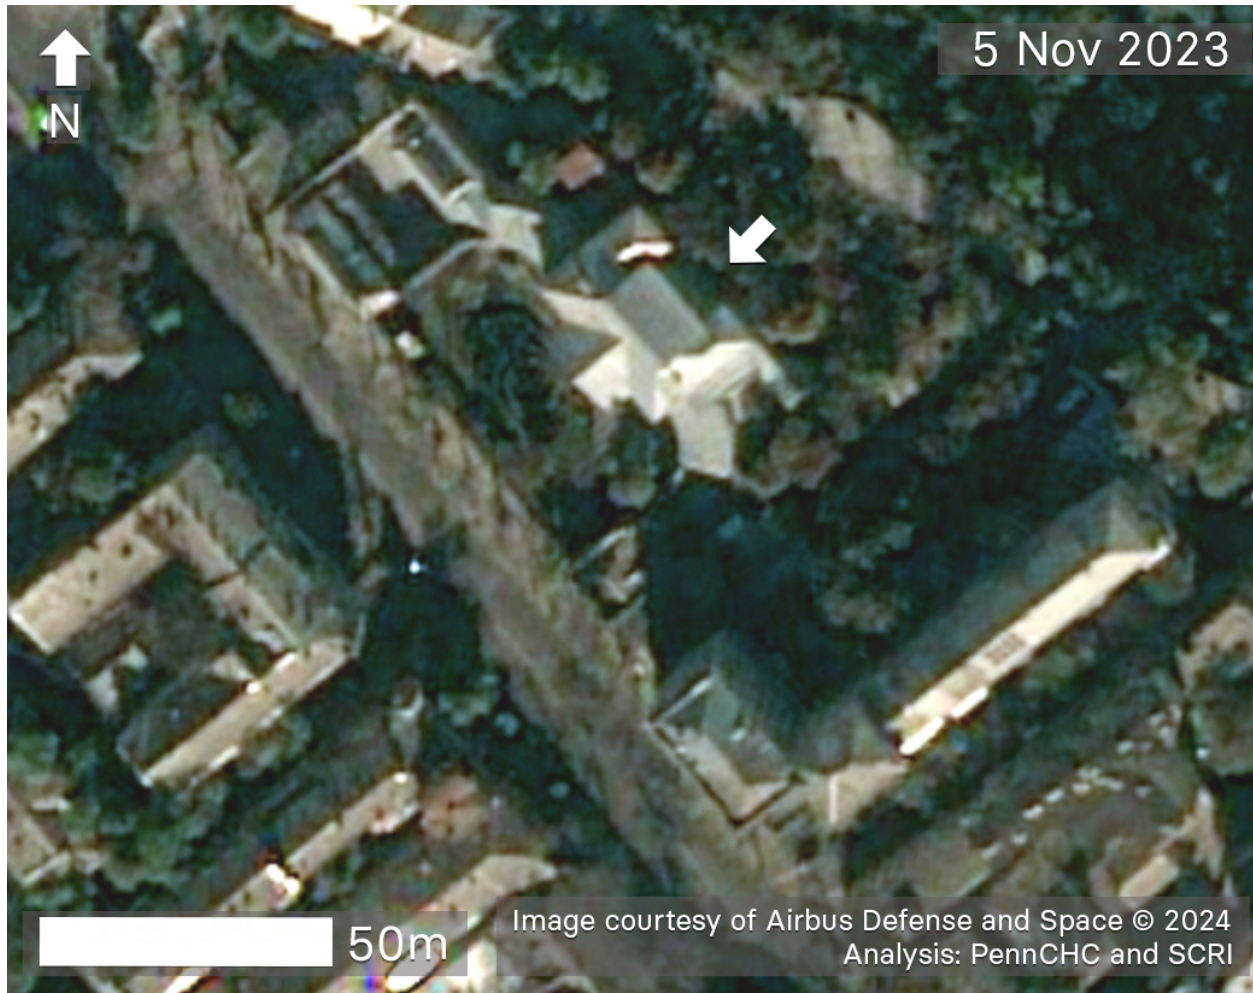
Image 2.

Satellite image of the Odesa Art Museum (dated 5 November 2023) shows no visible damage. Scale: 50m. Arrow points to the museum building. Source: Airbus SE, Image © Airbus.

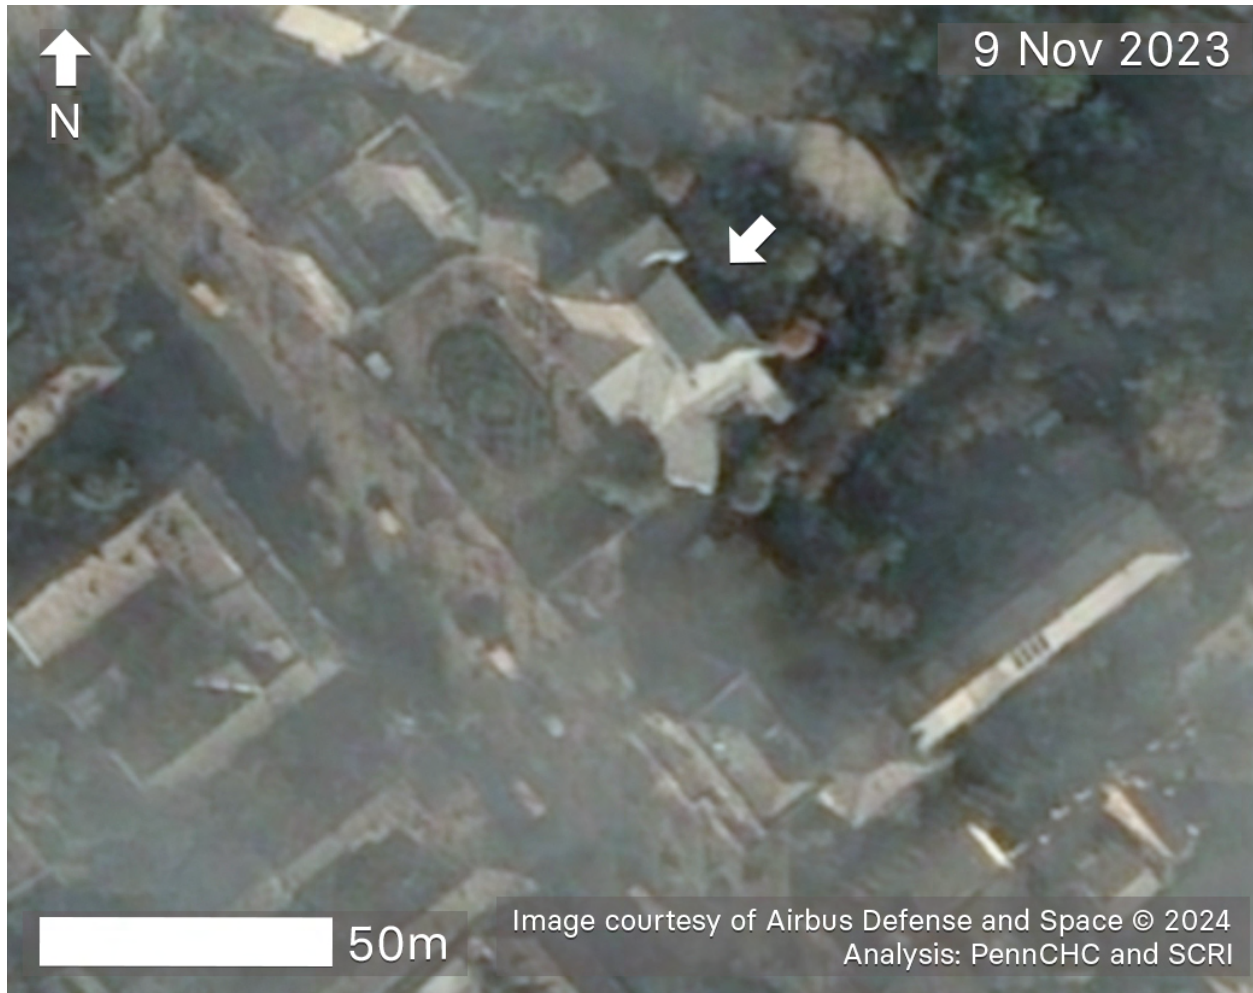
Image 3.

Satellite image of the Odesa Art Museum (dated 9 November 2023). Debris and impact craters are visible in the road and grounds in front of the museum. Scale: 50m. Arrow points to the museum building. Source: Airbus SE, Image © Airbus.

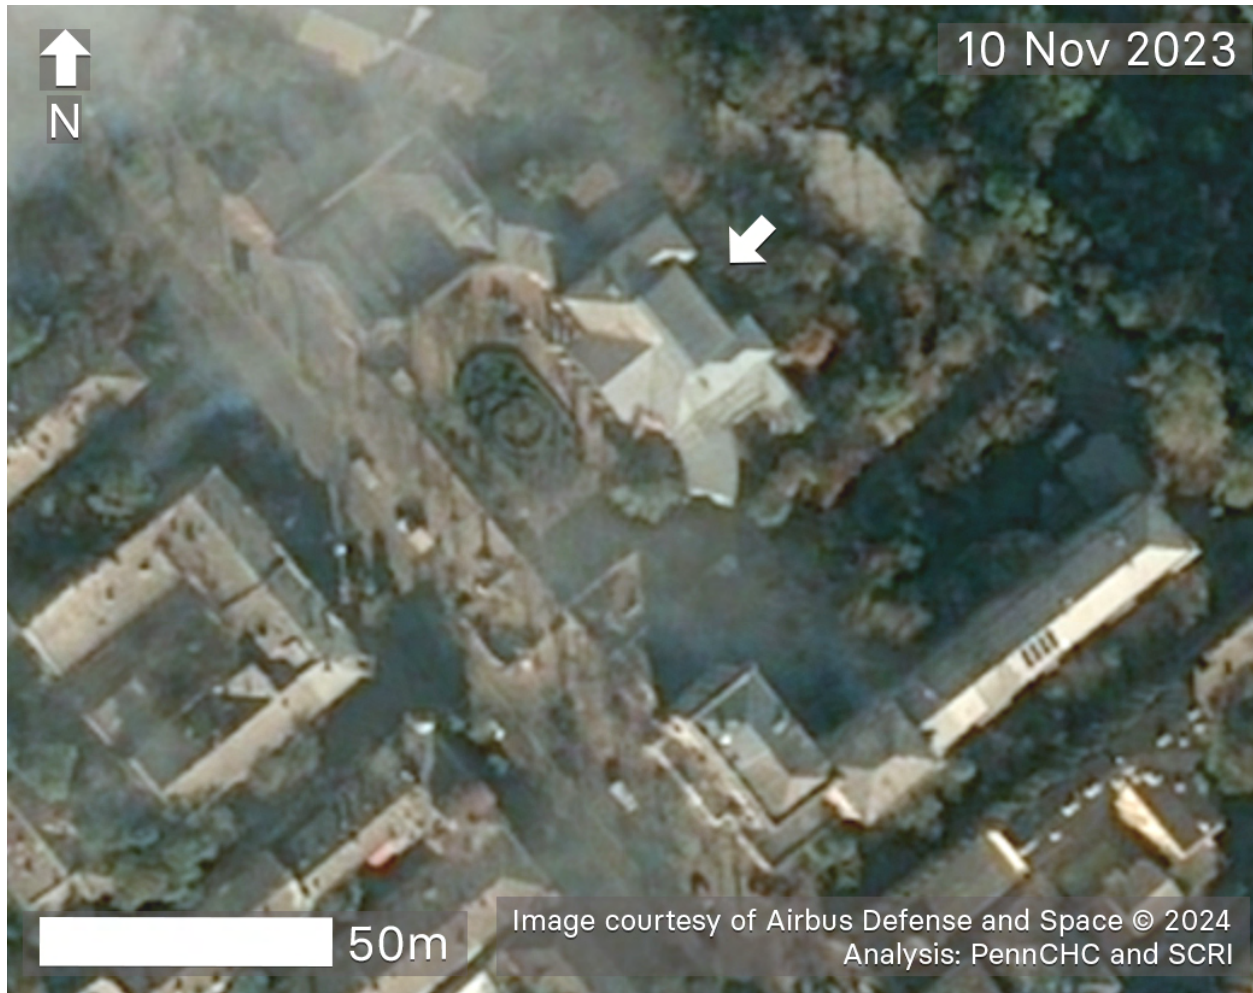
Image 4.

Satellite image of the Odesa Art Museum (dated 10 November 2023). Debris and impact craters are visible in the road and grounds in front of the museum. Scale: 50m. Arrow points to the museum building. Source: Airbus SE, Image © Airbus.

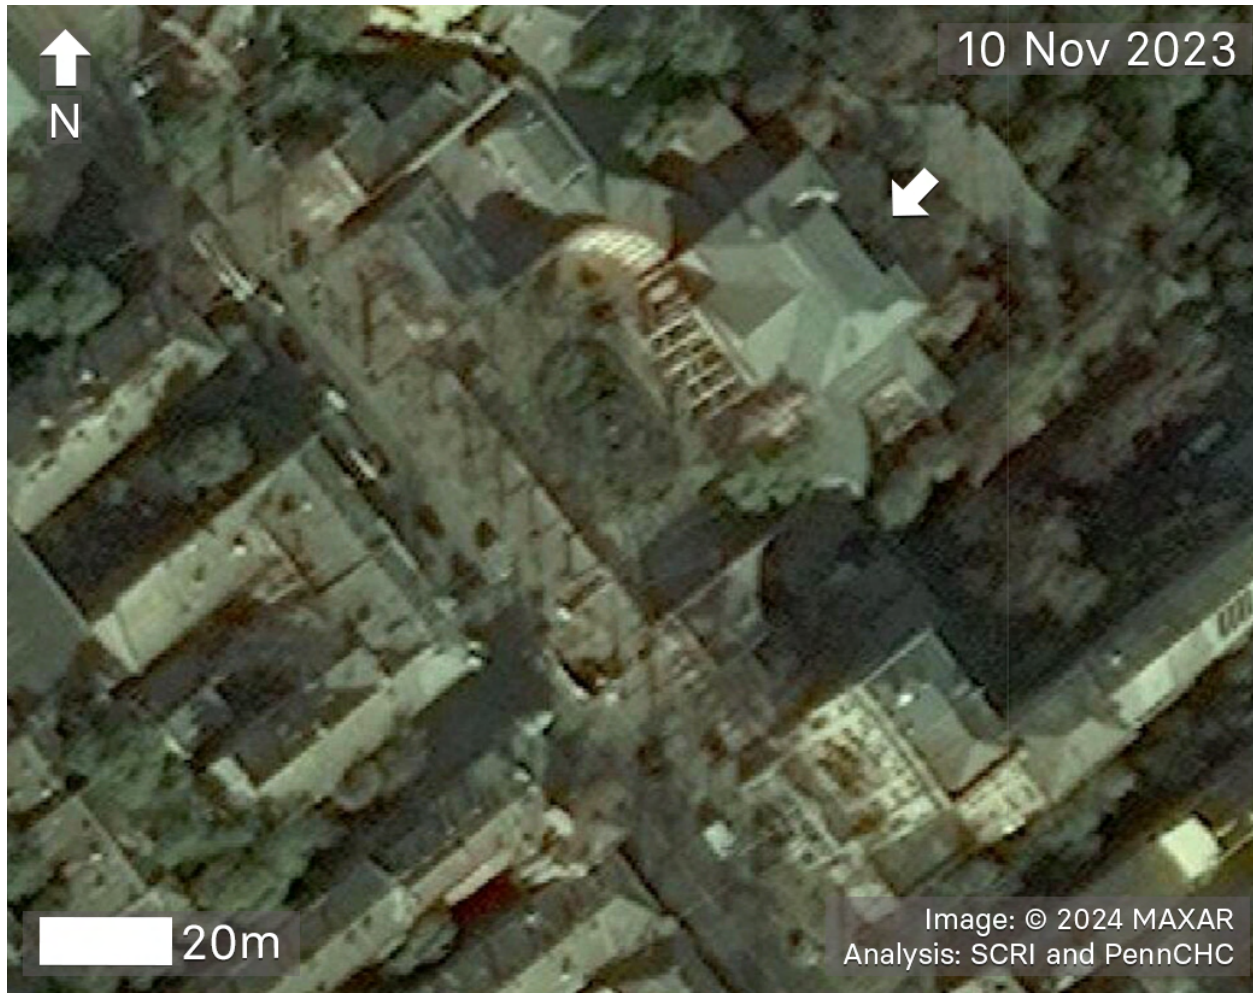
Image 5.

Analysis of commercially available satellite imagery (MAXAR and Airbus) enables researchers to identify the timing and extent of damage to a site and its surroundings. However, the scale of the damage done to the Odesa Art Museum and the limits of commercially available satellite imagery make it difficult to discern specific areas of damage to the building from satellite imagery alone. In imagery dated 1 October 2023 and 5 November 2023 [**Images 1 and 2**], the Odesa Art Museum shows no visible damage. In imagery dated 9 November 2023 and 10 November 2023 [**Images 3 and 4**, respectively] impact craters and debris are visible on the road and grounds directly in front of the museum, but direct damage to the museum building is not discernable. Imagery dated 10 November 2023 shows the same damage [**Image 5**].

Satellite image of the Odesa Art Museum (dated 10 November 2023). Debris and impact craters are visible in the road and grounds in front of the museum. Scale: 20m. Arrow points to the museum building. Source: © 2024 MAXAR.

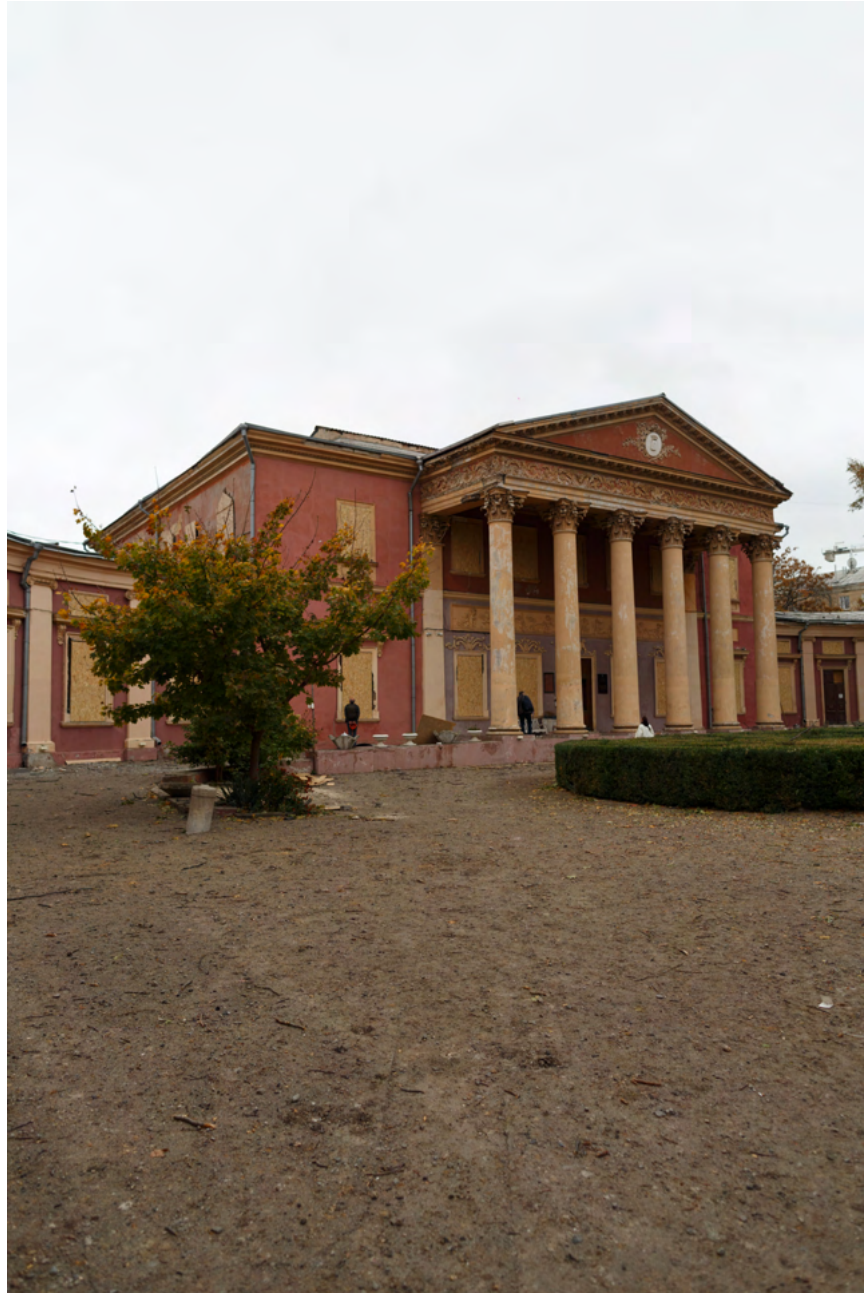
Image 6.

Ground photography taken by HeMo identified damage to the Odesa Art Museum. **Images 6, 7, and 8** document damage to the museum's external windows as well as missile debris and an impact crater on the museum grounds. **Images 9, 10, and 11** illustrate additional damage to the internal walls, ceiling, and skylights of the museum. Together, these photographs suggest that a nearby rocket impact caused internal damage to the museum building.

Image of the facade of the Odesa Art Museum (taken 8 November 2023). The broken windows are covered with plywood. Source: Matvii Pohranychnyi, Ukrainian Heritage Monitoring Lab.

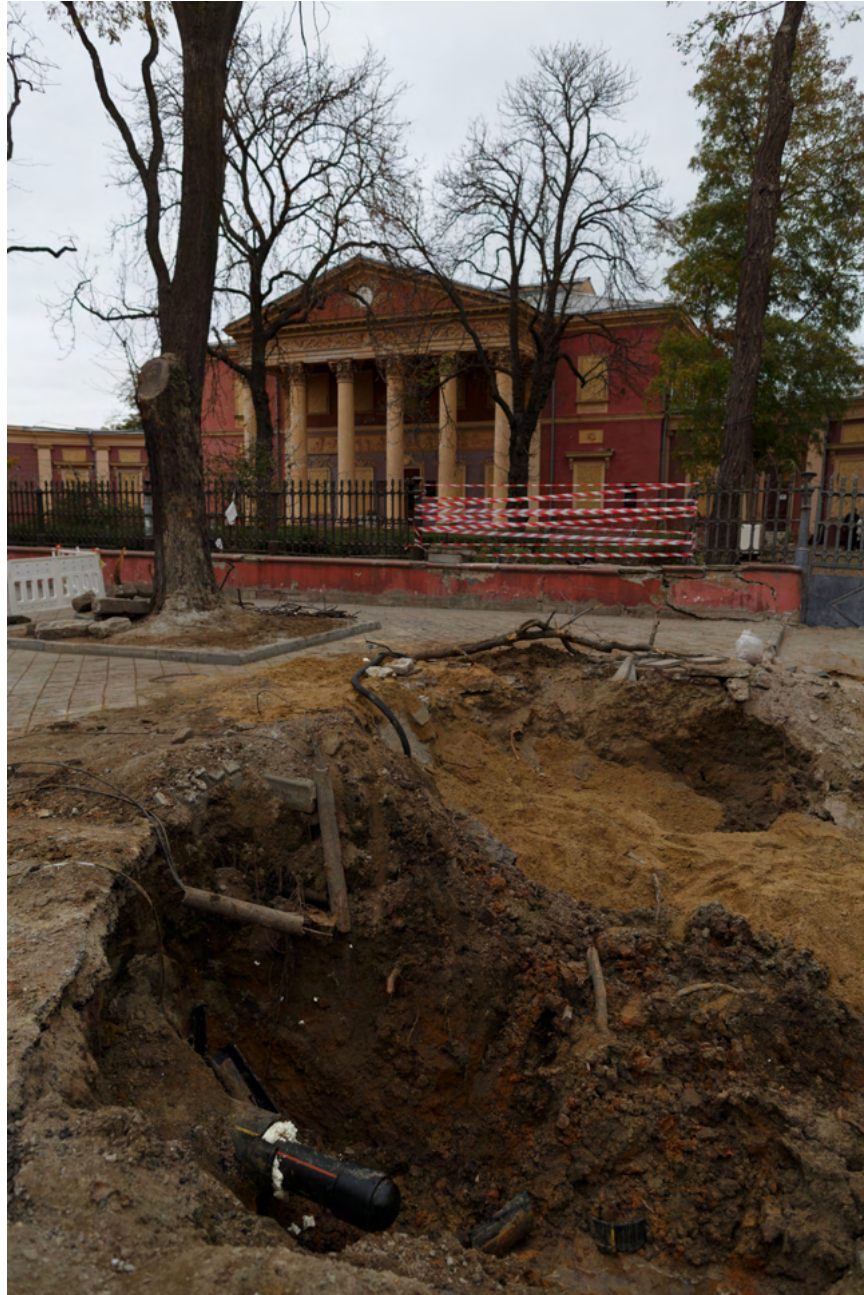
Image 7.

Image of the facade of the Odesa Art Museum (taken 11 August 2023). An impact crater is visible in front of the museum. Source: Matvii Pohranychnyi, Ukrainian Heritage Monitoring Lab.

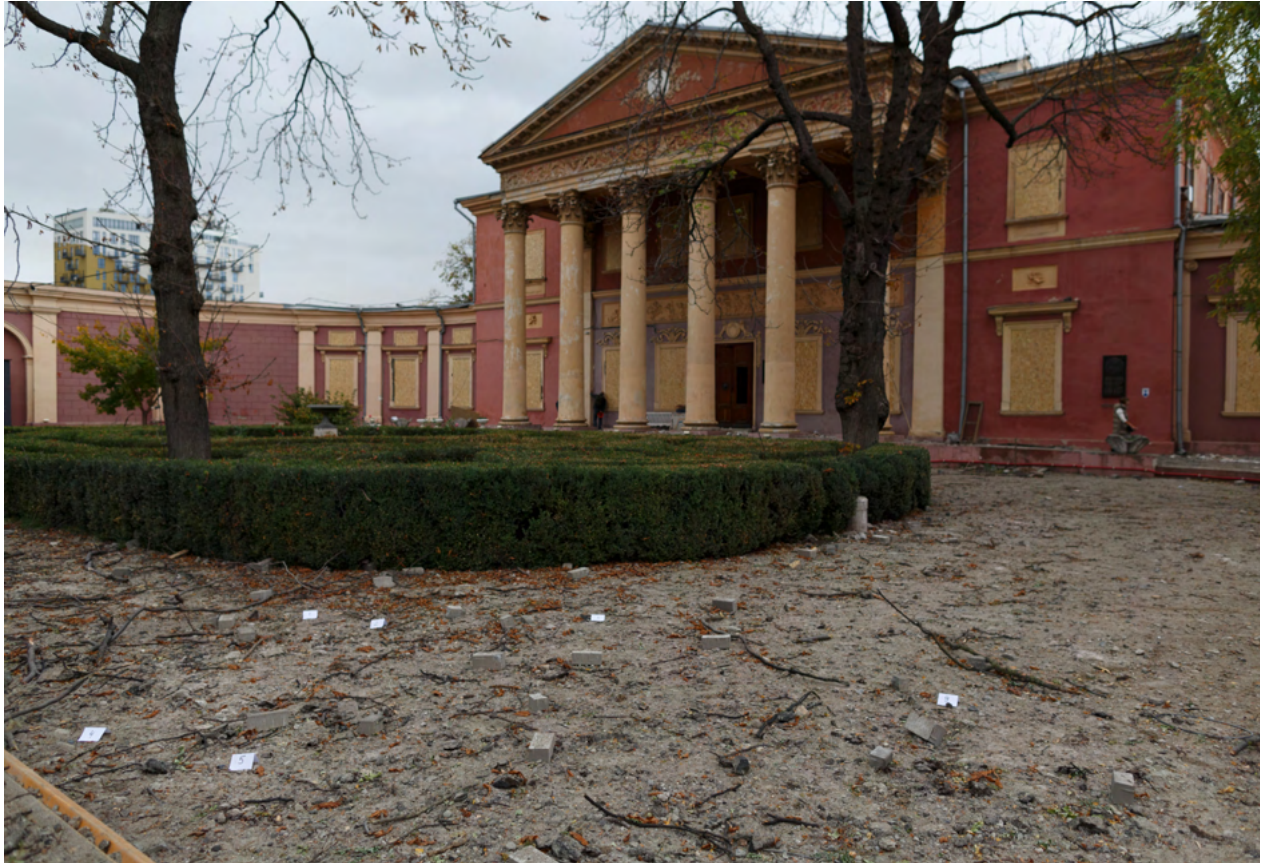
Image 8.

Image of the facade of the Odesa Art Museum (taken 8 November 2023). White square evidence markers on the ground indicate rocket debris found by the documentation team.
Source: Matvii Pohranychnyi, Ukrainian Heritage Monitoring Lab.

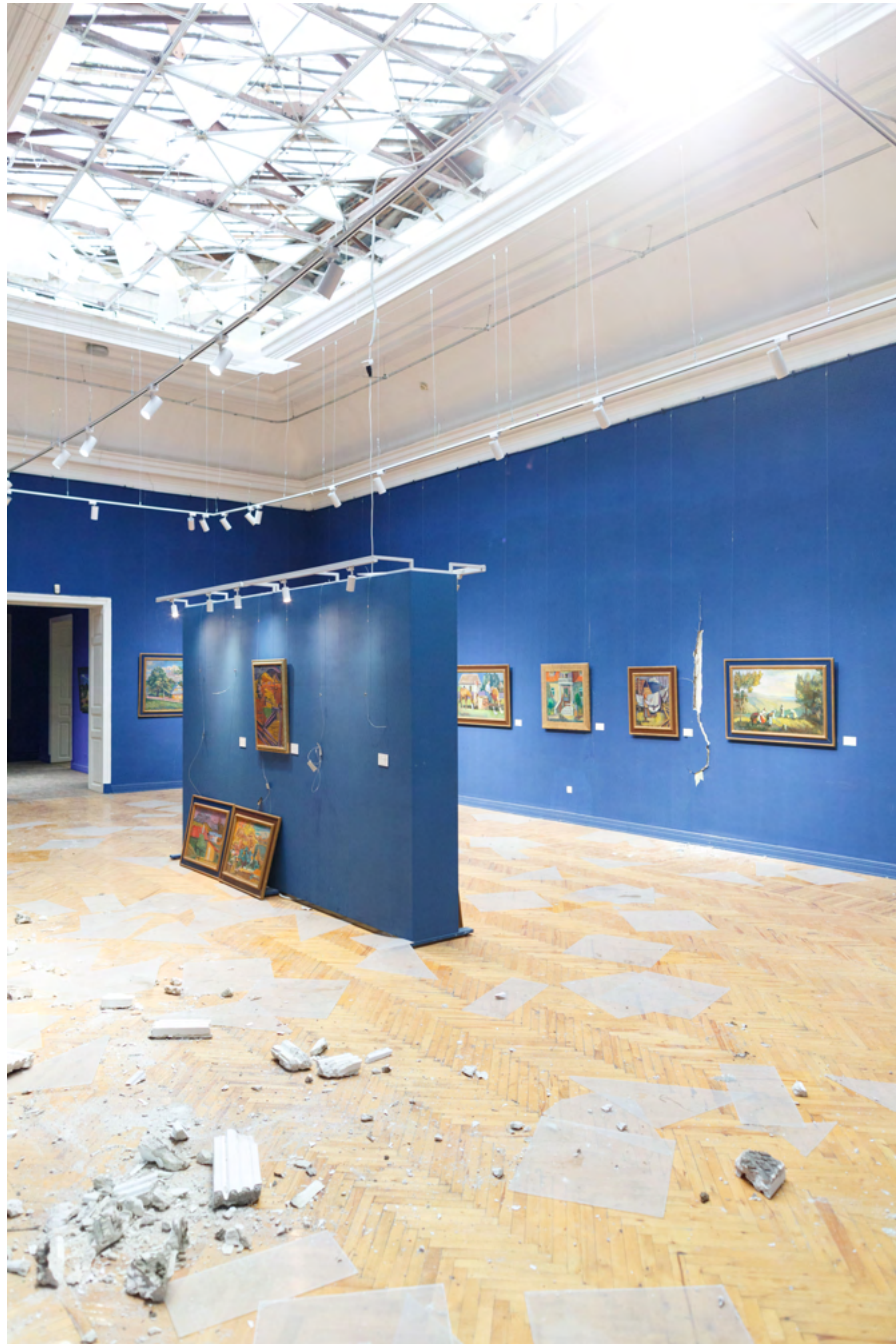
Image 9.

Image of an exhibition hall in the Odesa Art Museum (taken 8 November 2023). Damage to a skylight, the ceiling, and walls is visible. Source: Matvii Pohranychnyi, Ukrainian Heritage Monitoring Lab.

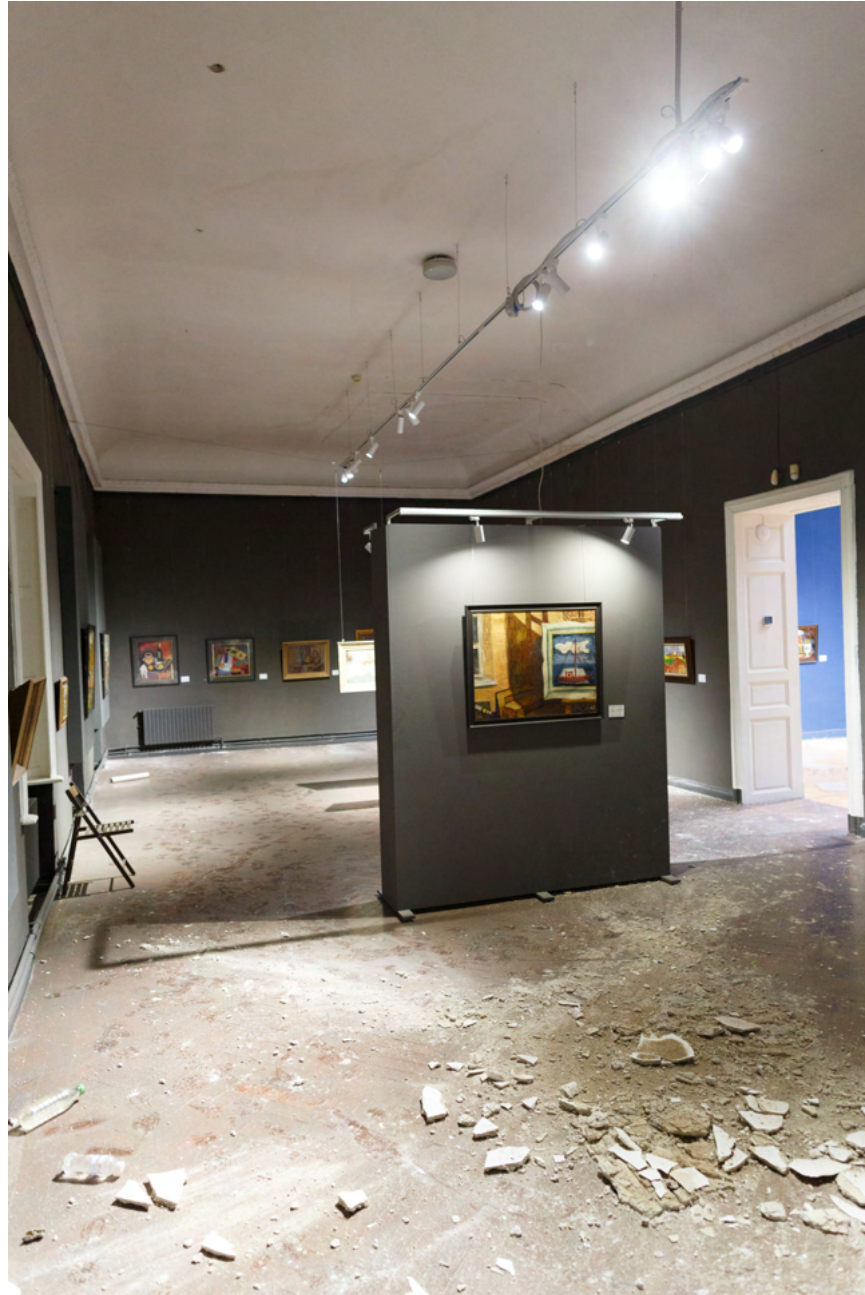
Image 10.

Image of an exhibition hall in the Odesa Art Museum (taken 8 November 2023). Plaster in the ceiling collapsed due to the blast wave. Source: Matvii Pohranychnyi, Ukrainian Heritage Monitoring Lab.

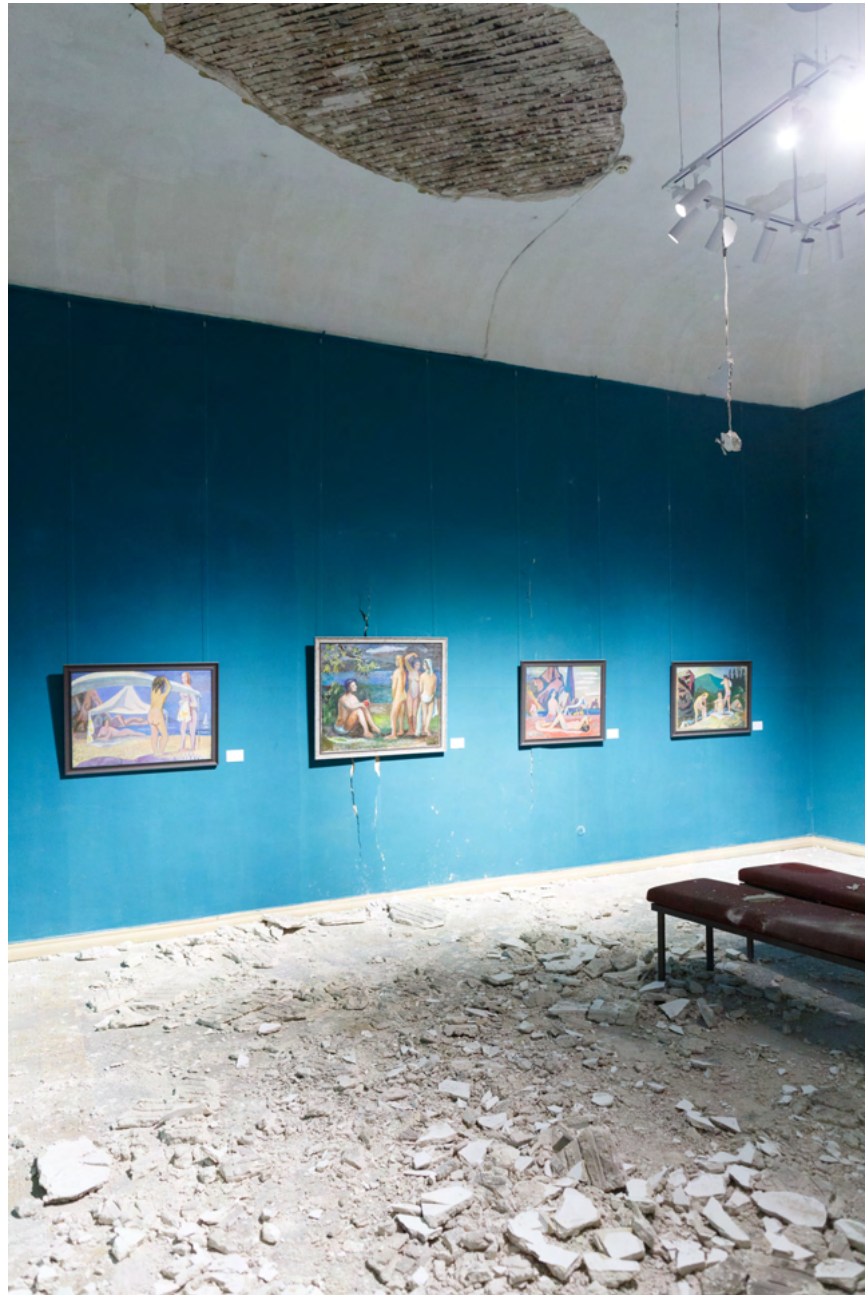
Image 11.

Image of an exhibition hall in the Odesa Art Museum (taken 8 November 2023). Plaster in the ceiling collapsed due to the blast wave. Cracks are visible on the wall. Source: Matvii Pohranychnyi, Ukrainian Heritage Monitoring Lab.
