Re: Tahuehueto Project – Initial Site Visit and Preliminary Site Assessment

SOHO RESOURCES CORP.

TAHUEHUETO PROJECT

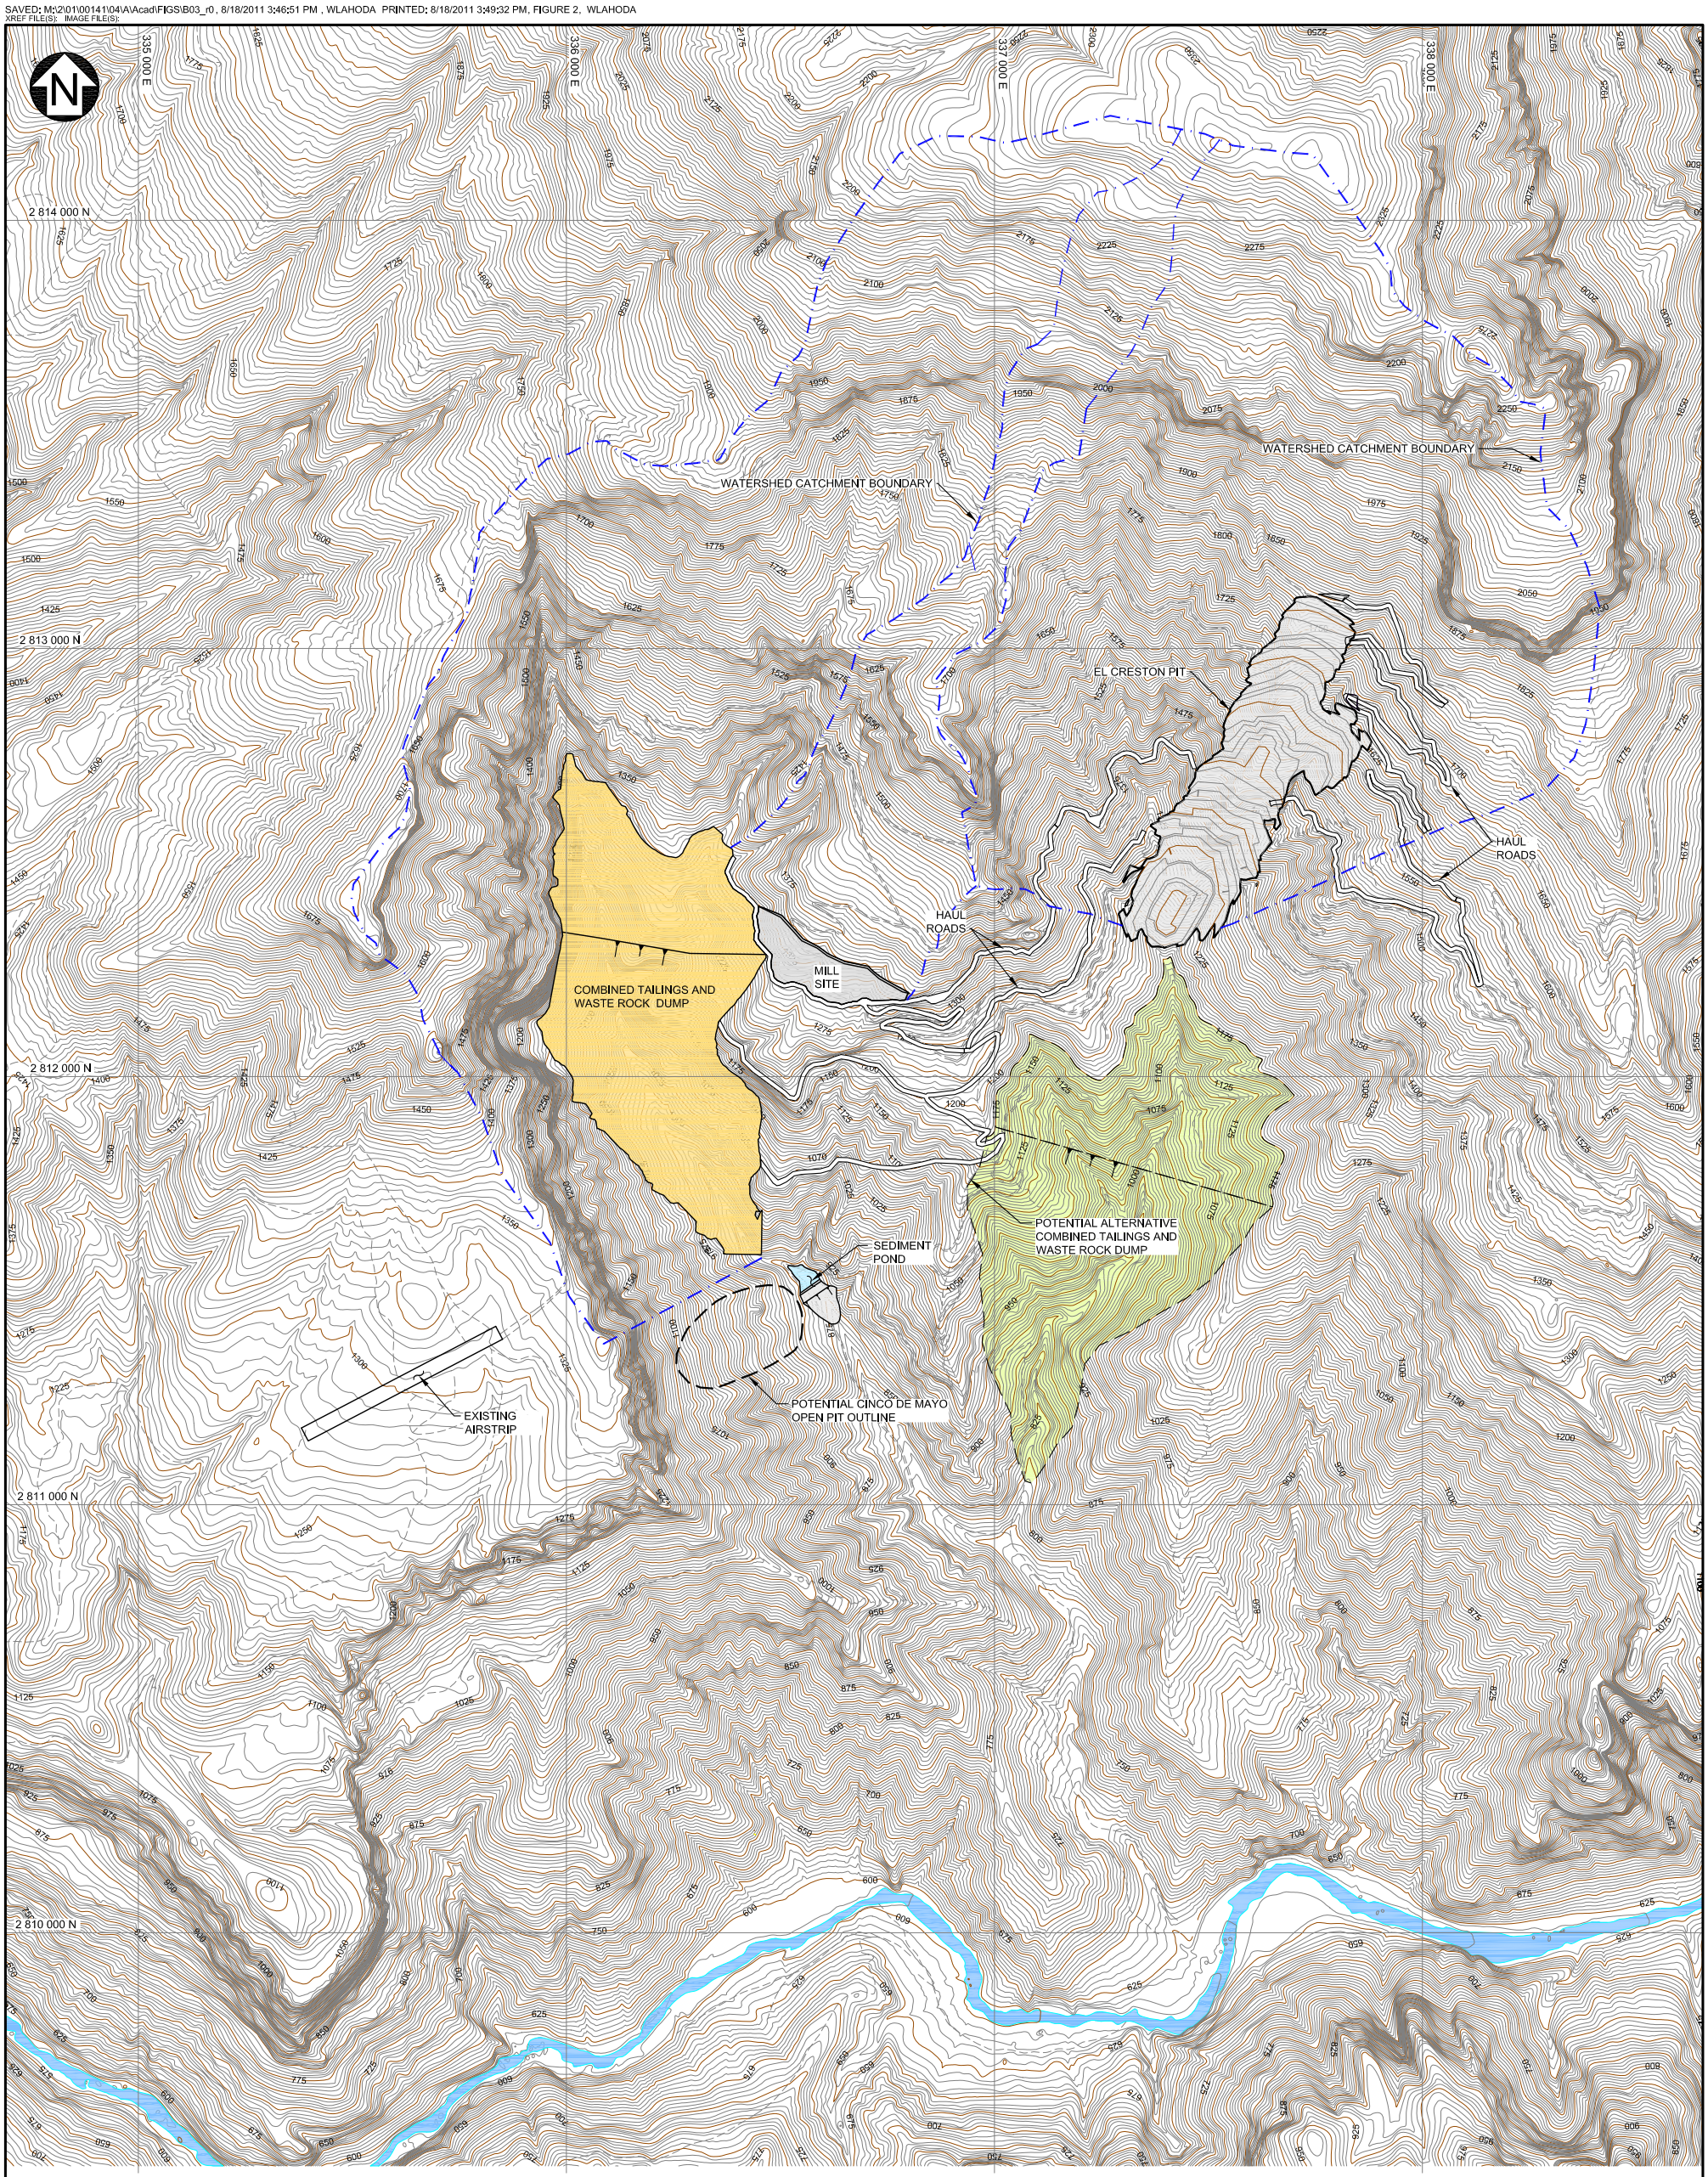
FIGURE 2 REV 0

A combined tailings and waste rock dump has been developed that integrates the waste rock management and the tailings management as shown on Figures 2 and 3. The co-disposal facility has been sized to store of 35 M tonnes (20 Mm^3). This is in excess of the calculated total volume required and the additional volume provides expansion capacity. The combined tailings and WRD facility has final outer slopes of 26 degrees (2H:1V) to ensure stability during seismic events and to assist with reclamation of the dump surface at mine closure. A sediment control pond has been located downstream of the tailings/WRD facility to manage sediment and water quality.

- The development or partial development of the Cinco de Mayo deposit by open pit methods as shown on Figure 2. Preliminary pit slope angles are described in Section 3.0.

- The development of a combined tailings/waste rock dump in the valley immediately below the El Creston pit. A preliminary storage capacity evaluation and layout has been completed as shown on Figure 2. This preliminary analysis shows sufficient capacity exists in the valley to store the combined waste rock and tailings, potential benefits of relocation are a reduced haul distance for waste, a reduced watershed catchment area to be managed, and the containment of major surface disturbances to within one valley.

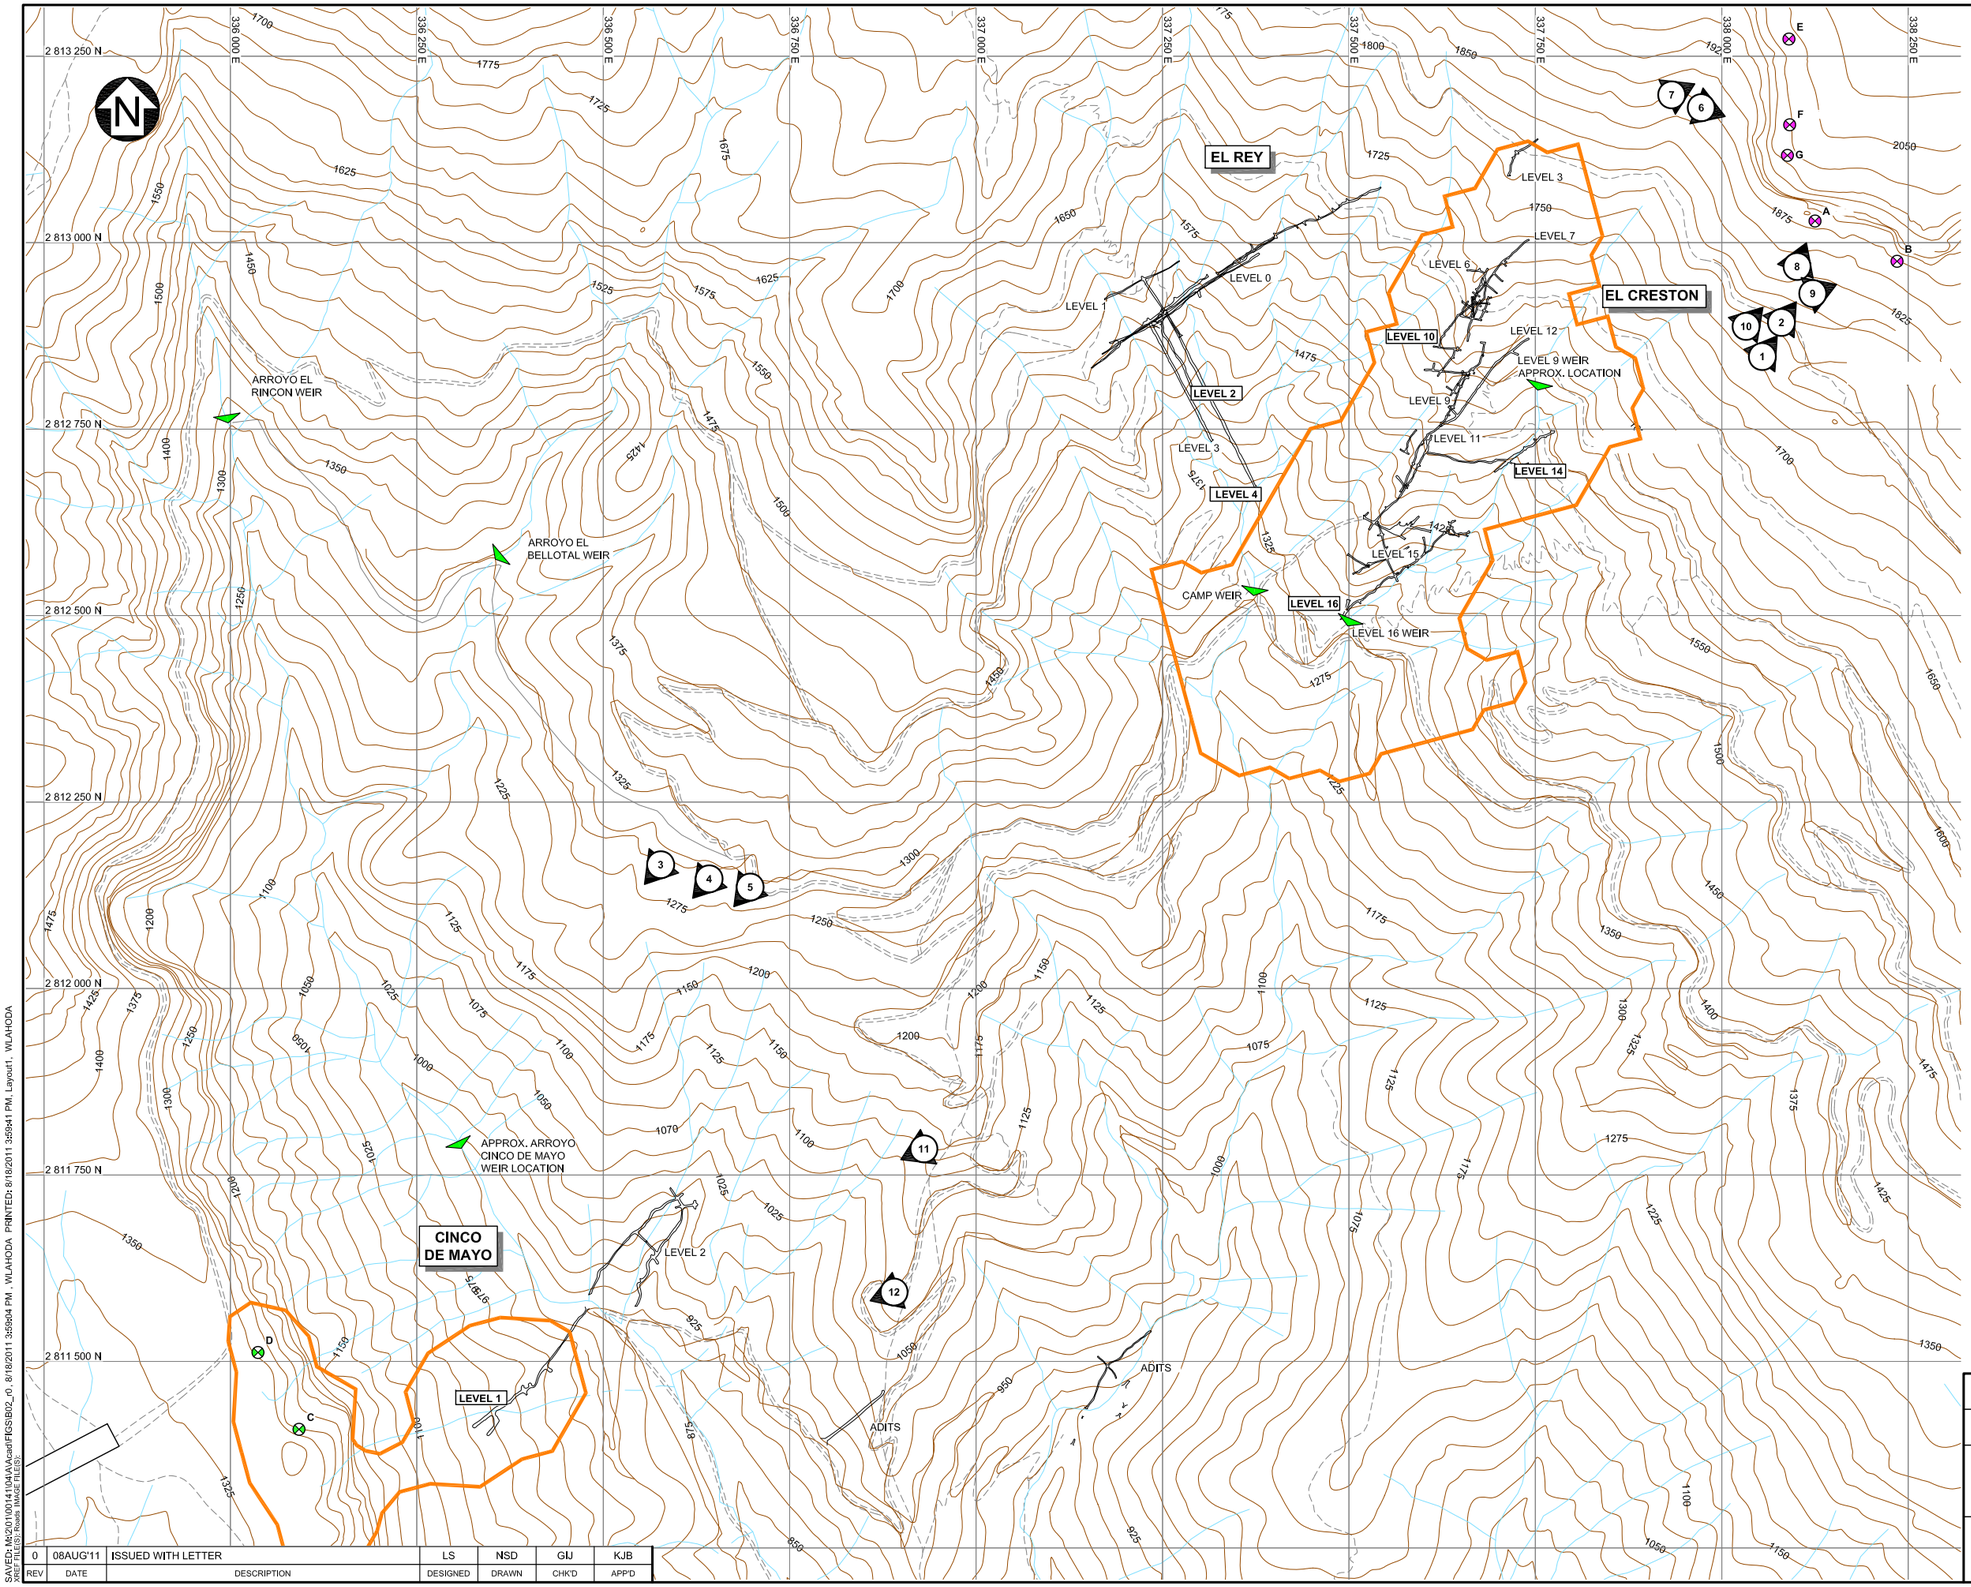
FIGURE 4 REV 0

UNDERGROUND MAPPING LOCATIONS

- A minor modification to the existing Arroyo Cinco de Mayo weir to ensure flow does not escape at the abutments (see Figure 4).
- Change the weir exit from the current rectangular notch to a V-notch. It would also be beneficial to put a small metal edge on the downstream face of the weir. This can be accomplished by bolting a thin strip of metal to the concrete. For V-notch weirs, a carpenter's square can be used, the thin edge helps to control the water passing through the weir so that the flow can be more accurately calculated.

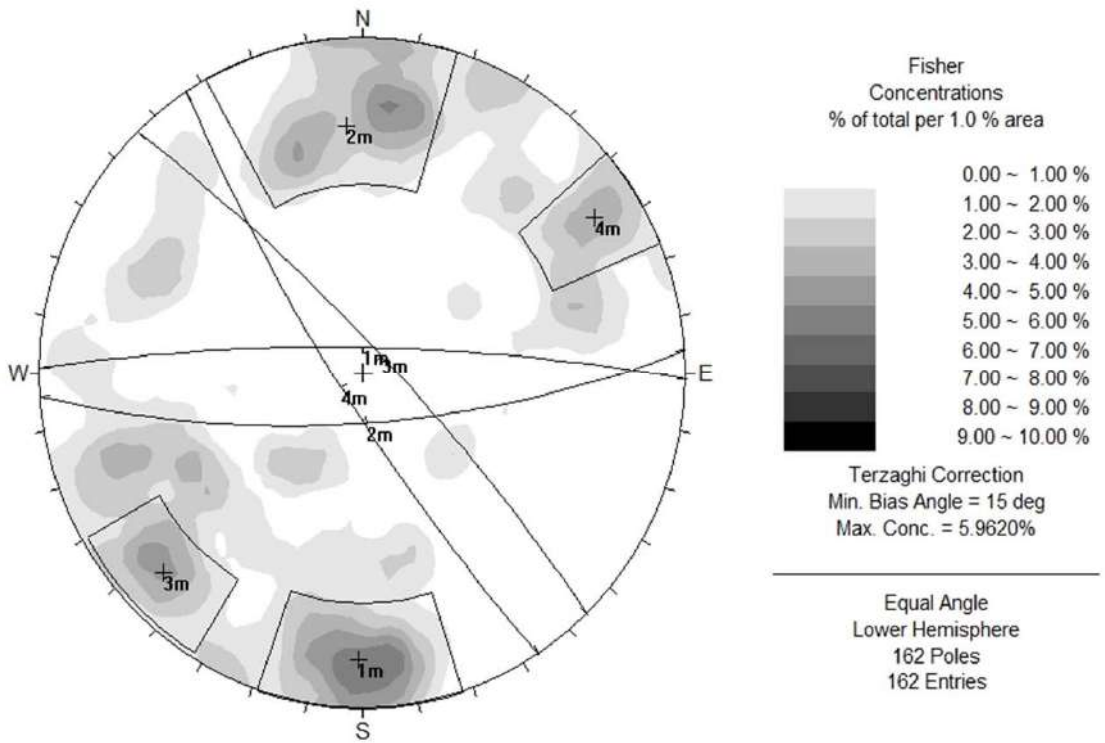
FIGURE 6

The majority of the joints and fault were found to be steeply dipping, planar with gentle undulations. Some small wedge failures were noted in the ceiling and walls of the underground workings. Only limited structural orientation data was collected during the site visit. Figures 6 to 8 present the stereographic plots of measured structural features at the El Creston, El Rey and Cinco de Mayo underground workings, respectively. The measured rock mass structural orientations are generally consistent with the northeast or northwest striking faulting and veining features, particularly at the Cinco de Mayo and El Rey deposits. However, mapping data at El Creston shows several predominant steeply dipping joint sets that strike perpendicular to the regional faulting and veining structures (see Figure 6).

KP has reviewed the proposed pit design, the site topography and the recently collected structural mapping data. The exiting topography in the proposed El Creston pit includes natural ground slopes of 30 to 35 degrees over more than 1,000 m in elevation change. The ridges adjacent to the proposed pit include natural slopes of 45 degrees over 1,000 m of elevation change. Analysis of the structural mapping data identified a potential toppling failure mode for the north-northeast wall of the proposed El Creston pit, due to the presence of the northwest striking, sub-vertical structures (see Figure 6).

STEREOGRAPHIC ANALYSIS
EL CRESTON MAPPING DATA

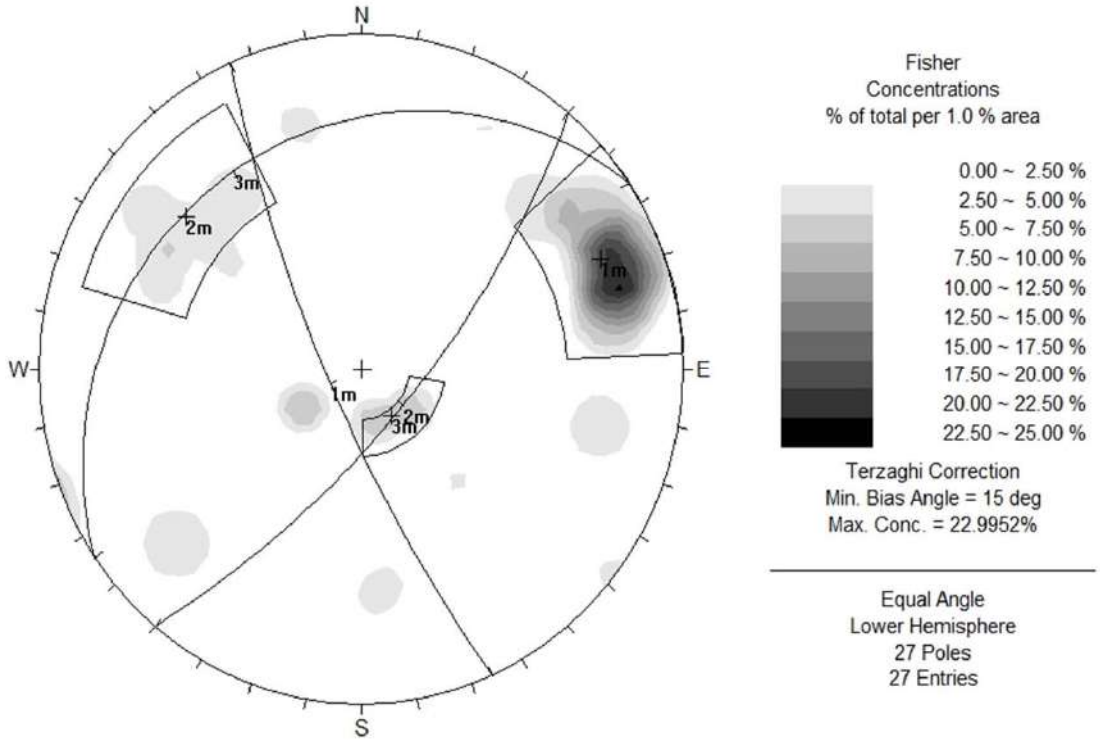
Location: El Rey - Level 2 and Level 4
Rock Type: Andesite

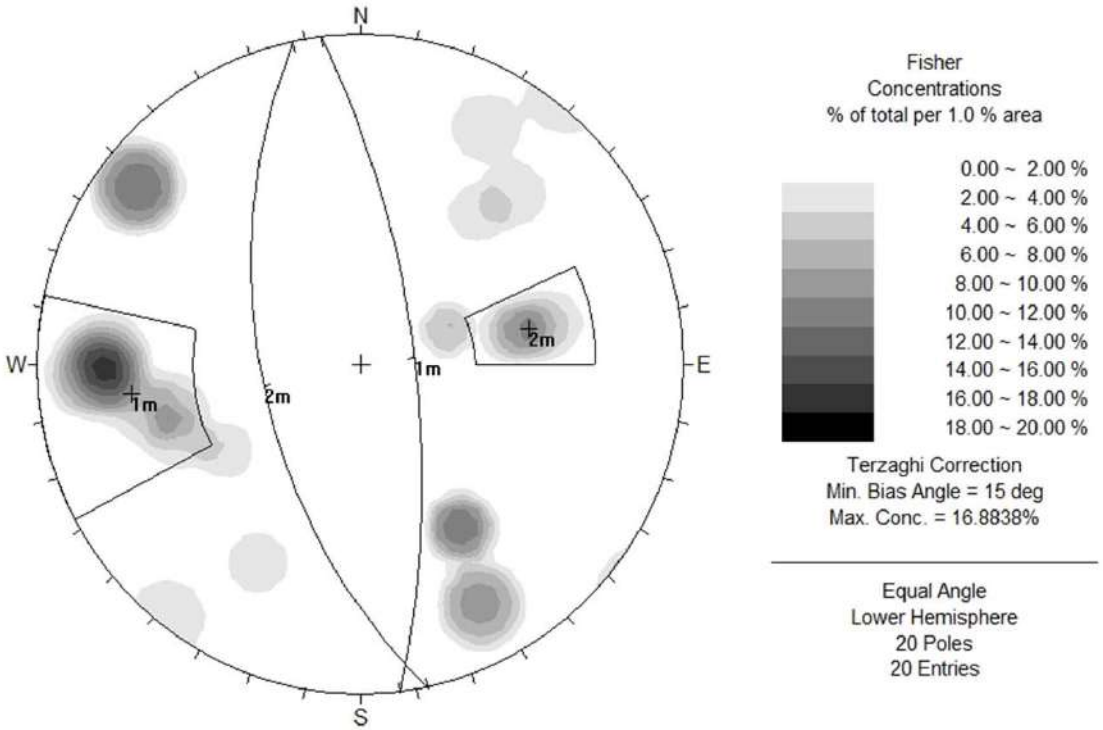
FIGURE 7

Location: Cinco de Mayo - Level 1
Rock Type: Andesite

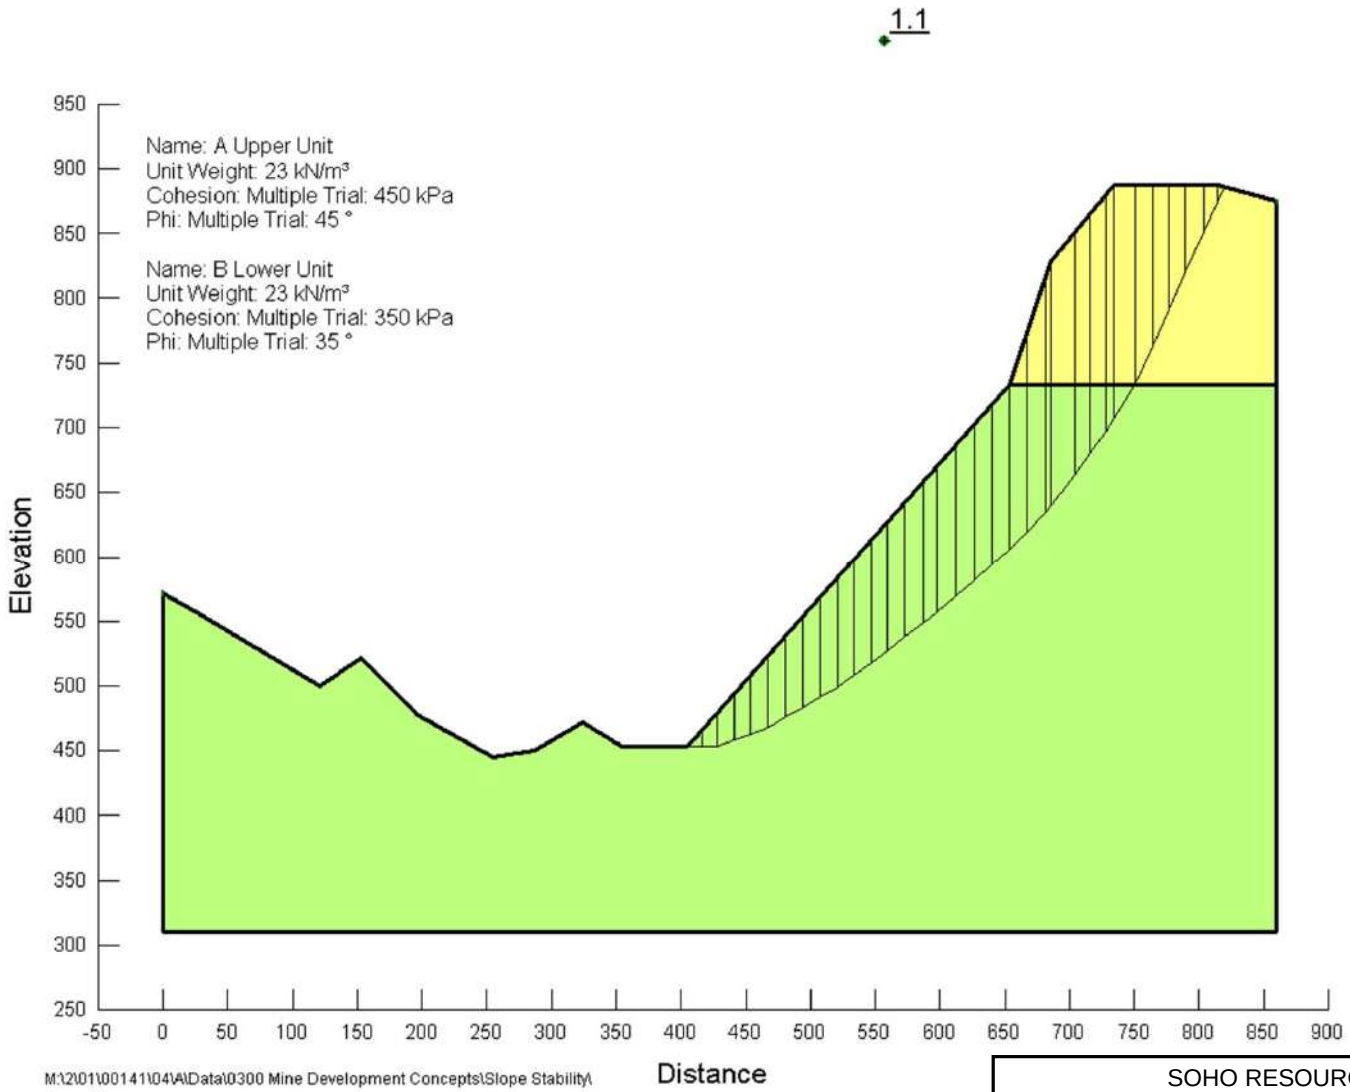
FIGURE 10 REV 0

KP has reviewed recent mapping data together with the topography of the Cinco de Mayo deposit. It is anticipated that the potential Cinco de Mayo open pit will include a major highwall along the west side of the deposit. The existing natural ground slopes at around 40 degrees over an approximate height of 450 m. The measured structural features in this area are generally north striking and steeply dipping, which appear to be favorable for the west pit high wall excavation (see Figure 8). A preliminary rock mass slope stability model for the potential Cinco de Mayo open pit was developed to evaluate the global stability of the potential west pit wall. The rock mass strength parameters were based on the findings of the site observations and a back analysis of the existing slopes. The Cinco de Mayo open pit stability model incorporates a proposed offset from the crest of the pit to the base of the cliffs of 75 m. The material strength parameters and modeling results are presented in Figures 9 and 10. This preliminary analysis suggests it is reasonable to develop the West Wall of the open pit with an overall slope of 45 degrees. This recommended overall slope angle is comparable to published open pit mining precedent as shown on Figure 11.

CINCO DE MAYO
ROCK MASS STABILITY ANALYSES
OPEN PIT WEST WALL

The development of an open pit in the Cinco de Mayo area will require the exposed cliff face above the proposed pit be scaled to remove loose rock, and rock bolting of large features plus the development of rock fall catchment areas at the crest of the pit may be necessary to ensure worker safety.

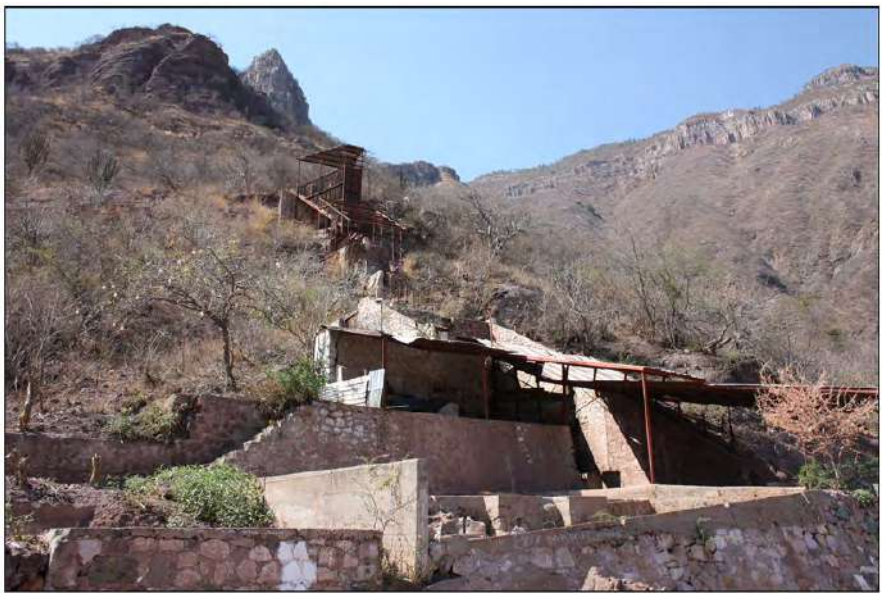
PHOTO 1 – Historic mill/plant site

PHOTO 2 – Conglomerate overburden at the historic mill/plant site.

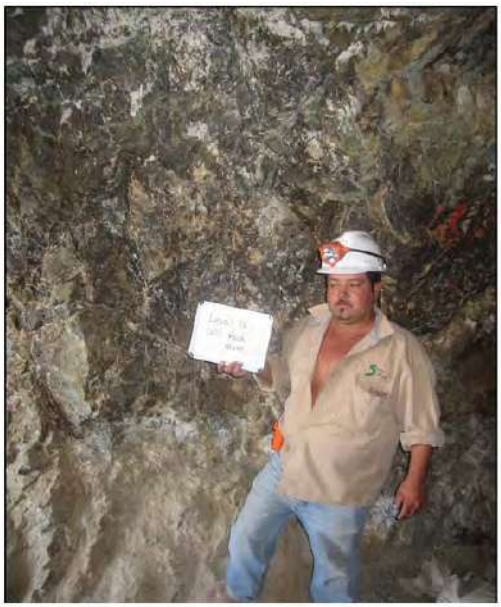
PHOTO 3 – El Creston Historic Underground Workings Level 16 (Entrance)

PHOTO 4 – El Creston Historic Underground Workings Level 14 (Historic explosives magazine)

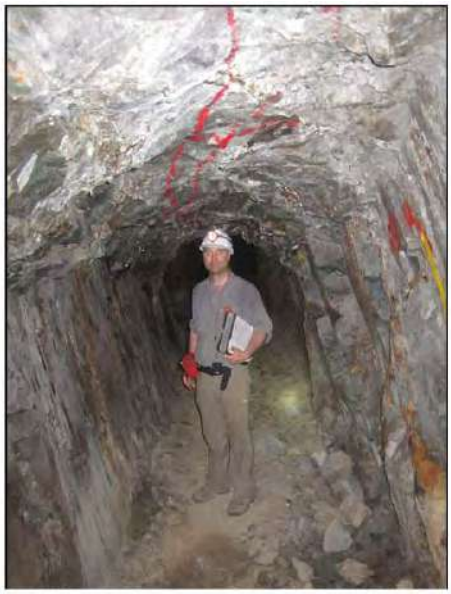
PHOTO 5 – El Creston Historic Underground Workings Level 10 Drift (drift following the fault breccia)

PHOTO 6 – El Creston Historic Underground Workings Level 10 Cross Cut (cross cutting between fault breccia)

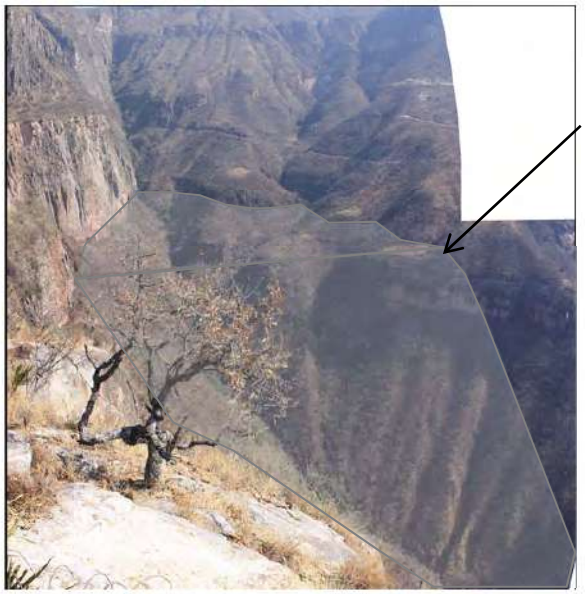
PHOTO 14 – Combined Filtered Tailings and Waste Rock Dump General Area
