Geotextiles and Geomembranes

Professional Practice Paper

Case history on failure of a 67 M tall reinforced soil slope

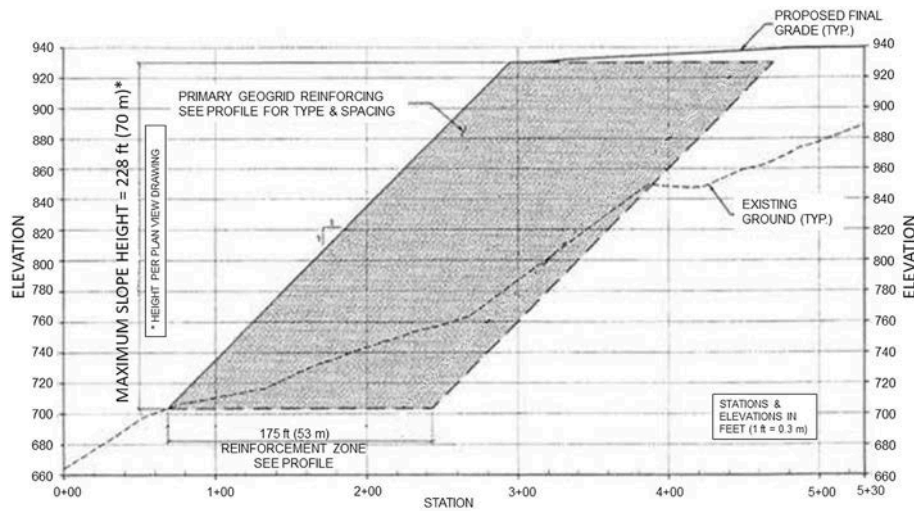
Fig. 3. Construction plan cross section, at maximum height (after Triad Engineering, 2005).

The design engineer’s analysis model for the maximum height section, as shown on the construction drawings, is shown in Fig. 3. Depth to rock was shallow and a little below the existing ground line shown and thus, either rock had to be removed to install the geogrid or the geogrids lengths would have to be shortened. However, neither option was noted. A front elevation view, as shown on the construction drawings, is presented in Fig. 4. The zones of where the three different grades of geogrids and the geogrid lengths are noted. The V-notch is the hinge point of this convex shaped (in plan view) RSS structure.

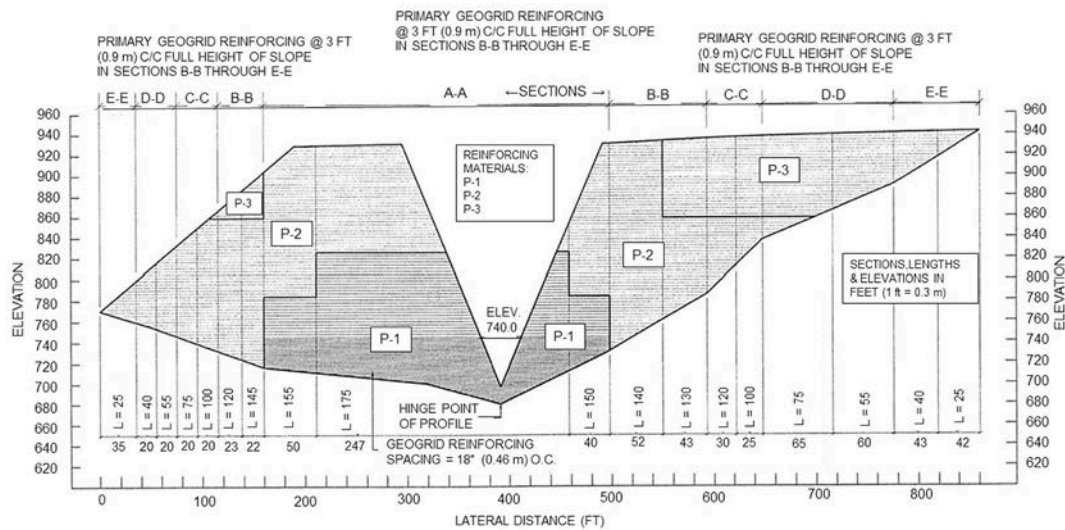
Fig. 4. Construction plan front elevation view of RSS (after Triad Engineering, 2005).

The bottom of the reinforced fill started at elevation 216.4 m (710 ft), which is 3 m above the planned elevation. This revision was at the contractor's request and due to constructability issues of placing fill and geogrids in the V-notch (see Fig. 4) detailed at the RSS toe. This lower 3 m was constructed with a rock fill to create a working platform, wide enough to start installation of reinforced fill and geogrids.

| Contributor | Discussion |
|--|--|
| Constructability | Reinforcement placement "V" shape at the base of the RSS at the maximum height section as shown on the construction plans, see Fig. 4, was not practical or constructible. A minimum base width is needed to operate equipment, and to install fill and soil reinforcement. The lower 3 m of the RSS structure was constructed as an unreinforced rock fill, to create a working bench to start fill and reinforcement placement. Fill, being hauled from the top down, required a haul road to be maintained. In some areas, this prevented installation of reinforcement to bedrock. |
