# REPORT

Datum / <i>Date</i>	Beteckning / <i>Reference</i>	Sida / <i>Page</i>
May 29, 2001	P005566	1 (7)

## Fire test of loadbearing columns

Givent system

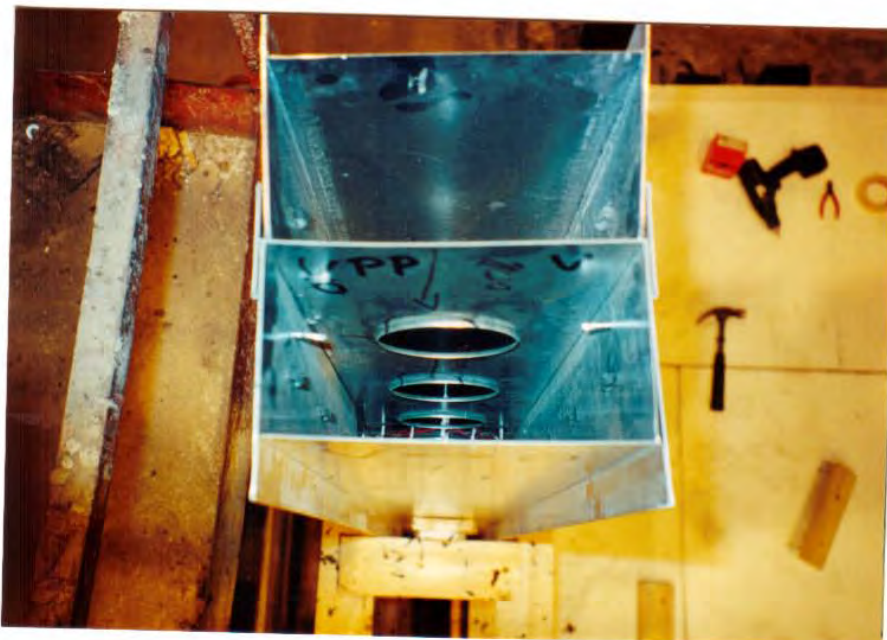
ENCLOSURE 24

Column type 1: The steel plate and the flange at the northern side has split open in the middle. The opening is around 70 mm wide and around 500 mm long. The concrete has spalled in a thin layer in certain spots at the northern and eastern side. Most of the spalling was located in connection to the opening in the steel plate.
