Inspection Report

Station: Any Station Unit: 0 Report Name: 1-Superheater Secondary Inlet

AREA: Superheater Secondary Inlet

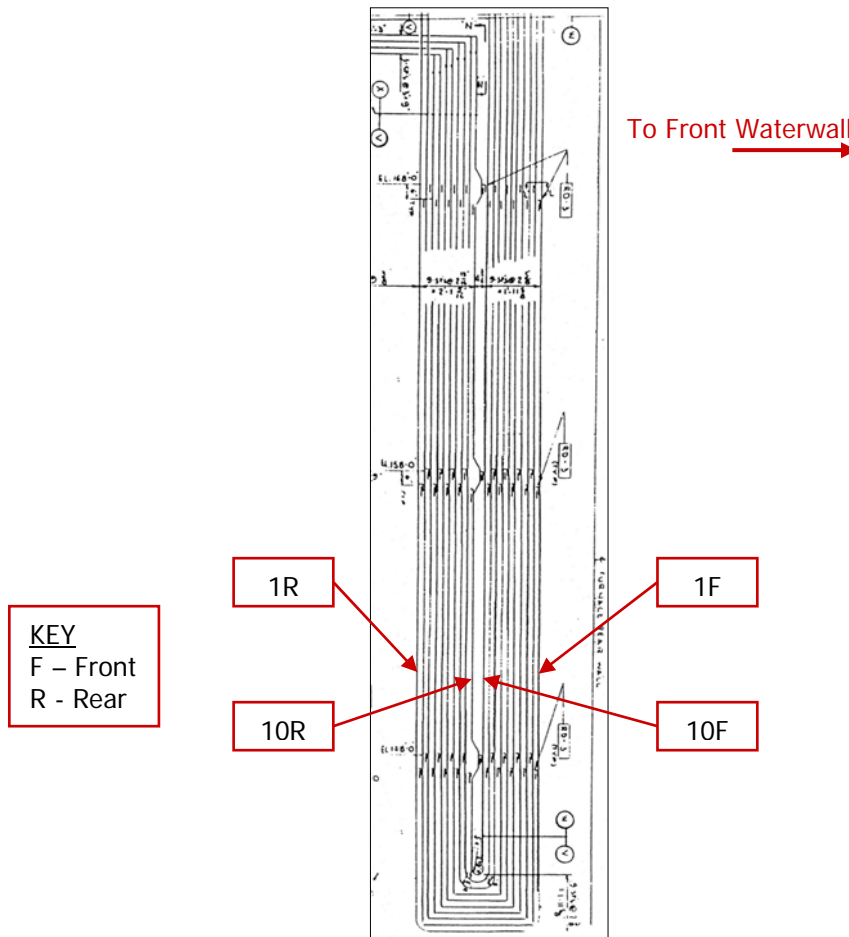
Tube Numbering Orientation

The area was numbered from boiler left side to boiler right side. Tubes were counted from front to rear or top to bottom unless otherwise specified.
