SUMMARY REPORT

Thursday, March 26, 2020

RE: 123 Abc St, Abcd, NJ 07XXX

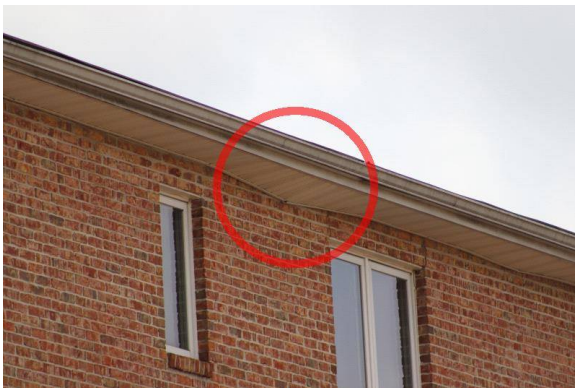
11. Loose soffit noted - Repair. Fascia should be checked for damage/rot/repairs.

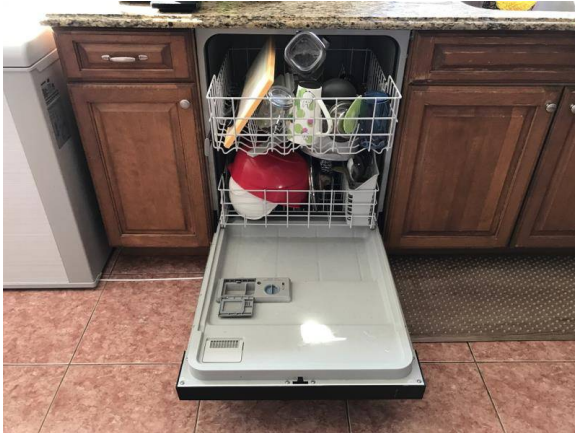
4. Dishwasher not evaluated at this time due to stored items. Test before closing.

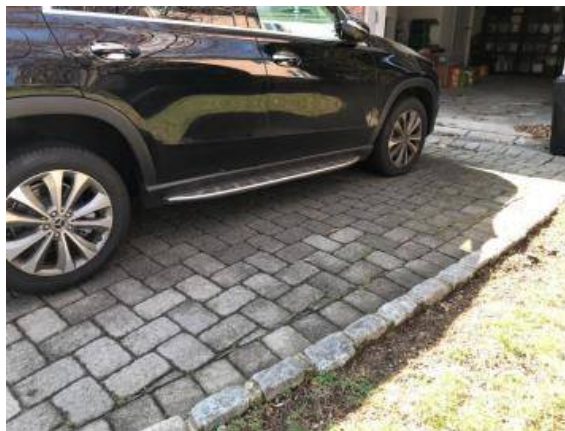
The driveway is in functional condition with only normal deterioration noted. Trench drain presented on the driveway. It prone to clogging by foliages. Recommend keep cleaning and regular maintenance.

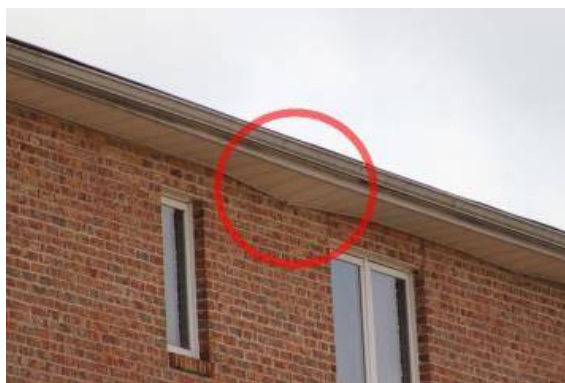
Loose soffit noted - Repair. Fascia should be checked for damage/rot/repairs.

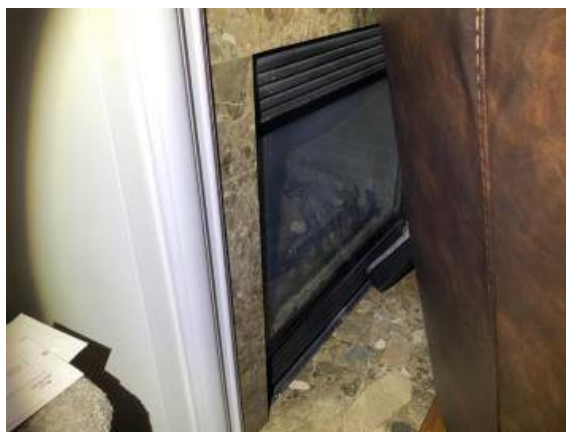
3. Location: Living Room, Gas fired burner and gas logs are not evaluated - They should be installed according to manufacturing specifications. Investigate further.

Location: Living Room, Gas fired burner and gas logs are not evaluated - They should be installed according to manufacturing specifications. Investigate further.

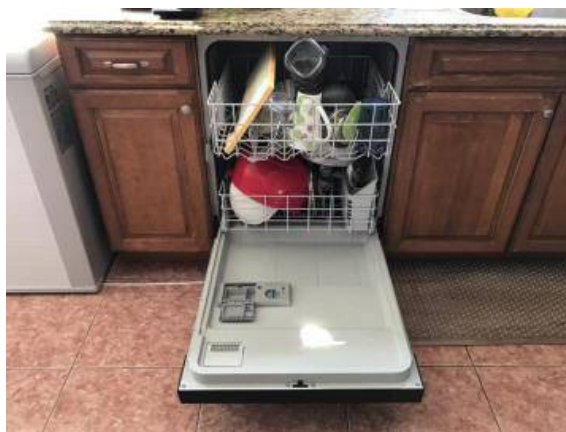
Dishwasher not evaluated at this time due to stored items. Test before closing.

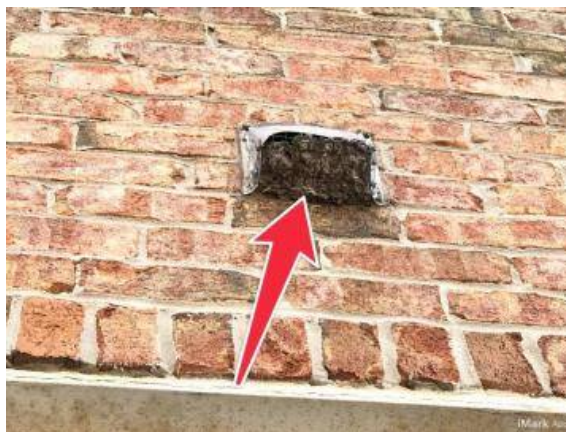
5. Based on the condition of the dryer hood at rear exterior wall, it is highly likely that the dryer vent is dirty and clogged with lint. Recommend cleaning at this time.

Based on the condition of the dryer hood at rear exterior wall, it is highly likely that the dryer vent is dirty and clogged with lint. Recommend cleaning at this time.

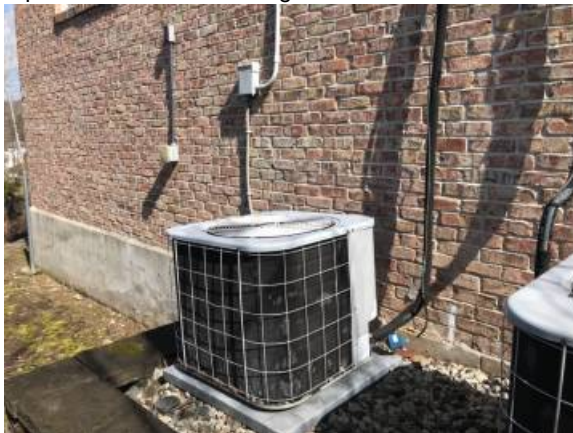
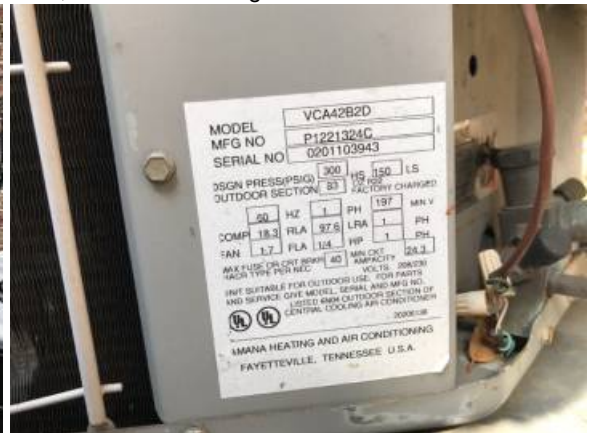
3. Electrical disconnect present. Insulation on the refrigeration line is worn/missing - Replacement is recommended. Mounting is satisfactory.

Central system - The average life of a condensing unit (compressor) is 17-20 years. The system is Amana brand. Approximate Compressor age is 18 years, manufactured in 2002. Capacity of the unit is approximately 3.5 ton. EPA stated that 1 ton(12000 BTU) of capacity covers approximately 400 to 500 square feet for old building and 800 to 1000 for well sealed, insulated building.

Electrical disconnect present. Insulation on the refrigeration line is worn/missing - Replacement is recommended. Mounting is satisfactory.
