SUMMARY REPORT

Tuesday, June 16, 2020

RE: 123 Abc St, Abcd, NJ 07000

Confidential Property Condition Report

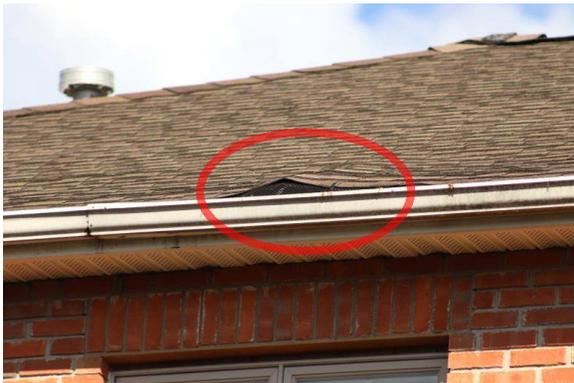
3. **Heavy buckling noted on the roof.** A licensed roofing contractor should be called to make further evaluation and repairs/replacement as needed.

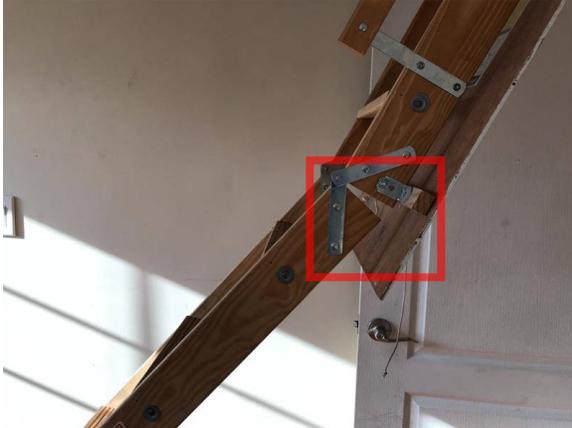
6. There is a pull down ladder installed. Ladder to the attic is weak and presents a safety hazard. Make improvements as needed.

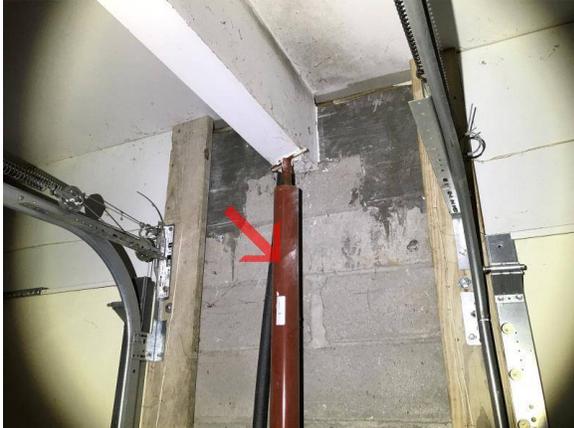
14. Temporary steel J-post being used permanent post - Evaluate by a qualified structural contractor recommended.

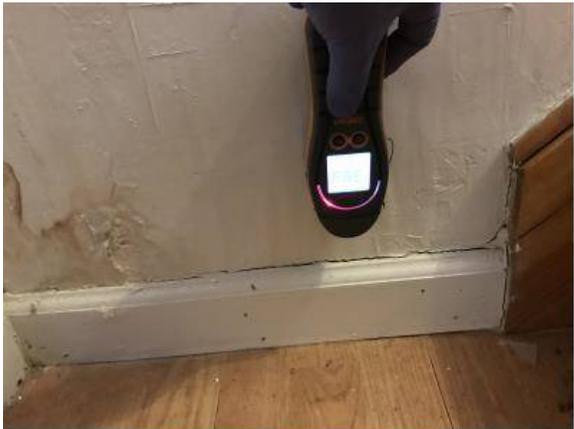
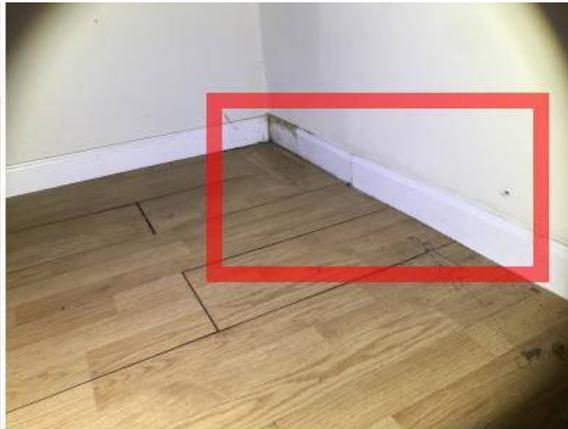
15. (1) Moisture meter readings were taken at the drywalls that indicated high moisture inside the drywalls at the time of the inspection. It appears that moisture issue on the right walls are related with site drainage(Refer to Site Drainage section) - Remove damaged walls and evaluate further.

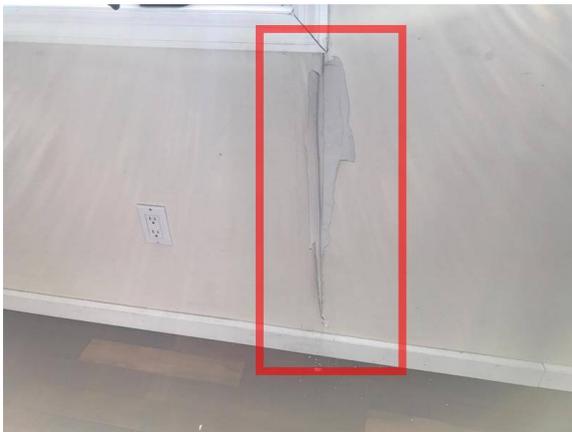
1. **Water stains and water damaged drywall noted** but does not appear current. Recommend to have the stain painted so that future incident would be easily identified. It appears that the water stain was made by rain water intrusion or water penetration from above roof (Refer to ceiling section)

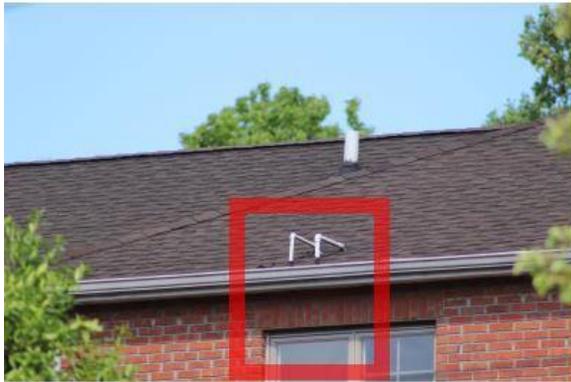
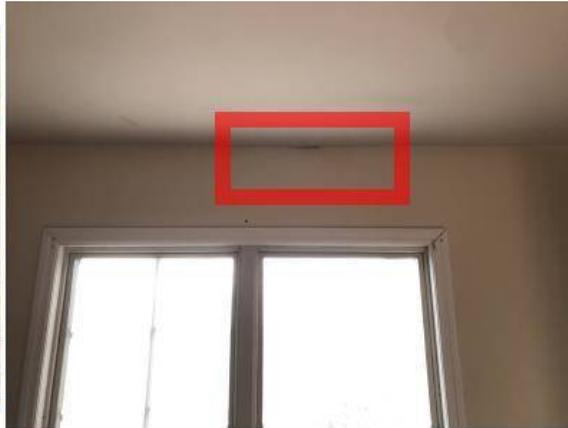
2. **Water stains noted** under condensate drain lines of the air handler in the attic. but does not appear current. Recommend to have the stain painted so that future incident would be easily identified.

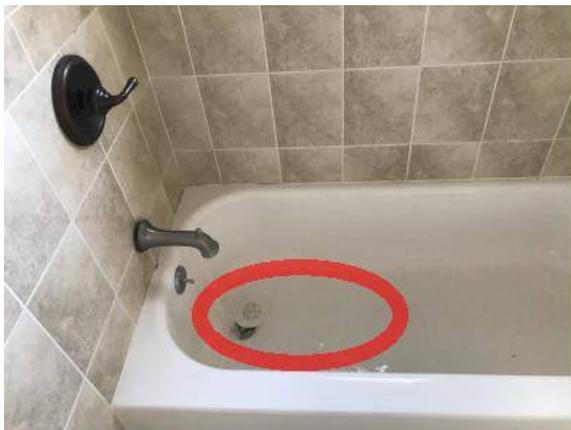
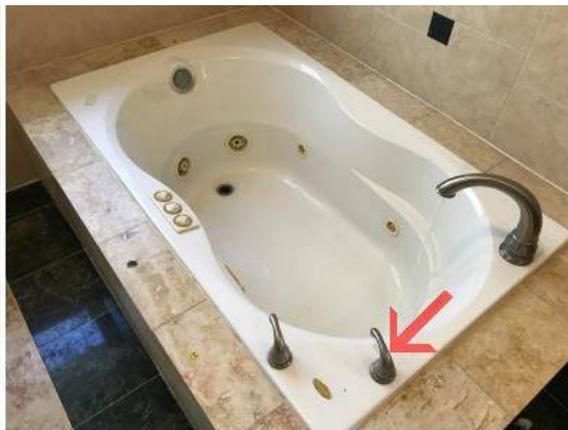
4. Whirlpool tub presented but not be evaluated during this inspection. Have a qualified service contractor test before closing. Water leak noted at faucet handles/body in the master bathroom and the basement bathroom - Replace washers or gaskets. Some type of faucet may require to replace entire faucet. Drainage is slower than normal preventing functional drainage in the first floor bathroom and 2nd bedroom bathroom. This should be evaluated by a licensed plumber.

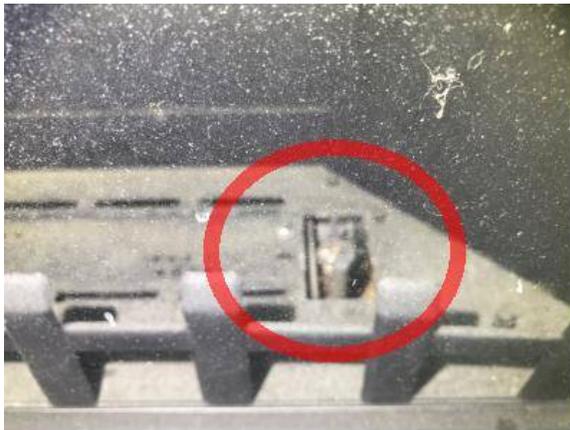
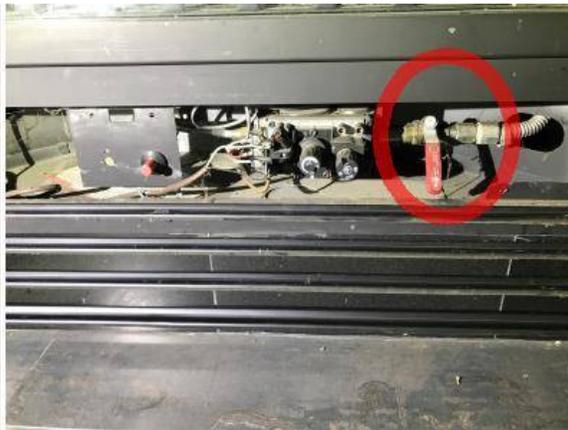
9. Location: Living Room, Gas fired burner and gas logs are not evaluated - They should be installed according to manufacturing specifications. Investigate further. Die to pilot light off. Test prior to closing.

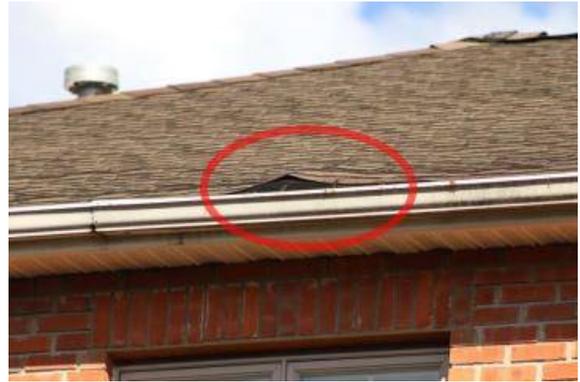
Heavy buckling noted on the roof. A licensed roofing contractor should be called to make further evaluation and repairs/replacement as needed.

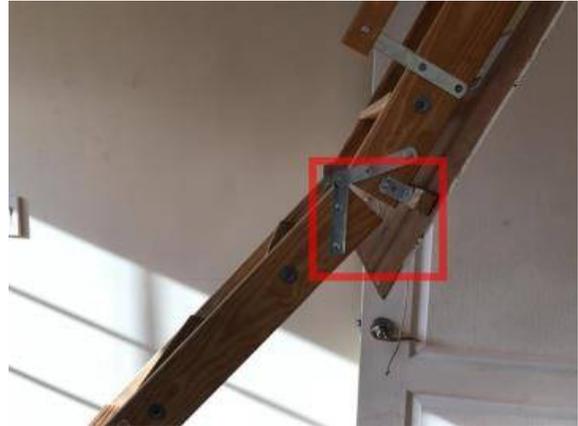
There is a pull down ladder installed. Ladder to the attic is weak and presents a safety hazard. Make improvements as needed.

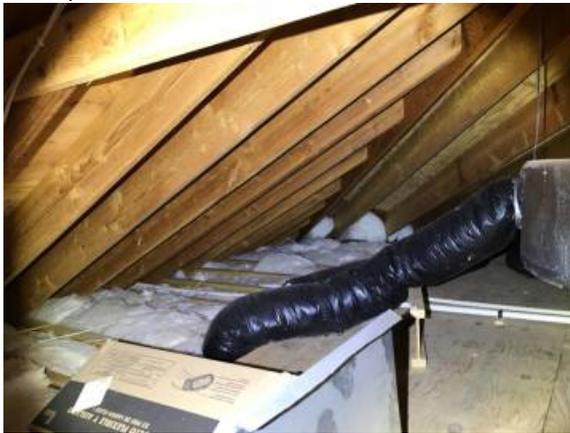
There is at least one bathroom, kitchen ventilation fan which discharging moisture laden air to the attic. It is preferable to direct all vent openings to the outside so that additional moisture is not introduced into the attic space and insulation.

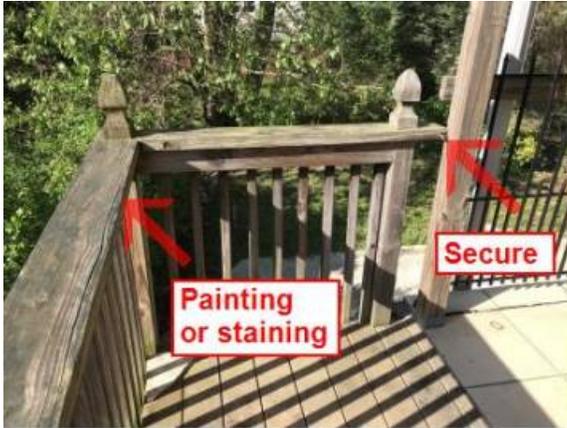
CONDITION:
Railing: **Loose railing viewed, safety hazard** - Repairs are necessary at this time. Painting be advised on handrail/guardrail to prevent water/insect damage. Cracked tiles noted - Replace.

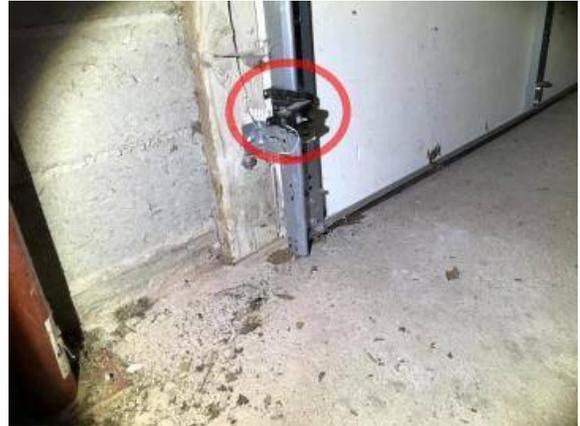
Eye sensor are installed too high from the floor. It should be installed 4-6" - Adjustment needed.

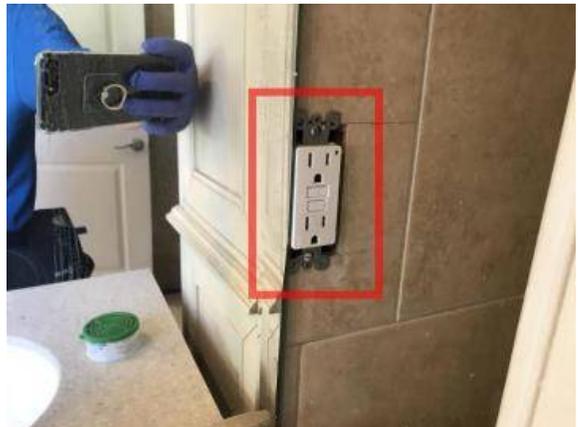
Missing or Damaged receptacle cover noted - Replace.

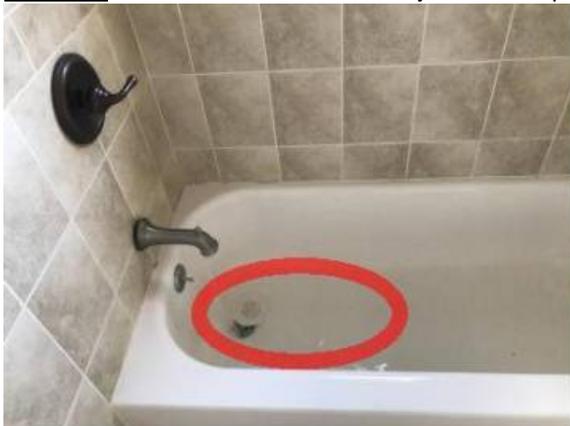
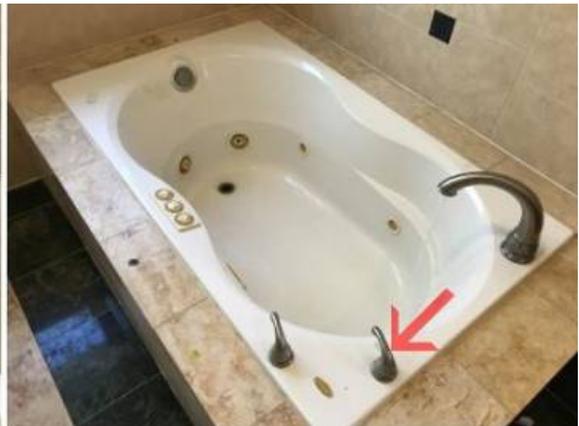
Whirlpool tub presented but not be evaluated during this inspection. Have a qualified service contractor test before closing. **Water leak noted at faucet handles/body in the master bathroom and the basement bathroom** - Replace washers or gaskets. Some type of faucet may require to replace entire faucet. Drainage is slower than normal preventing functional drainage in the first floor bathroom and 2nd bedroom bathroom. This should be evaluated by a licensed plumber.

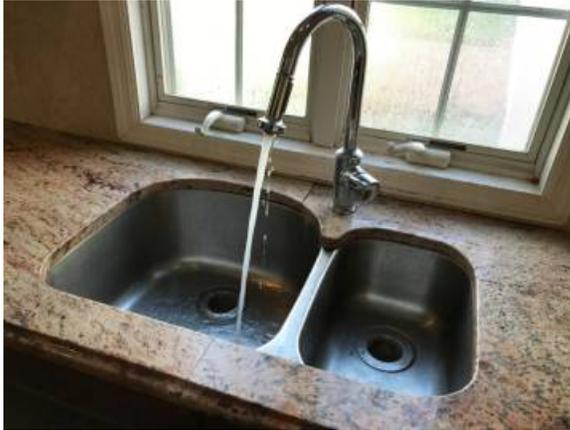
Leakage is noted at the drain line - Repairs are necessary.

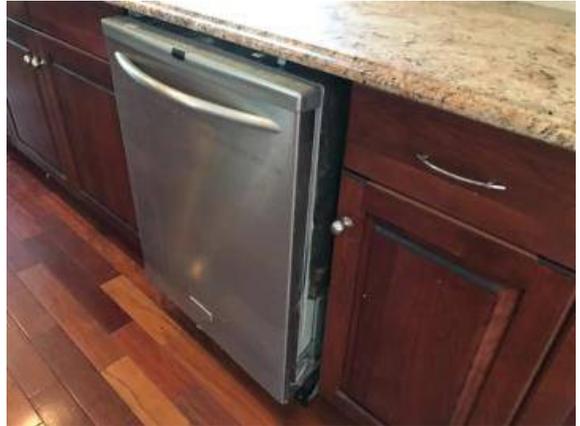
The dishwasher is not operational - Repair or replacement is recommended.

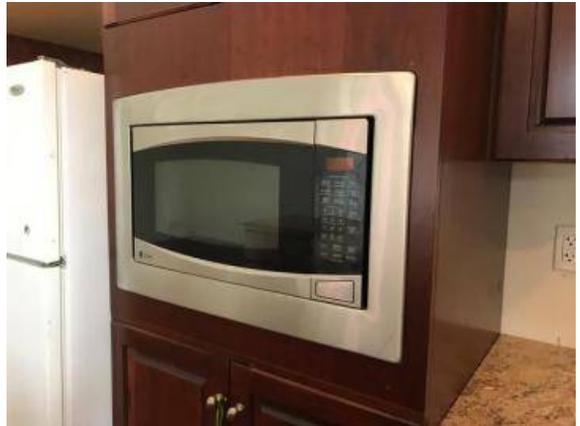
Not working - Further evaluation recommended.

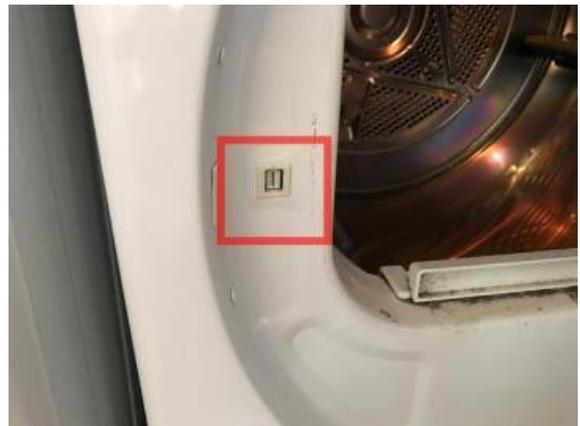
CLOTHES WASHER:
The cloth washer(s) was not operable. Replace.

CLOTHES DRYER:
Gas. Inoperative at the time of the inspection die to door lock switch defect - Repair.

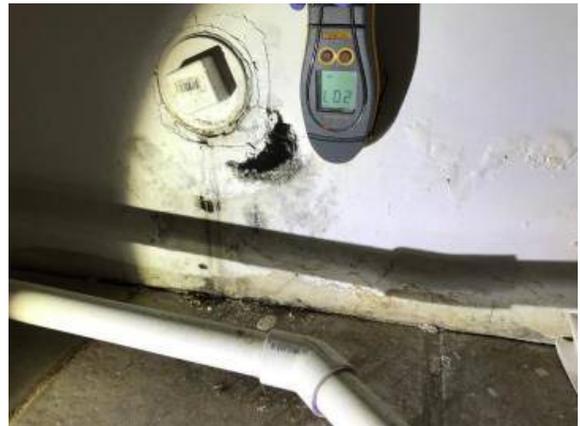
Leaks noted on the utility room wall. Moisture meter reading indicates high level of moisture around plumbing plug. **Mold growing also indicates moisture issue.** Remove damaged drywall and have a licensed plumber evaluate further.

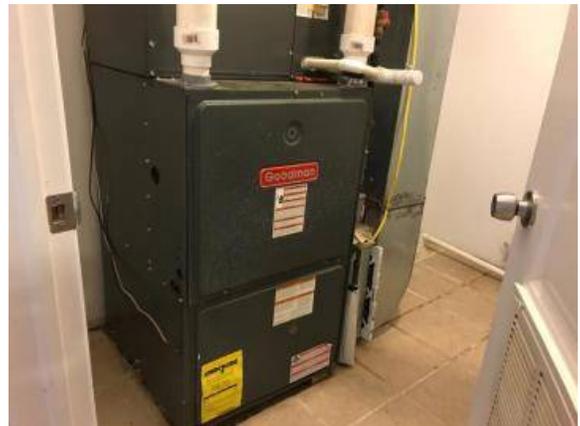
The unit is Goodman brand. Capacity of the unit is 110001~120000 BTU. Approximate age of the unit is 13 years, manufactured in 2007. Conventional gas furnace has 20 ~ 25 years of average life span.

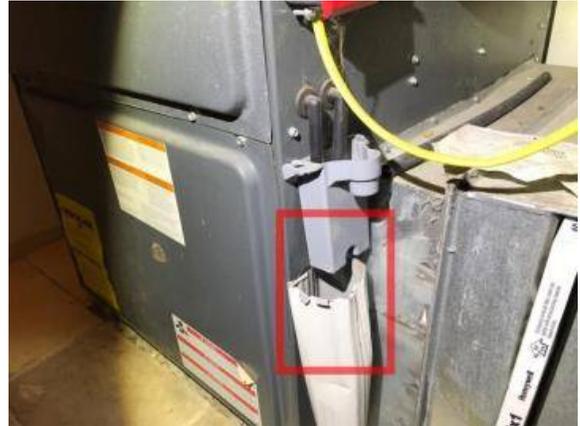
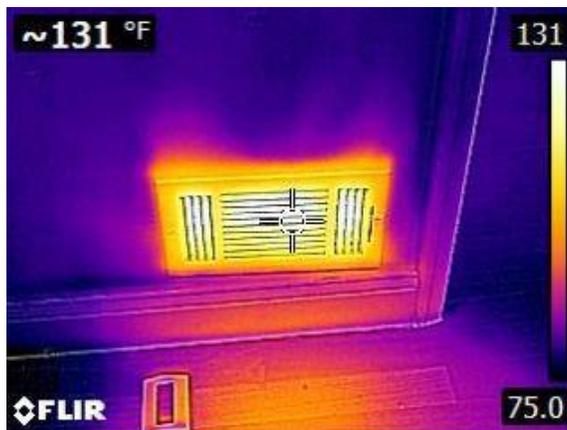
Condensate drain line missing. It should be discharged proper location. Have a licensed plumber install a drain line.

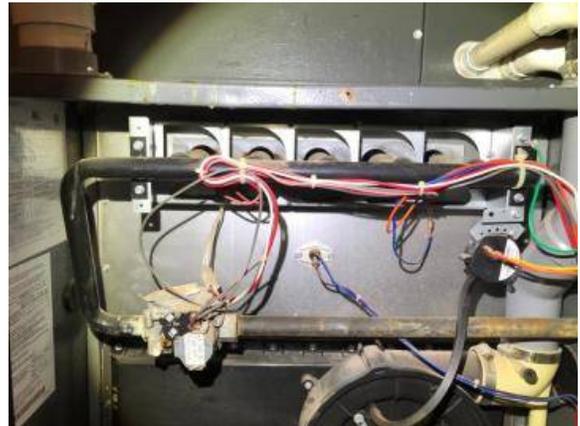
A gas shut off is present, but NOT tested during this inspection. A visual inspection of the visible areas of the burner tubes and the heat chamber appear satisfactory.

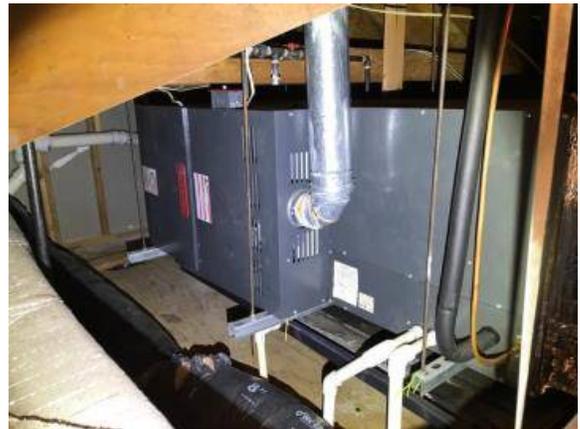
The unit is Goodman brand. Capacity of the unit is 130001~140000 BTU. Approximate age of the unit is 13 years, manufactured in 2007. Conventional gas furnace has 20 ~ 25 years of average life span.

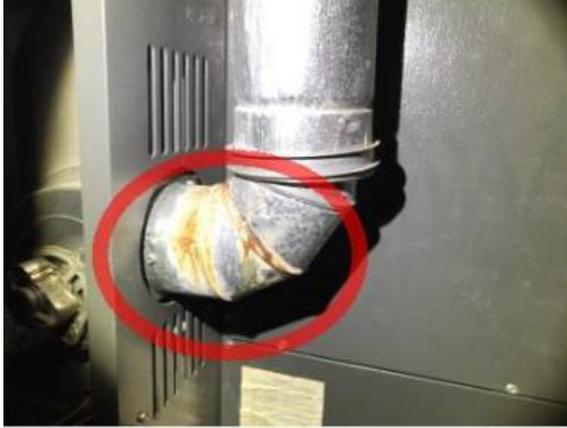
Rusted vent flue and sign of water leaking from the roof were observed. Have a qualified roof contractor inspect roof flashing (Refer to roof exposed flashing section)

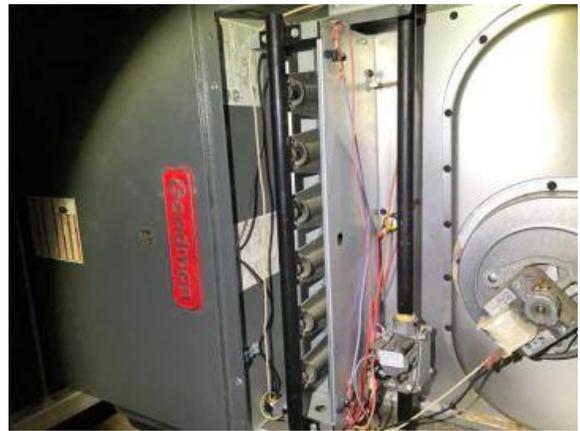
A gas shut off is present, but NOT tested during this inspection. A visual inspection of the visible areas of the burner tubes and the heat chamber appear satisfactory.

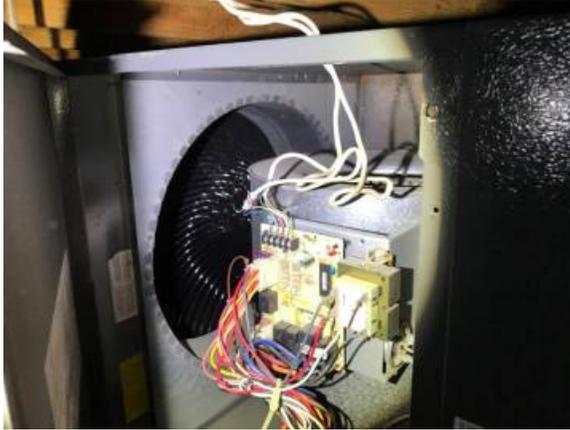
Dirty filters reduce airflow and increase cost of operation for heating. Replacement recommended at this time.

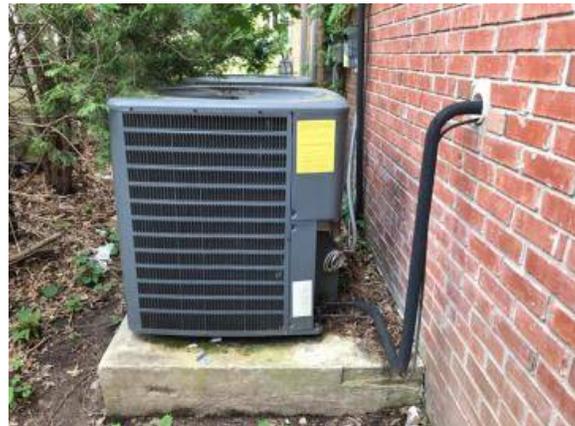
Central system - The average life of a condensing unit (compressor) is 17-20 years. The system is Goodman brand. Approximate Compressor age is 10~12 years, manufactured in 2008. Capacity of the unit is approximately 5.0 ton. EPA stated that 1 ton(12000 BTU) of capacity covers approximately 400 to 500 square feet for old building and 800 to 1000 for well sealed, insulated building.

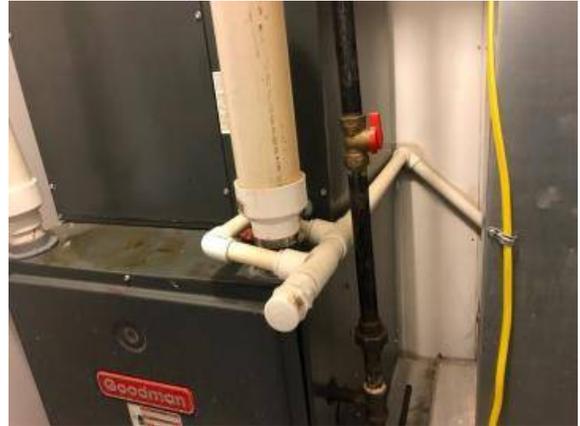
The condensate drain lines are installed without visible damage at this time.

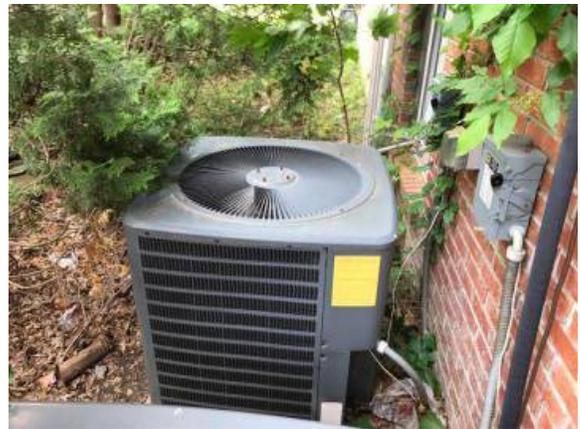
Central system - The average life of a condensing unit (compressor) is 17-20 years. The system is Goodman brand. Approximate Compressor age is 10~12 years, manufactured in 2008. Capacity of the unit is approximately 5.0 ton. EPA stated that 1 ton(12000 BTU) of capacity covers approximately 400 to 500 square feet for old building and 800 to 1000 for well sealed, insulated building.

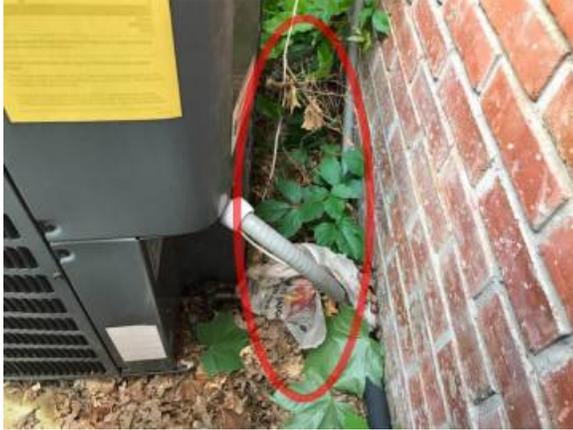
Recommend clearing foliage from unit; Not enough clearance.

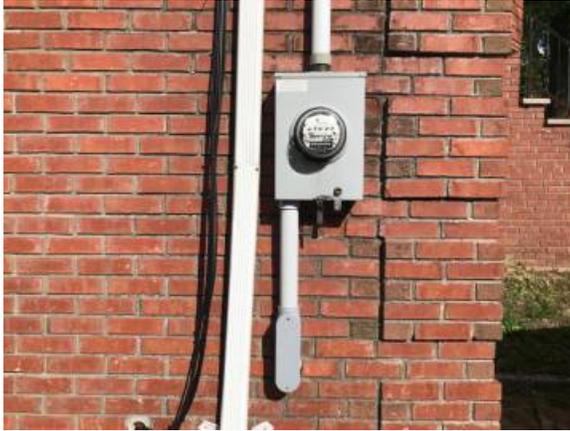
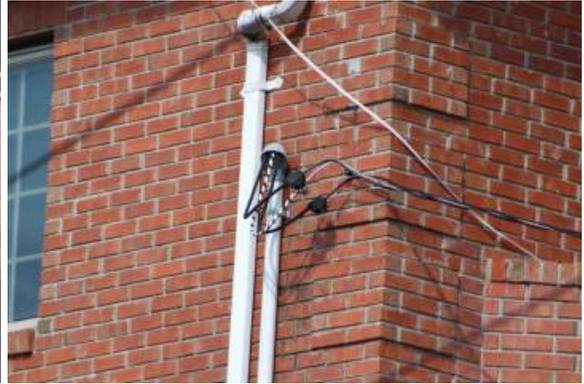
Overhead Electric Service, 120/240 Volt One meter presented. Electric service appears serviceable.

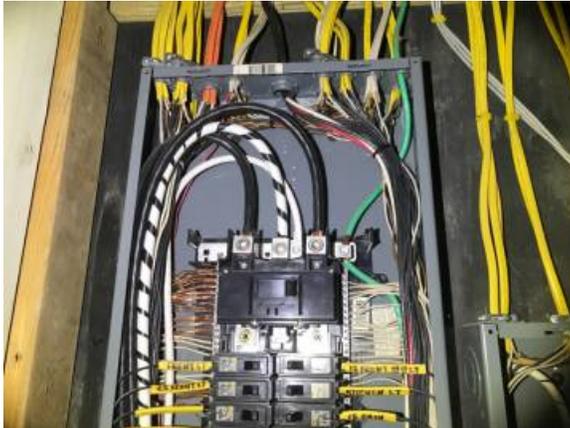
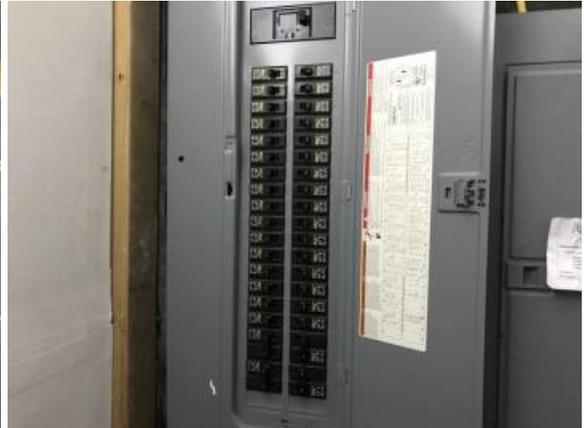
The electric panel is located in the basement. The main disconnect is in the main panel. Circuit breaker type main panel is being used. Service Size is 200 amps.

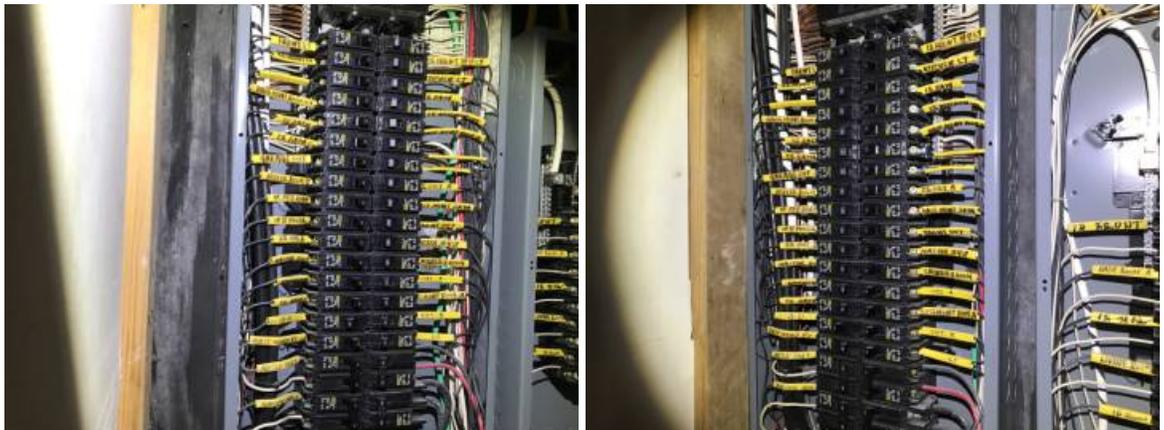
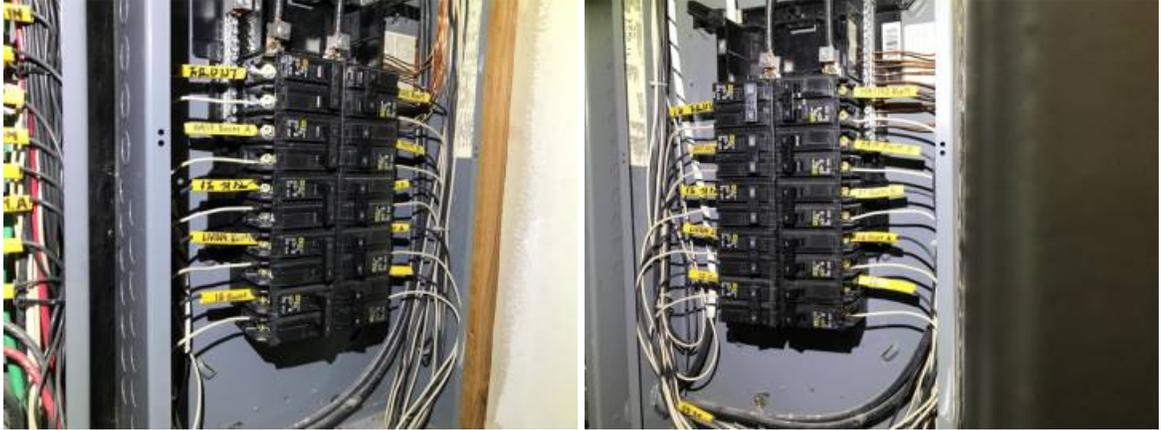
TYPE & CONDITION:
Non-metallic sheathed type wires being used. Copper wire being used, The visible branch wirings appear serviceable.

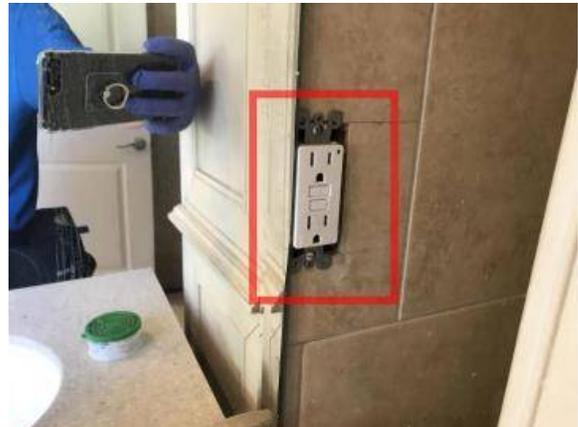
Missing or Damaged receptacle cover noted at the master bathroom - Replace.
