Dornier 328

This sheet transmits Revision 2 to Alert Service Bulletin ASB-328-57-037 titled: Wings – Inspection of the Lower Inner Panel for Cracks.

No. ASB-328-57-037

Title: Wings - Inspection of the Lower Inner Panel for Cracks.

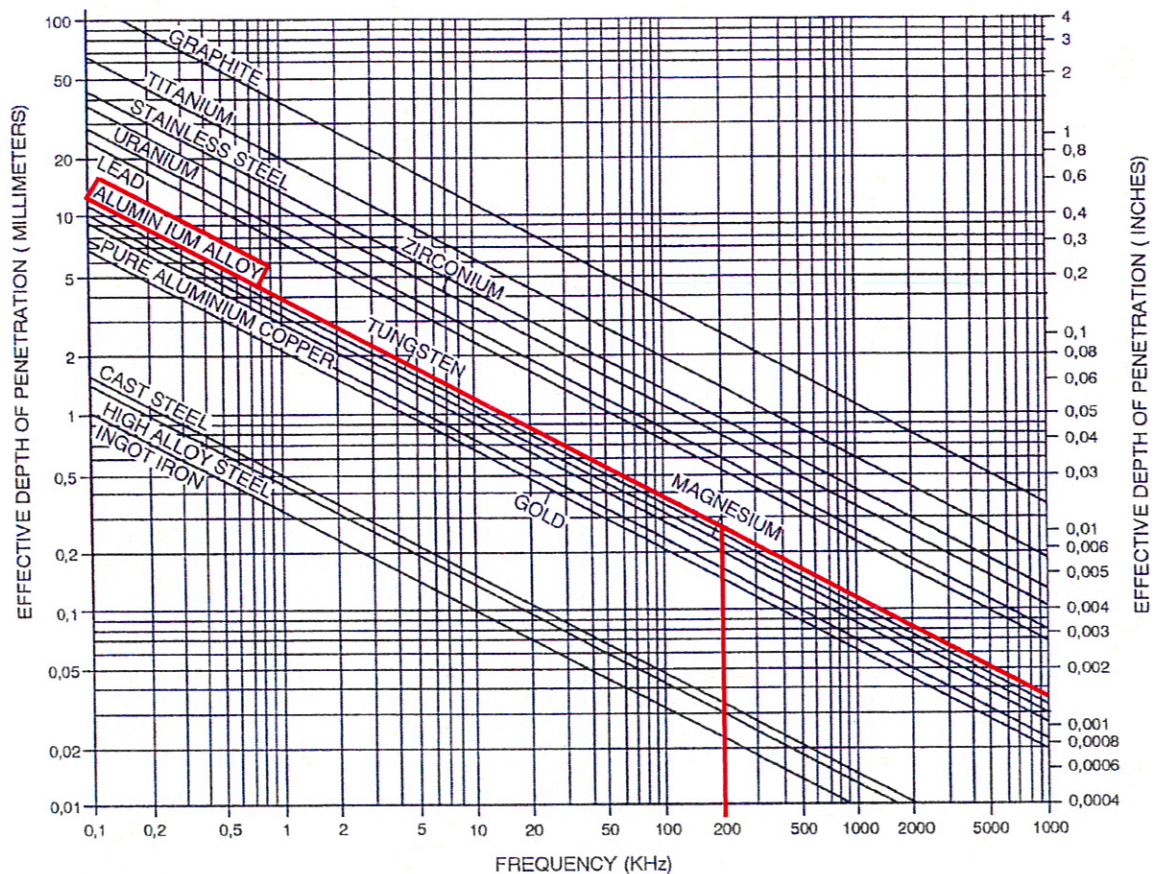
**Diagram 1: Depth of Penetration versus Frequency
(according NTM 51-25-60, Page 4, Fig.2)**

- (d) Calibrate the instrument using the calibration standard as given in the manufacturer's instructions.
- (3) Perform an Eddy current NDI in the area marked in Fig. 2, Fig. 3 and Fig. 1 (for cracks detected in former inspections).
- (a) Set the necessary frequency to 200 KHz according to NTM 51-25-60, page 4, "Depth of Penetration versus Frequency" (refer to Diagram 1).

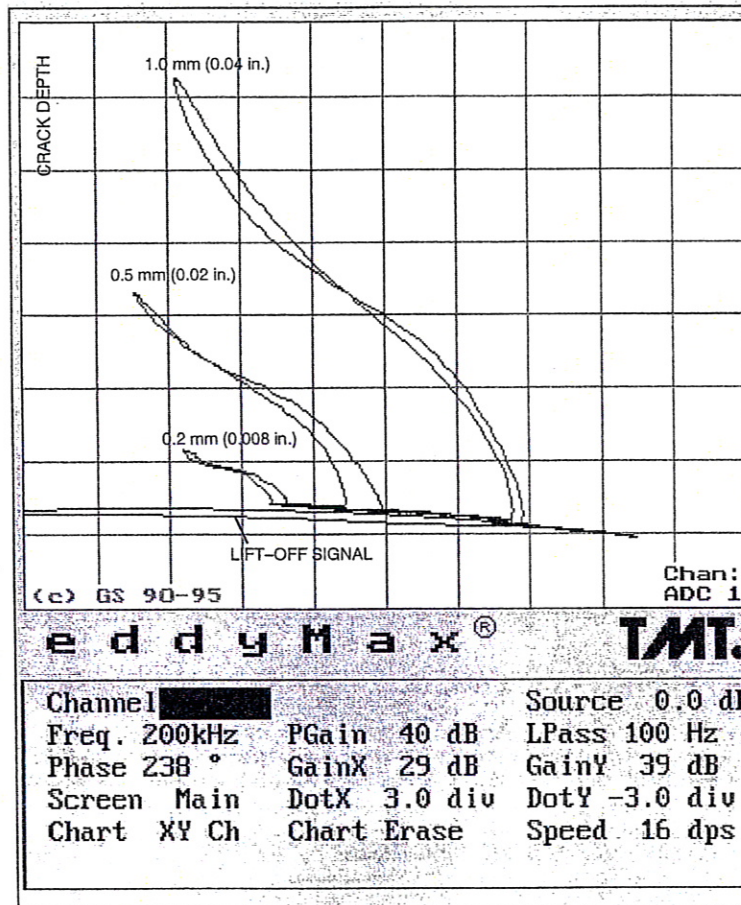
Diagram 2: Equipment calibration signal according NTM

- (b) Calibrate your equipment using the calibration standard according NTM to achieve the crack signal for 1.0mm located at approximate 80% Screen Height (refer to Diagram 2). Put the probe on the compensation point near to the inspection area and set the lift-off as necessary, refer to Fig. 2.
