INTRODUCING GEOSPRAY

AN ENVIROSTRAW PRODUCT

What is GeoSpray?

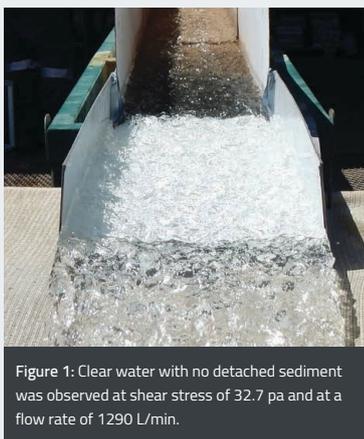
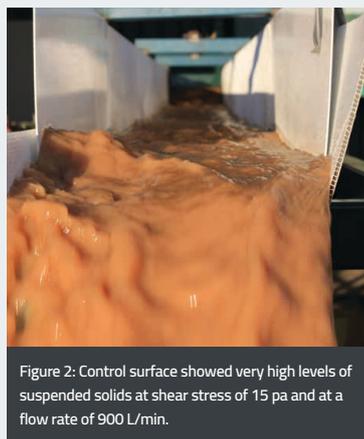
INDEPENDENT TESTING

Independent testing has proven that GeoSpray delivers near-perfect erosion control - the effectiveness of GeoSpray as a soil surface stabiliser under concentrated flow conditions goes beyond expectations.

Results show that the application of GeoSpray to bare soil increased the surface strength to a point that, at maximum flow rate (based on testing equipment used), no erosion to the underlying soil occurred. This means EnviroStraw has not yet discovered a fail point for Geospray.

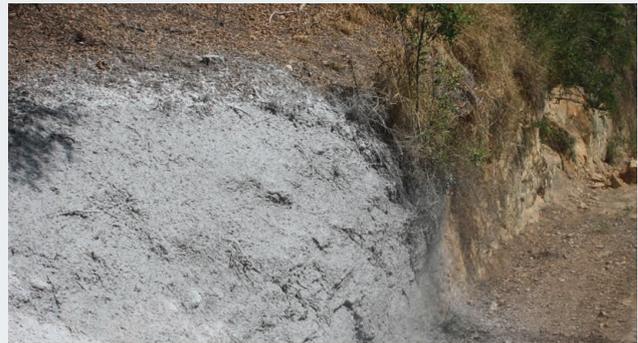
November 2012

GeoSpray was applied to the surface - a combination of soft sand, sandstone and rock - six weeks before a major cyclone hit. Cyclone Oswald caused extensive damage to the area and severe flooding in the Brisbane region.

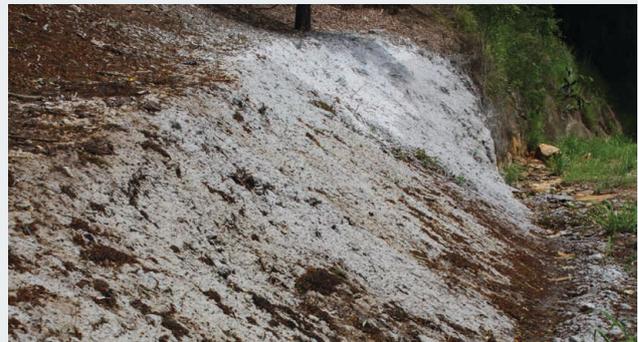
Post-Cyclone Oswald: January 2013

The area received more than 400mm of rain over a 24 hour period. The grassed areas (treated with GeoSpray) experienced a significant run-off, yet the surface held fast, did not crack or lift, and remained stabilised.

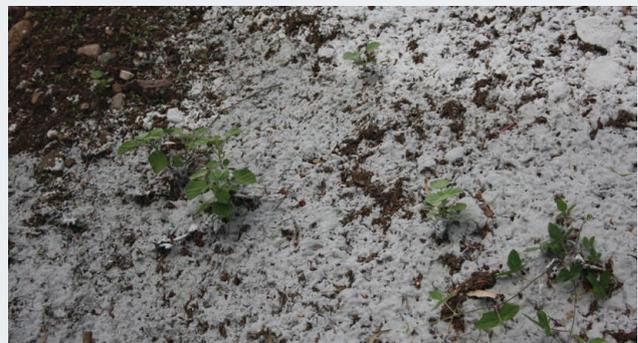
The highly bonded fibre matrix of the coating had little or no visible sign of delamination. Adhesion to the substrate was exceptionally good.

Little or no sign of delamination

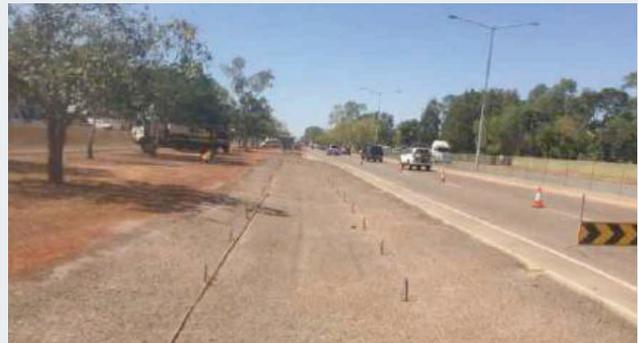
EnviroStraw applied GeoSpray plus grassing at an application rate of 1:5:1 to prevent further erosion and washouts. The site was irrigated three times daily for 15 minutes.

Immediately after application

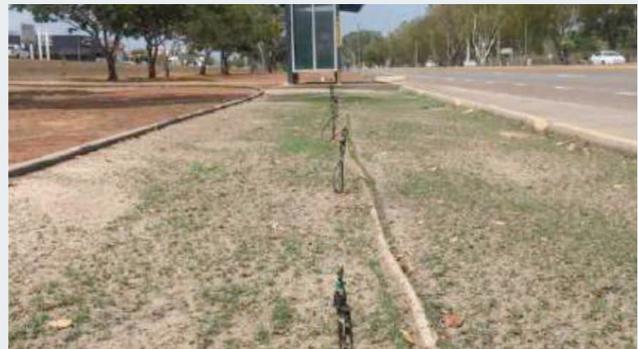
One month after application

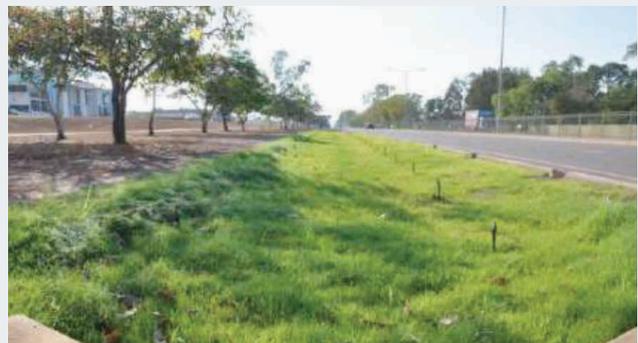
The GeoSpray membrane held fast despite the heavy irrigation. The grass grew in thickly and remains plush and well-established.

Two months after application
