TANK BATTERY SITE BIOREMEDIATION

Site Description and Soil Sampling

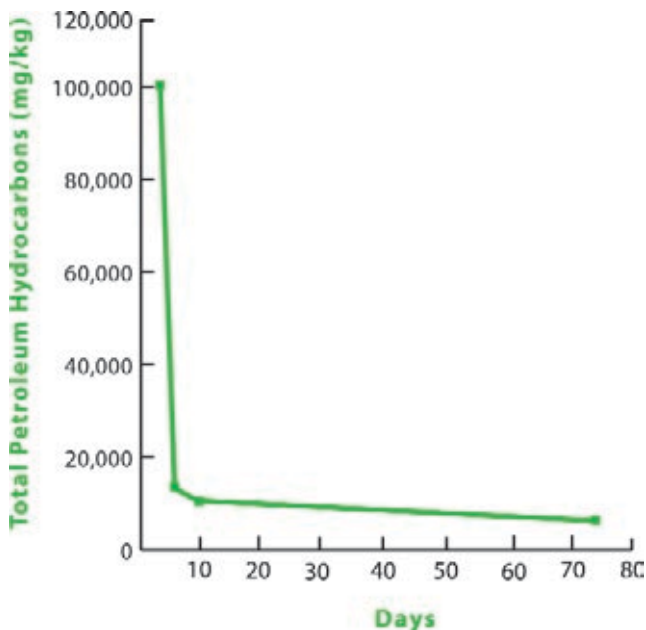
An initial soil sample for the site was a composite taken from the five identified areas. This sample was analyzed and determined to contain 102,000 mg/kg TPH. The day 5 sample showed the TPH level to be 14,500 mg/kg, an 86% reduction. On day 10, the TPH was 11,100 mg/kg, an 89% reduction from the initial level. On day 24, five samples were taken at each area of contamination. The average of these TPHs was 8,046 mg/kg, a 92% reduction from the initial TPH. The tank battery site is under the jurisdiction of the Texas Railroad Commission; which requires soil TPH to be no higher than 10,000 mg/kg. TPH degradation at the tank battery site was excellent, with average TPH below the maximum allowable level by day 74.
