SCT Logistics, Penfield, SA

We were contacted by SCT Logistics in early 2020, subsequent to them receiving an engineer's report regarding their facility on Ranger Road at Penfield. The steel required remediation to ensure the structural integrity of the canopy at their depot.

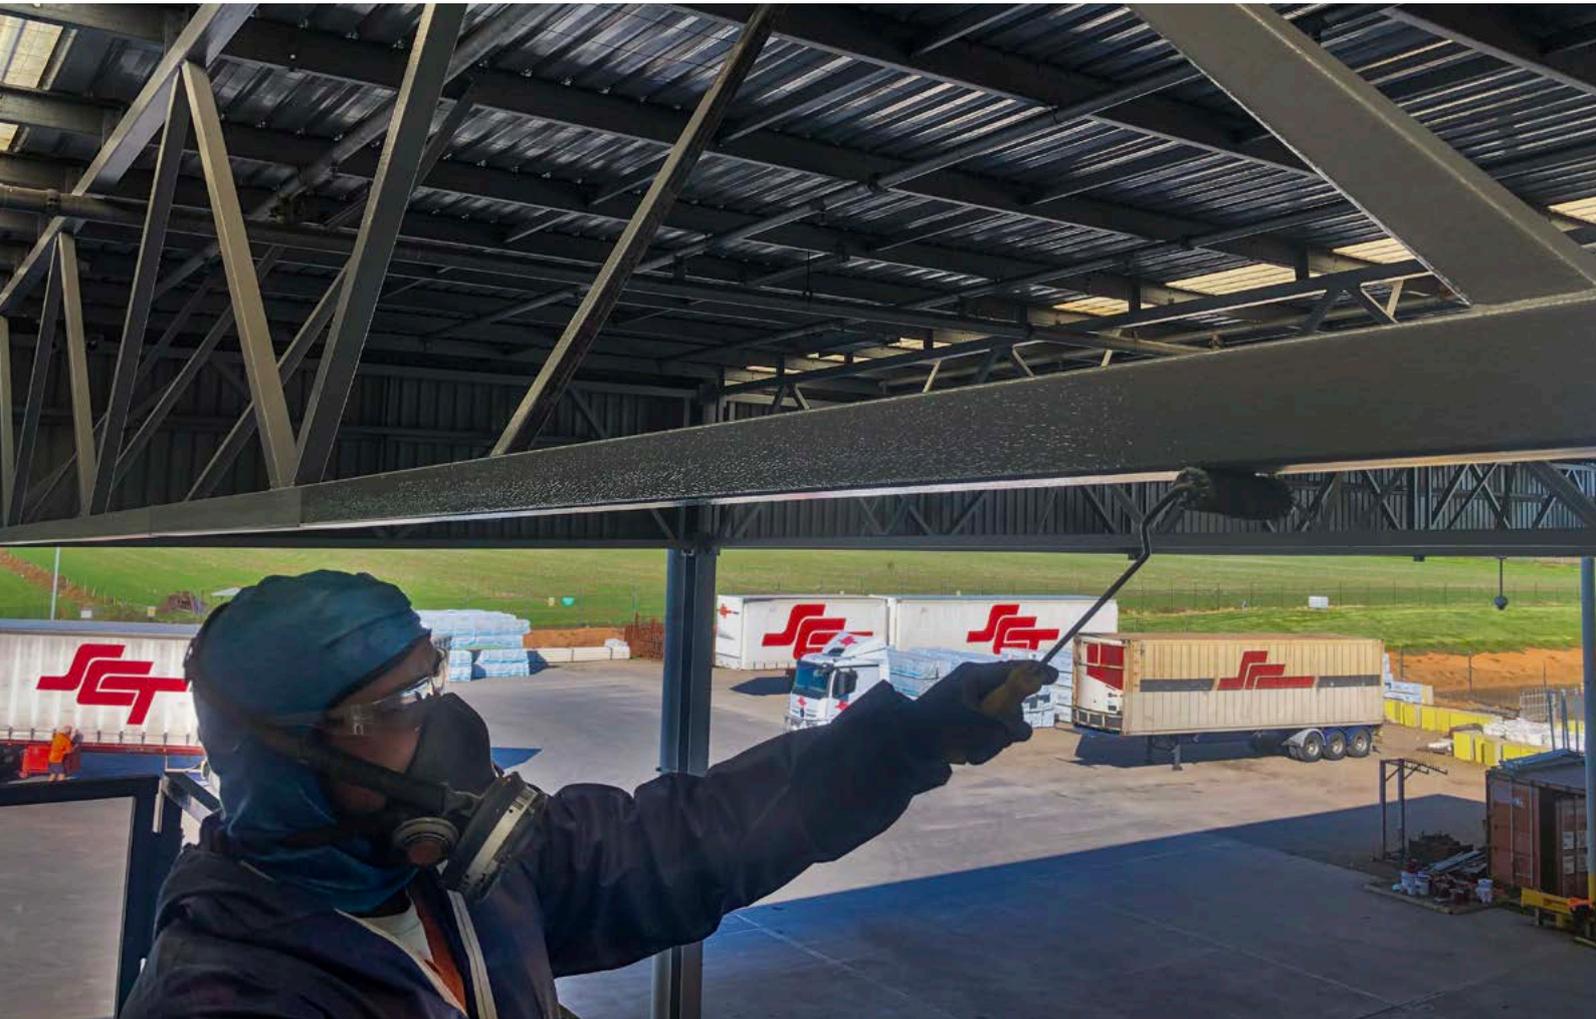
Steel exposed to the elements was showing signs of rusting and deterioration. If not acted upon quickly, this rusting could result in damage to the structure which would impact the business and its key stakeholders.

Surfaces to be coated were cleaned, rust was removed and other surfaces sanded to create the correct profile for the coating. Once surfaces were correctly prepared, the coating was applied to prevent any further damage to the steel.

Rusted areas of steel were then cleaned to level SP3 and all other areas were sanded to create the correct profile for the adhesion of coatings.

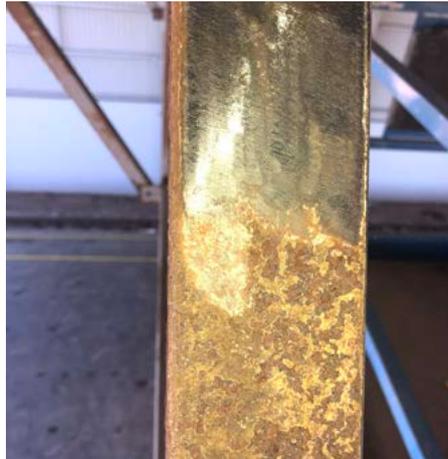
The treated steel, showing its condition before and after cleaning and rust removal

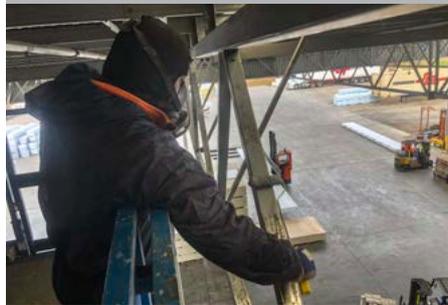
Painting in progress using a roller to ensure that surfaces and workers below were not subject to any product overspray

The coating was applied in two coats to achieve the required thickness.

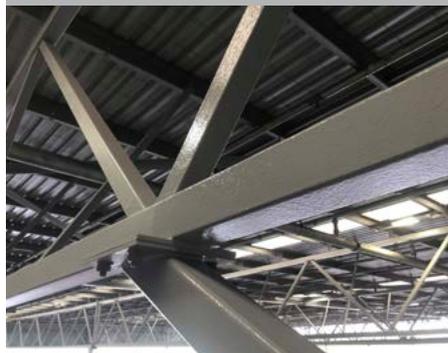
Trusses and beams following application of two coats of epoxy coating to a combined DFT of not less than 200µm

On completion DFT testing was conducted to confirm the required thickness was achieved.
