Three bridges, Adelaide Hills

In April 2018 Swart & Sons were contracted by the Department for Infrastructure and Transport (DIT) to carry out cleaning and protective treatment to structural steel components of three bridges in the Adelaide Hills. One of the bridges contained lead paint so strict WHS and environmental conditions needed to be adhered to, ensuring no lead residue affected Swart workers, members of the public or the environment.

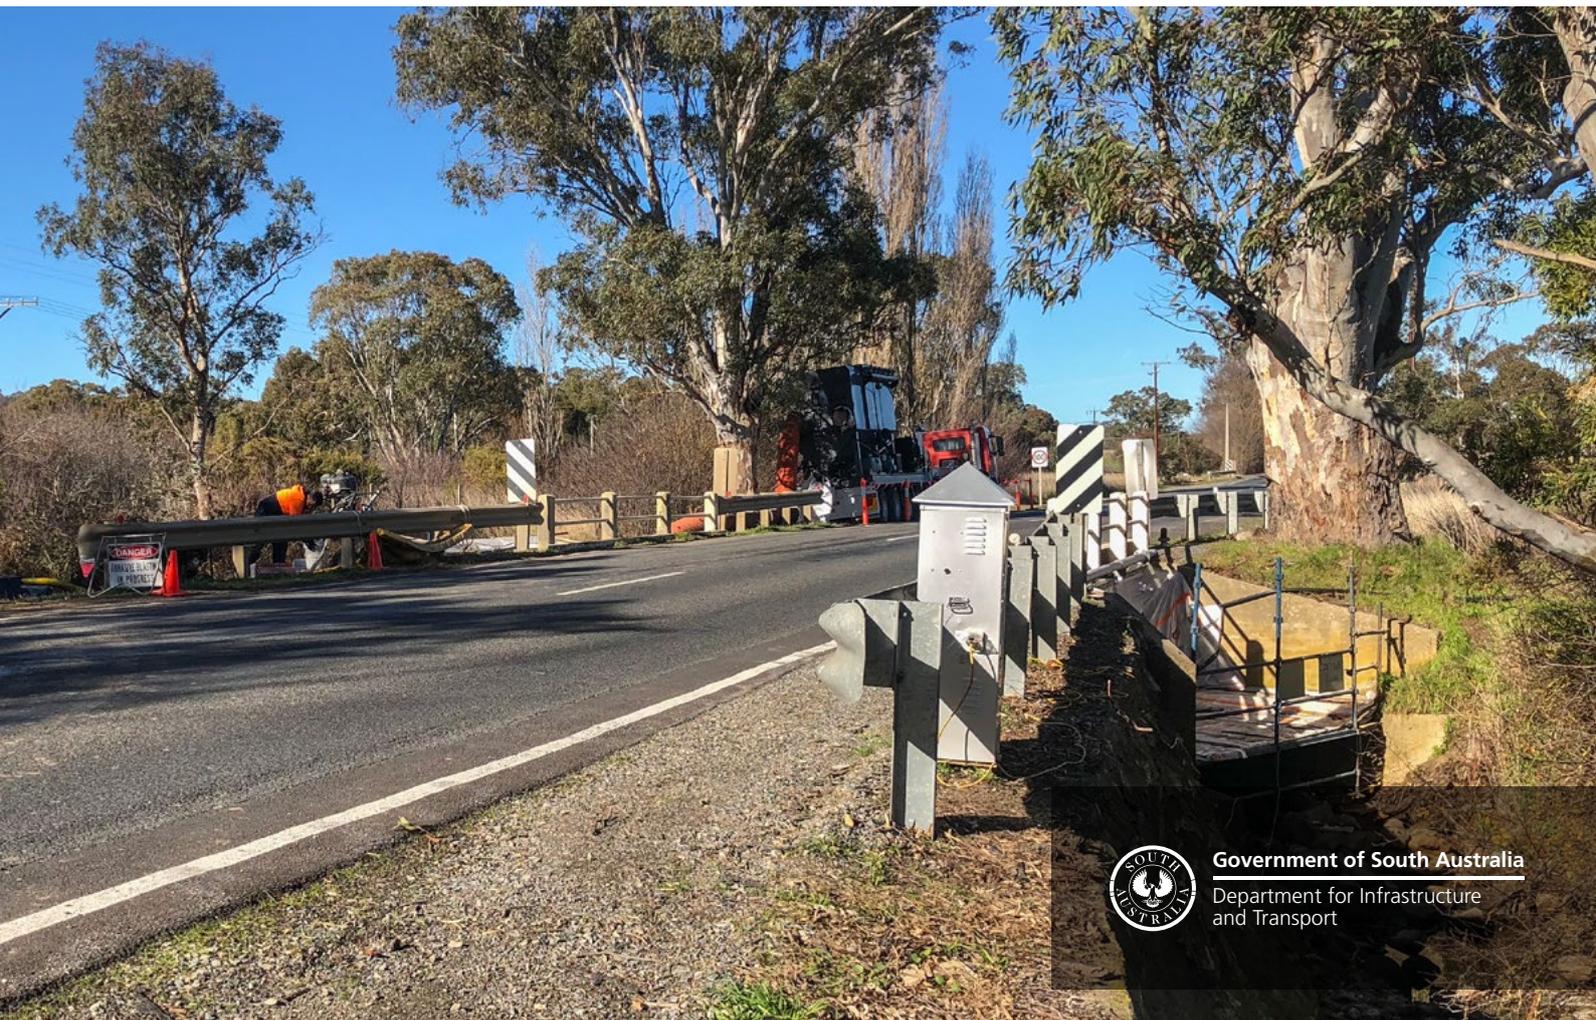
Concrete repairs carried out on the underside of the bridge located on Torrens Valley Road

Steel beam repairs encompassed welding steel plates to the existing beams whilst concrete remediation consisted of breaking out damaged concrete and applying a zinc rich primer to exposed reinforcement.

Larger repairs were formed-up and filled with repair mortar whilst smaller crack repairs were injected with an epoxy binder/adhesive.

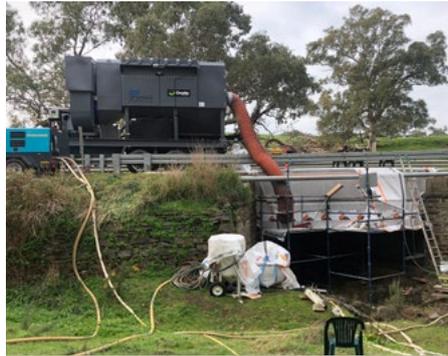
Bridge contained with dust extraction in place, enabling work to be carried out whilst protecting the surrounding area and creek underneath

Before commencing any work, containment was established to ensure all debris was captured.

This was facilitated by erecting scaffolding, around which we built timber framework, and lining the sides and floor with heavy-duty, geo-textile fabric.

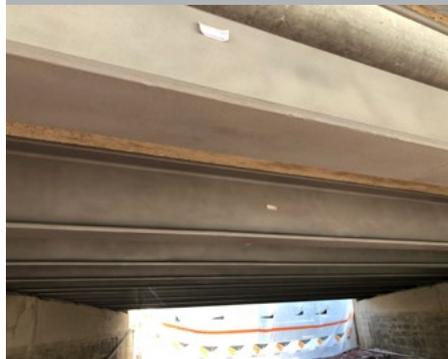
Beams under the bridge after abrasive blasting, showing profile testing being carried out and containment in place

Initially we were contracted to carry out abrasive blast cleaning to the three bridges, plus application of a three-part protective coating system.
