Mason-Likar electrode configuration can confound the recognition of electrode cable interchange

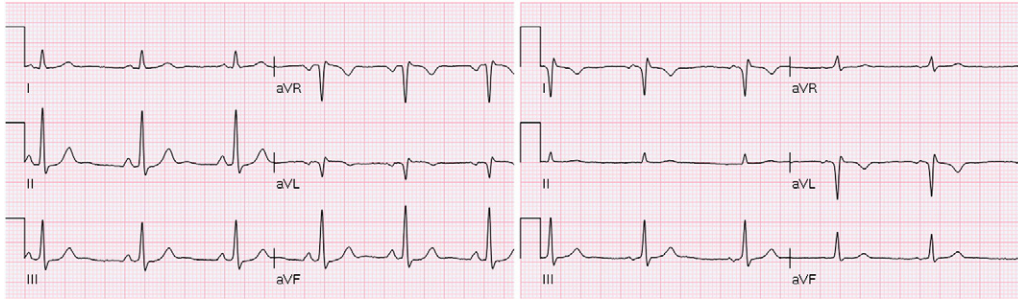
Fig. 1. A 12-lead resting ECG with correct (top panel) and with incorrect (bottom panel) cable connections.

Fig. 1 (left panel) presents a 12-lead resting electrocardiogram (ECG) acquired in a healthy subject who has participated in a drug trial. Except for a mild prolongation of the QRS complex to 114 milliseconds, the ECG is within normal limits. The ECG presented in Fig. 1 (right panel) has been recorded in the same subject 8 minutes later using the same set of electrodes. Obviously, the second ECG has been acquired with incorrect cable connection, but exactly which cables were interchanged?

In this case, the right arm and right leg (ground) cables have been swapped. However, the telltale sign of this technical mistake,¹ namely, a (almost) flatline in lead II, is missing, although the amplitude of lead II is reduced. The reason is that the leg electrodes have been positioned on the iliac crests, in a modification of the Mason-Likar configuration,² instead of the ankles. Although the potential between the 2 ankles is practically 0, this difference is substantially greater between electrodes positioned on the abdomen and increases further when the electrodes are moved further cranially on the abdomen.³ Therefore, if, in this case, the leg electrodes were positioned more cranially according to the original Mason-Likar configuration (“...in the anterior axillary line, halfway between the costal margin and the crest of the ilium.”²), the amplitude of “lead II” would be even higher.

In the ECG on Fig. 1 (right panel), there is a change in P wave morphology compared with Fig. 1 (left panel), which cannot be attributed to the cable misplacement because interchange of the right arm and right leg cables does not affect lead III.³ The likely cause is transient appearance of an ectopic atrial rhythm. Apart from that, the P wave shape in Fig. 1 (right panel) fits the expected changes because of right arm–right leg cable interchange.³ Because of the small amplitude of the P wave, the abdominal position of the neural electrode visibly affects to a much lesser degree the P wave than the QRS complex during right arm–right leg cable interchange.
