# PARTS BREAKDOWN

<b>Haws</b> <sup>®</sup>		1455 KLEPPE LANE SPARKS, NEVADA 89431 (775) 359-4712 FAX (775) 359-7424 E-MAIL: HAWS@HAWS.CO.COM WEBSITE: WWW.HAWS.CO.COM	
		ECN NO. REVISED PER BY ECN: 5218 JP	MODEL(S) 1119
DRAWN DATE CHKD F.VASQUEZ 04/15/98 GC	APPROVED DATE FV 11/23/17	REVISION 19	SCALE: 1:4 DRAWING TYPE: PARTS BREAKDOWN SIZE: A SHEET 1 OF 1

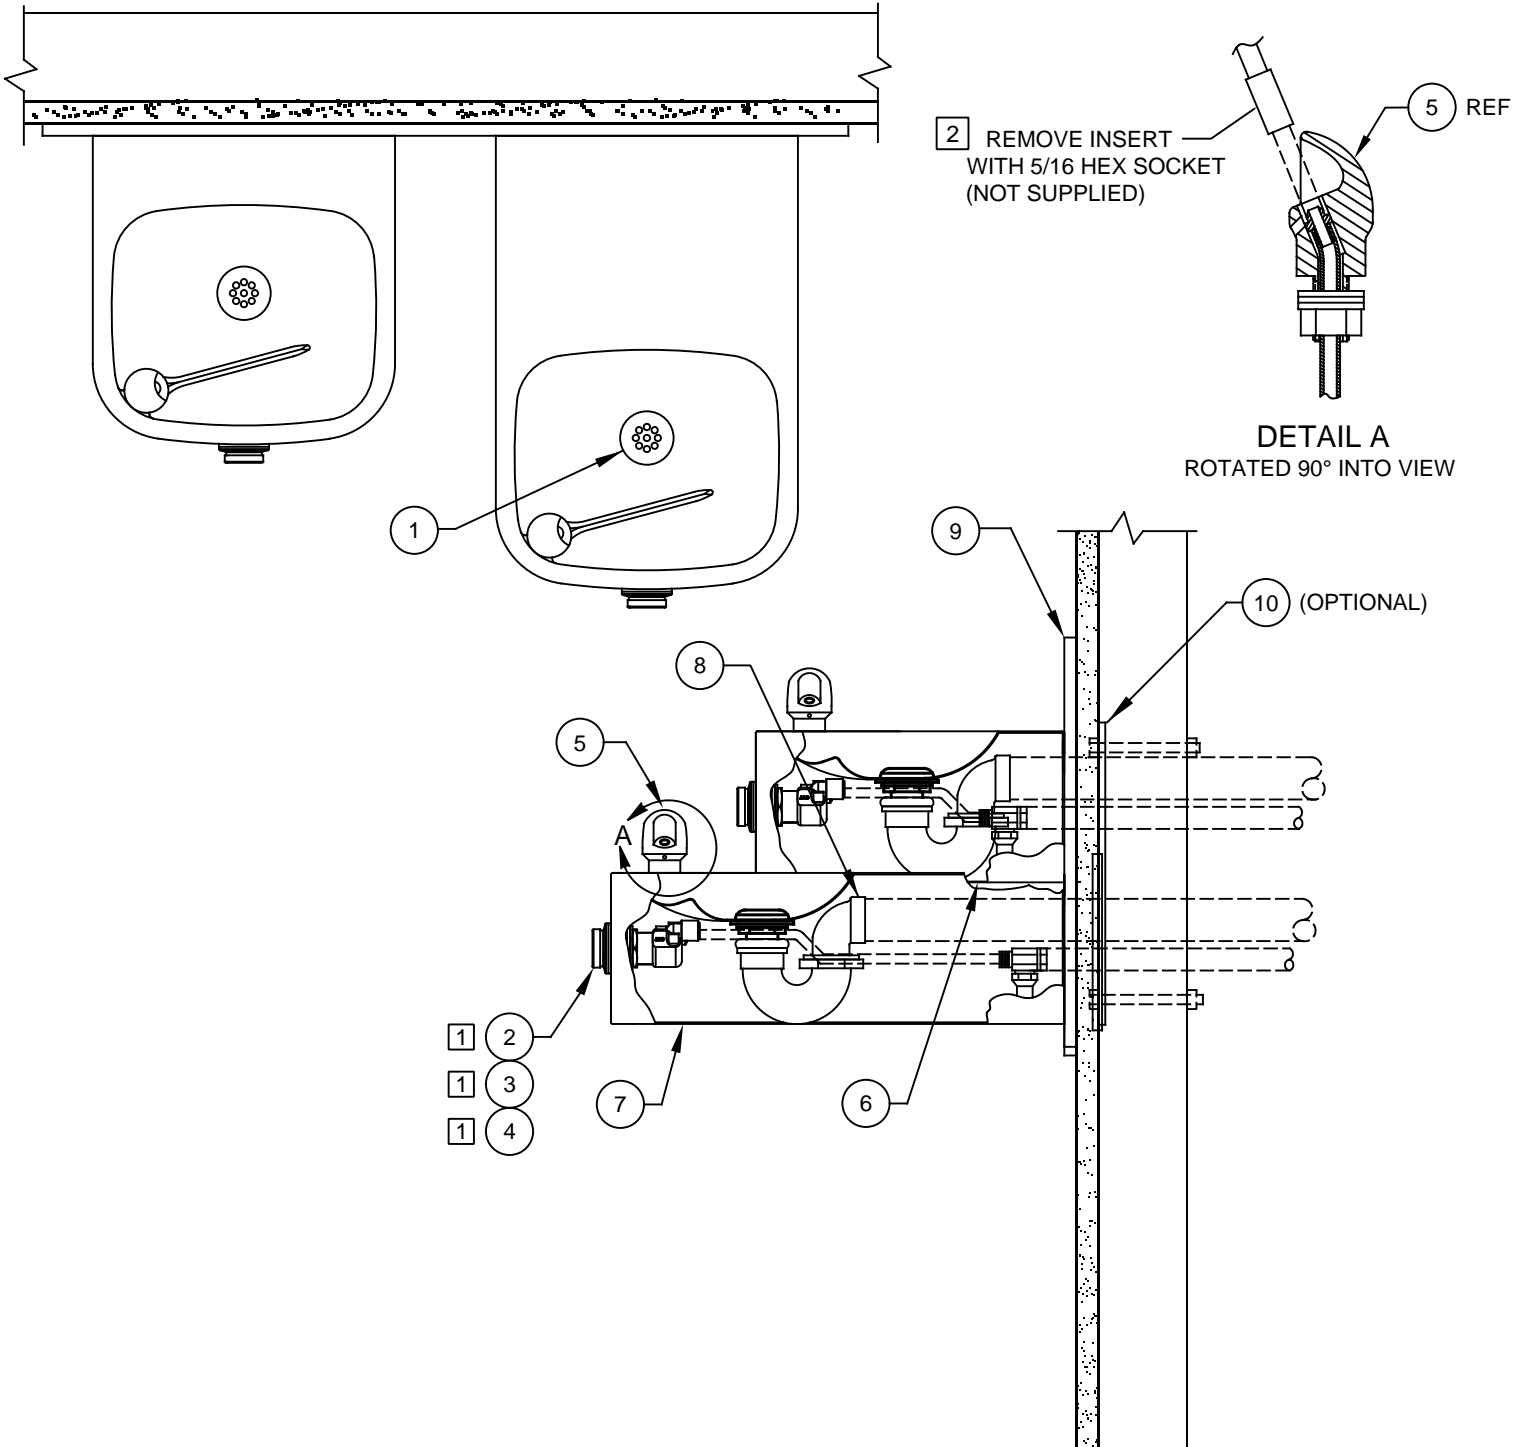
ITEM	DESCRIPTION	1119
1	STRAINER, WASTE ASSY	6462
2	BUTTON, PUSH, FLANGED, PCP W/ VALVE	5874PBF
3	VALVE REPAIR KIT	VRK5874
4	PUSH BUTTON ASSY	PBA6
5	BUBBLER HEAD ASSY, PCP	5703M
6	PLATE, BOTTOM	PBM1105
7	PLATE, BOTTOM	PBM1109
8	TRAP	0005982900
9	BACK PANEL	0004023580
* 10	PLATE, MOUNTING	6700.4

- 1 5874PBF (ITEM 2) INCLUDES VRK5874 CARTRIDGE ASSEMBLY (ITEM 3) AND PBA6 FLANGED PUSH BUTTON (ITEM 4).
- 2 ENSURE TUBE IS DISCONNECTED FROM PUSH BUTTON VALVE BODY PRIOR TO REMOVAL. APPLY ONE DROP OF LOCTITE 222MS TO NOZZLE THREADS PRIOR TO FASTENING BACK ONTO BUBBLER HEAD. RE-ATTACH TUBE TO VALVE.
