88 Plunger History

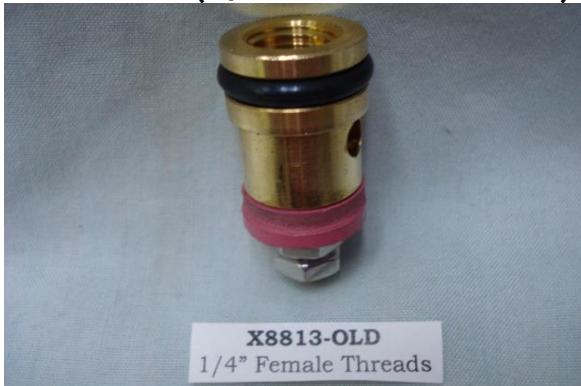
2004-2011 (1/4" Female Threads)

NOTE: This Plunger is NO LONGER available

In order to replace your 2004-2011 Plunger, you will order the X8813-RETRO. Remove the bell reducer and pipe nipple from the end of the rod and thread on the new plunger.

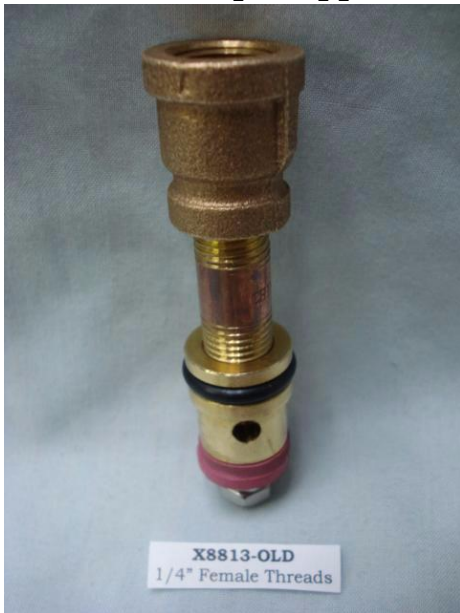
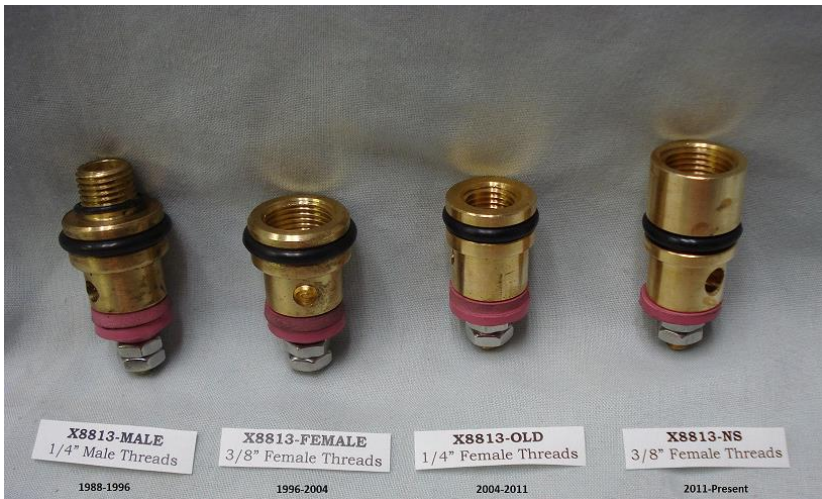
X8813-OLD attached to rod with a 3/8" x 1/4" Brass Bell Reducer and a 1/4" Pipe Nipple

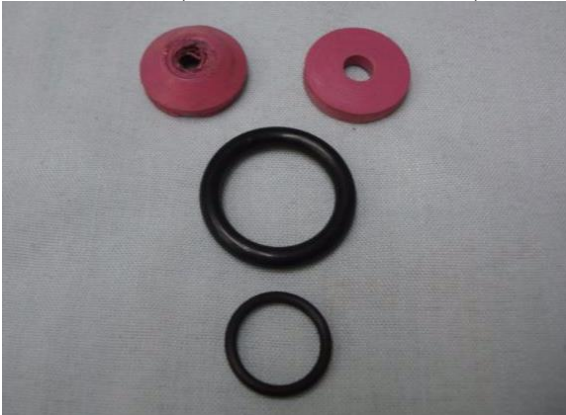
1988-1996 (1/4" Male Threads)

X884-MALE (88-11 O-ring, 88-12 O-ring, 418-A Flat Washer, 418-B Beveled Washer)

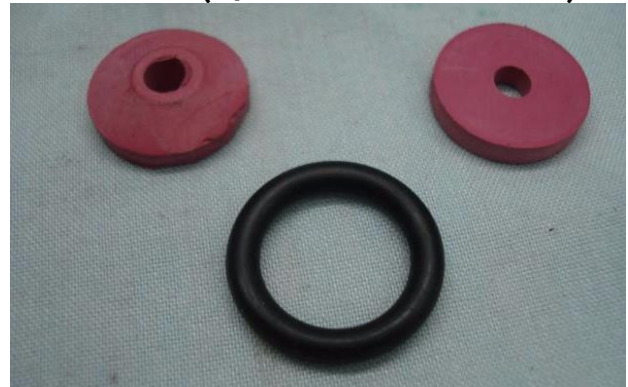
2004-2011 (1/4" Female Threads)

X884-OLD (88-21 O-ring, 418-A Flat Washer, 418-B Beveled Washer)

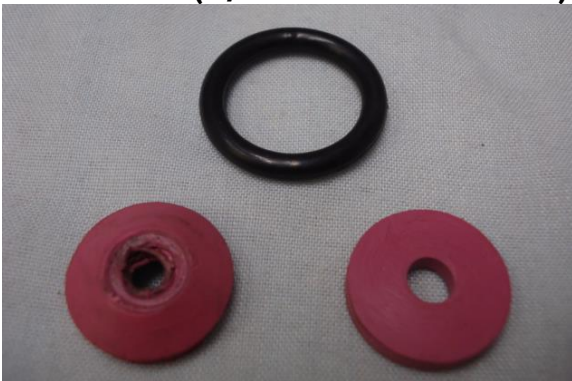
1996-2004 (3/8" Female Threads)

X884-FEMALE (88-12 O-ring, 418-A Flat Washer, 418-B Beveled Washer)

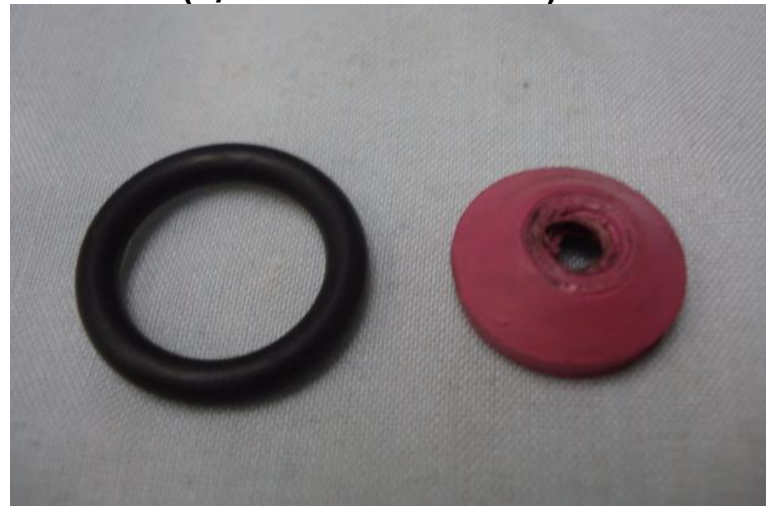
2011- (3/8" Female Threads)

X884 (88-21 O-ring, 418-B Beveled Washer)
