STRAIGHT·UP  
INSPECTIONS

# CERTIFICATE OF INSPECTION

Client	J Sample
Address of Property	Sample Street, Tauranga
Inspector	Alistair Simpson
Company	Straight Up Inspections
Position	Director
Qualifications	Builder
Date of Inspection	28 Jan 2019

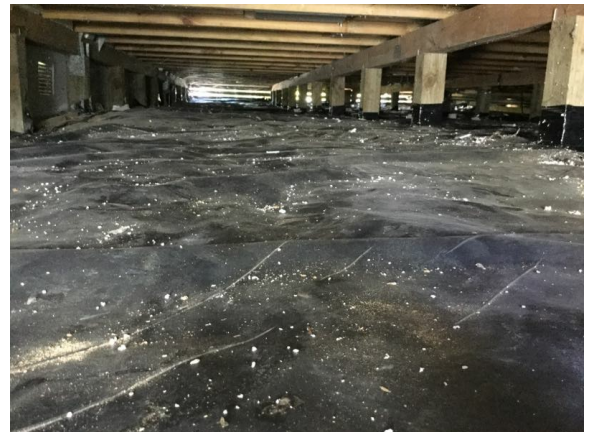
The ground under the building was dry at the time of inspection. There was no drainage sighted, a full vapour barrier covers the ground and there is good ventilation.

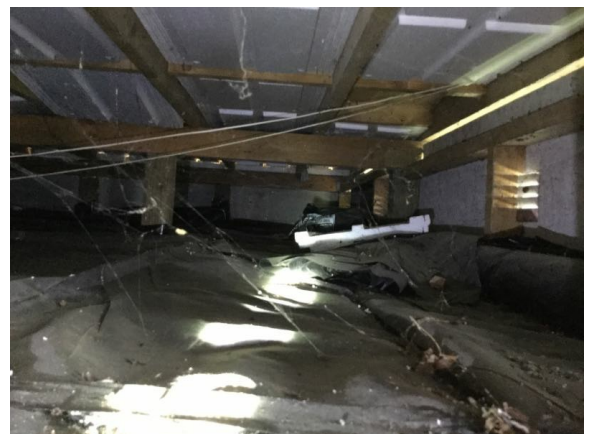
The subfloor framing is over the required minimum of 450mm above ground level.

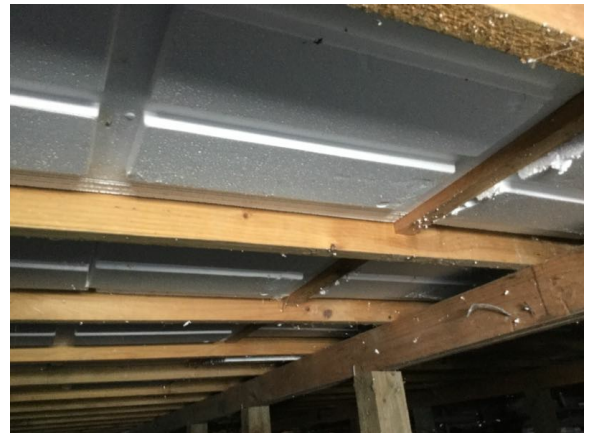
There is polystyrene insulation under the entire floor. The average thickness of the insulation is 6-8cm.

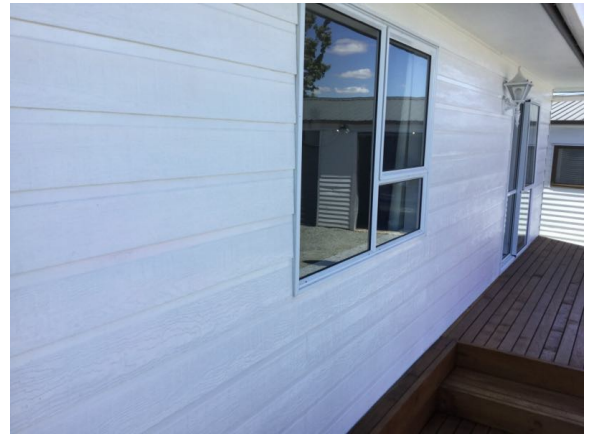
There is no cavity behind the cladding, this is common for a building of it's age.

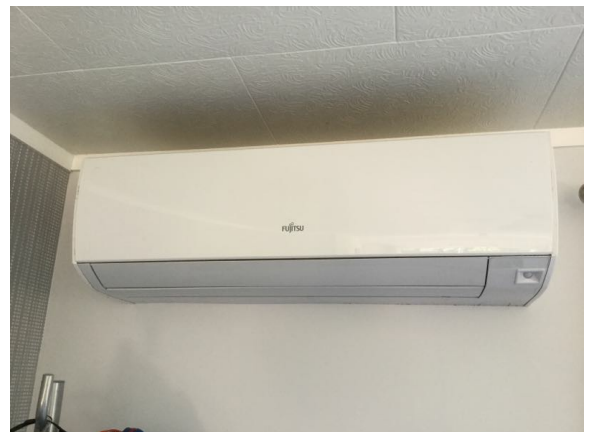
- Fujitsu heat pump. We suggest the filters are cleaned regularly and serviced as per manufacturers instructions. No heating systems were checked on the day of the inspection. Heating systems are a specialist field which require a specialist to carry out a separate inspection.

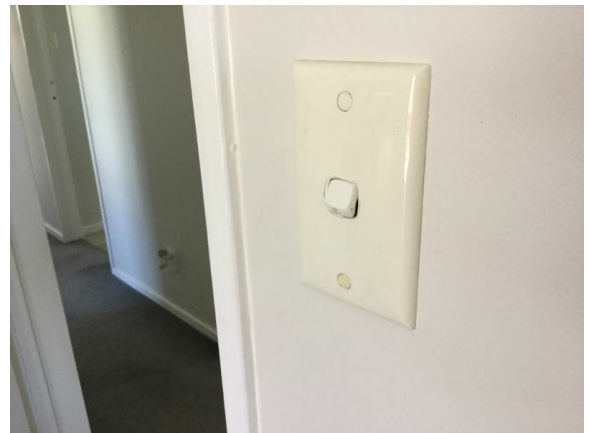
## Bedroom 1 - Electrical Switches and Outlets

Broken light switches: 1

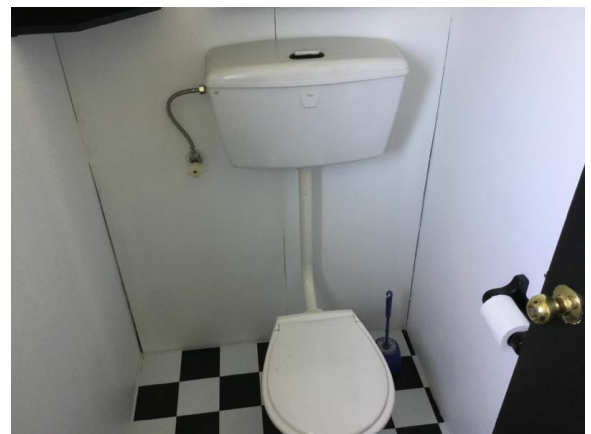
- Dux
- floor mounted toilet
- s-pan
- plastic, wall hung cistern
- single flush
- plastic seat and lid
